US Army Corps of Engineers

(Albuquerque District)

Floodwater Lessons Learned:

Best of Lessons Learned

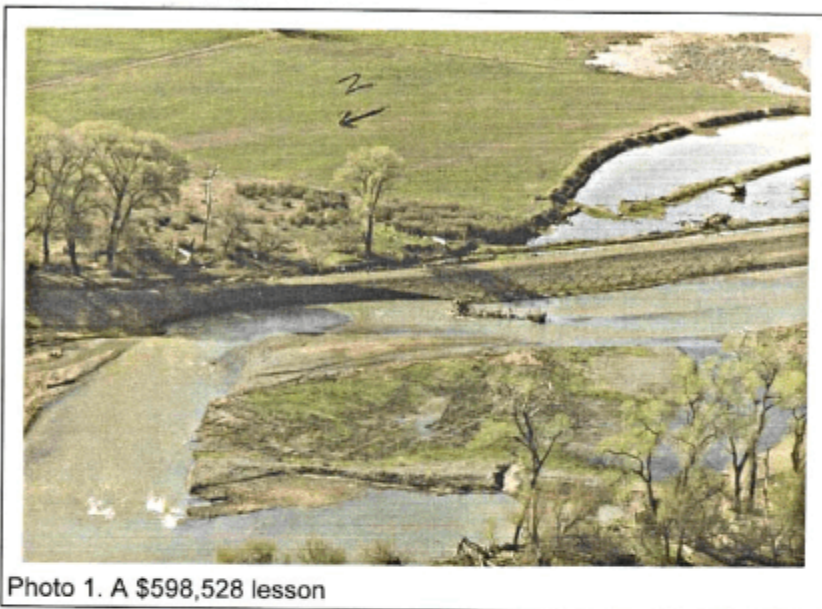
Photo 1. A \$598,528 lesson

Photo 1 has lessons to tell. US Army Corps of Engineers project DACW47-79-C-0055, 18,850 feet of levees and 1,375 feet of single-line jetty jacks, repaired 1978 flood damage on the Gila River, NM. The caption indicates the cost.

A 1980 flood damaged the levee toe. The sponsor, a private party, did not address progressive failure noted in Corps inspections. Flooding in 1983, the time of the photograph, further eroded the earthwork, flanked the levee, and pulled out the jackline, all visible in the picture. Flooding in 1984 destroyed the project.

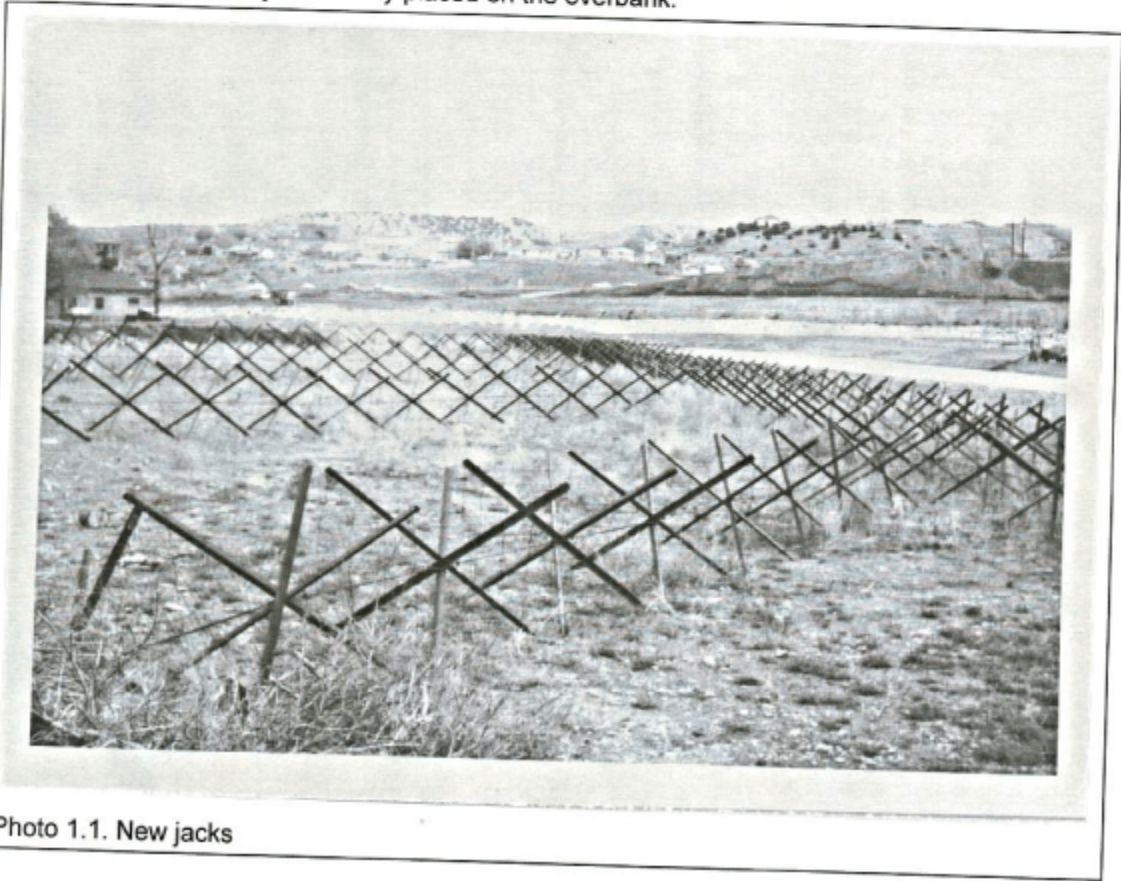
Photo 1.1. New jacks

The Kellner jetty jack is the pinnacle of Albuquerque District's engineering successes. Approximately 150,000 units have been installed. Only a few have failed. Photo 1.1 shows jacks newly placed on the overbank.

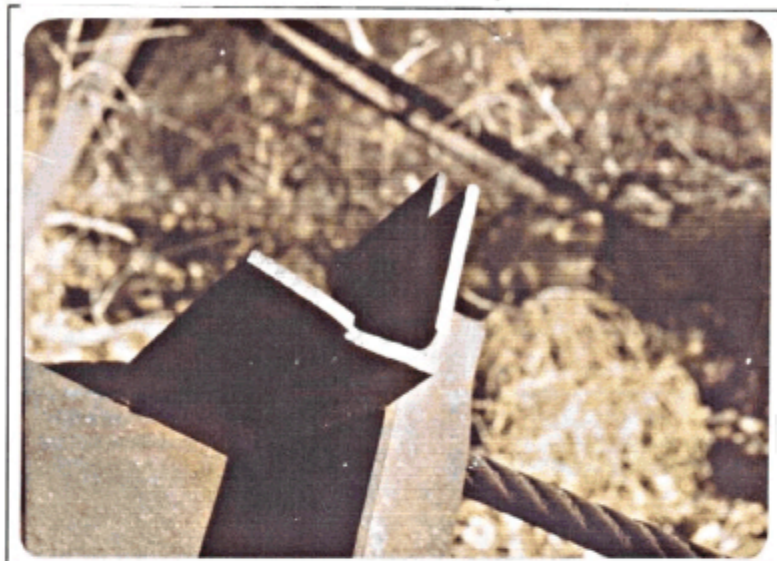
Photo 1.2. Jack steel

When first installed, jack design life was presumed to be 50 years. That duration is now achieved and the units show few signs of age. Photo 1.2 reveals new-looking steel in a sawed section.

Photo 1.2 also illustrates the work of thieves. Jacks in accessible areas are occasionally stolen for their angle iron. The jacklines are sufficiently robust to compensate for several missing members.

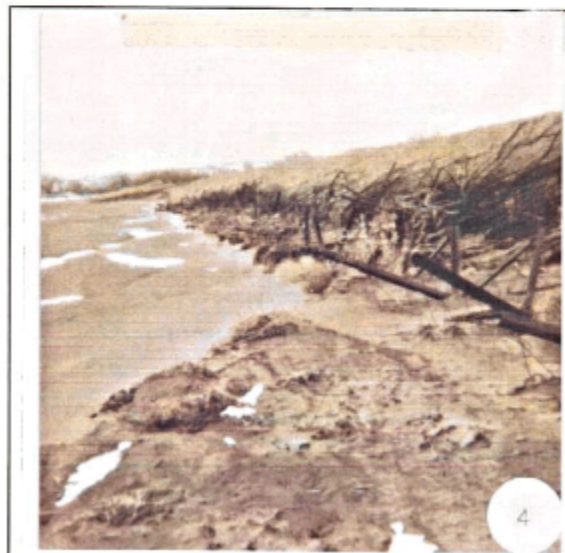
Photo 1.3. Eight-foot jacks

Photo 1.3 shows jacks smaller than the standard Kellner design. Several jack fields appear deficient by standard specifications. Significantly, these units appear to function well. The Kellner design appears to be conservative.

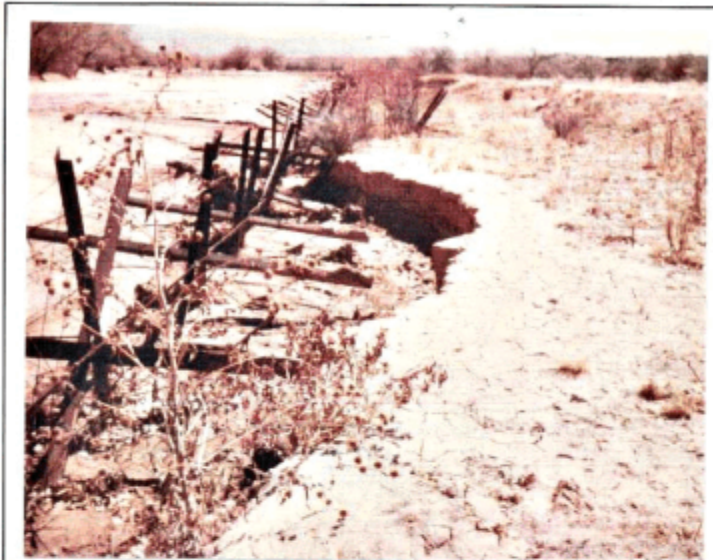
Photo 1.4. Eroded line

Jacks are not problem free. Photo 1.4 shows erosion under a jack line, most likely due to clean water.

The more the debris and the higher the turbidity, the better the jack performance.

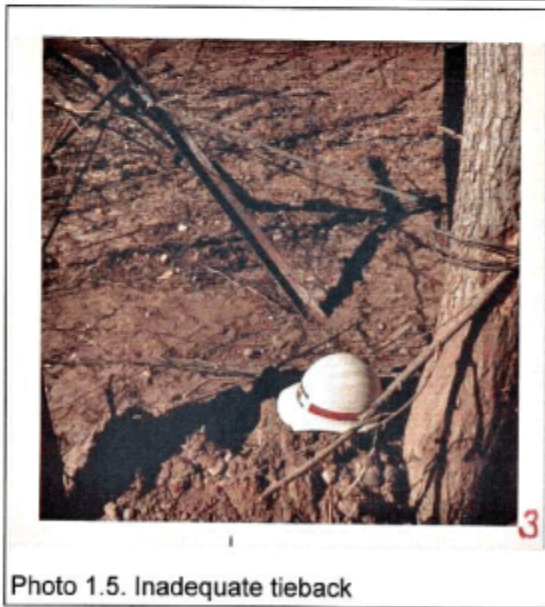
Photo 1.5. Inadequate tieback

The jackline in Photo 1 pulled out from its end anchoring. Photo 1.5 illustrates tieback to a tree. Secure jacklines with deadman anchors, not vegetation.

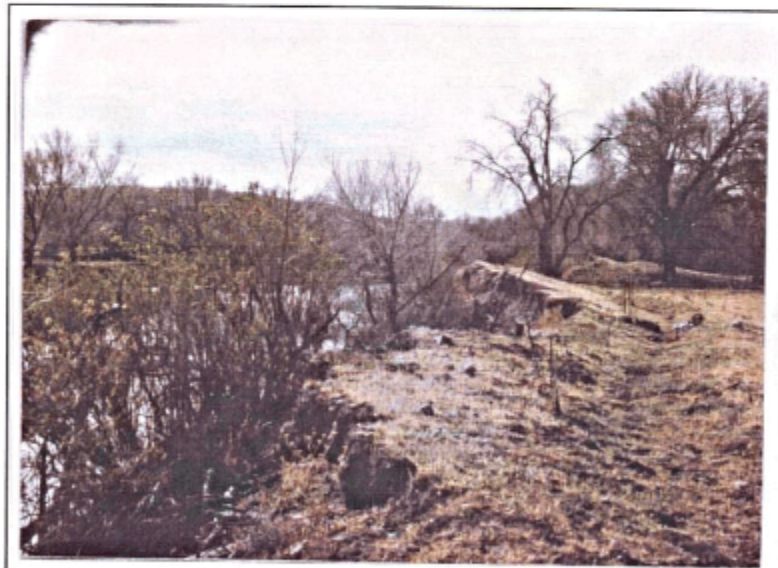
Photo 2.3. Remnants

Photo 2.3 shows the remnants of an eroded levee. The project is no longer functional.

Resistance to toe erosion is a levee's most important design parameter. A fat levee is a good levee. A thick-skinned levee is even a better levee.

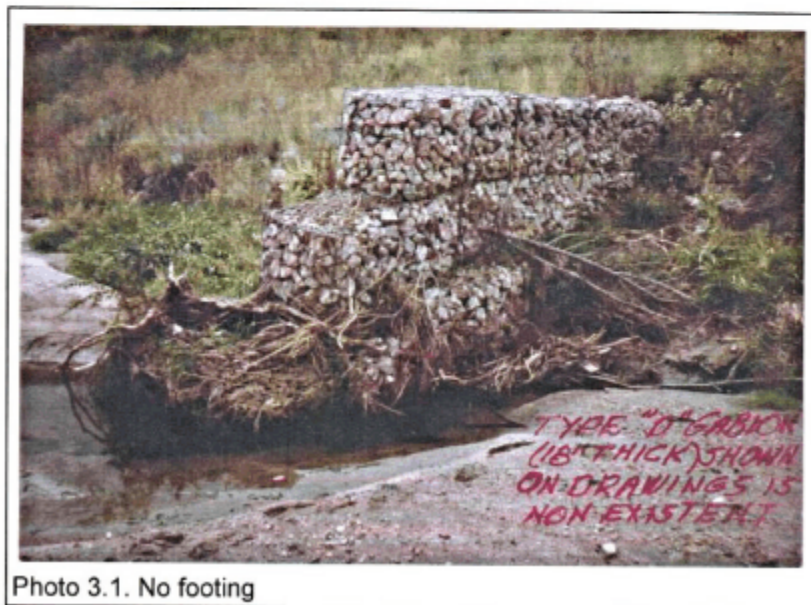
Photo 3.1. No footing

Water finds the easiest path downstream. Given the opportunity, water improves upon that path. That path is too often around or under the gabion or wire wrapped rocks. In Photo 3.1, the path is under the toe (or, as suspected by the inspector, through the sand where the toe wasn't built).

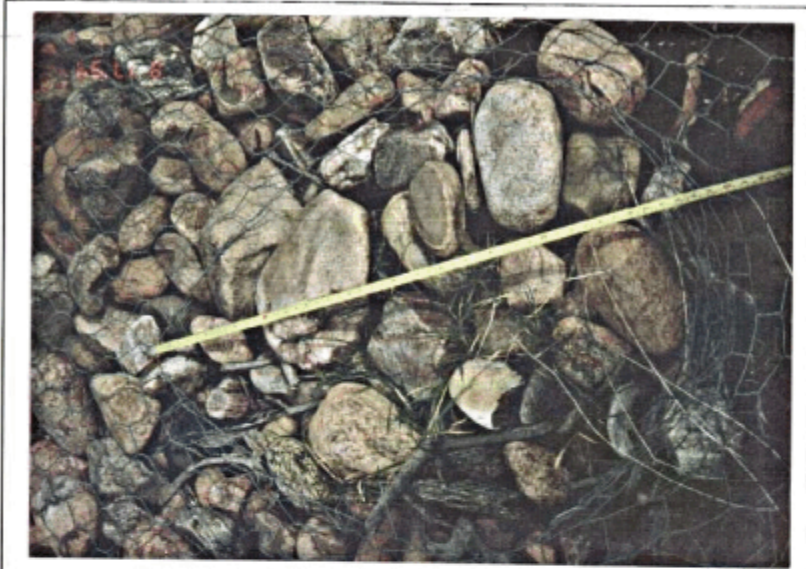
Photo 3.2. Undercutting

The wire wrapped riprap in Photo 3.2 is undercut, leaving the weight of the rock bearing on the mesh.

Bank treatment should be keyed beneath the channel bed a minimum of 2 feet, greater if additional degradation is possible.

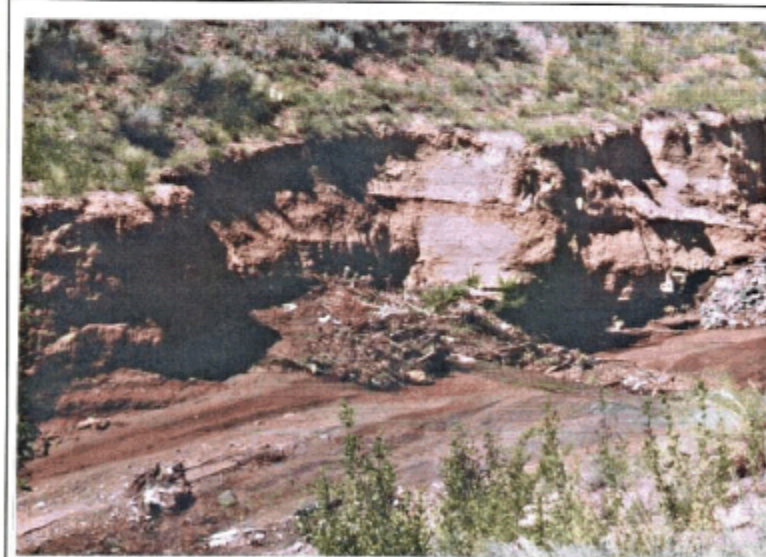
Photo 3.3. End erosion

Flow has moved around the end of the drop structure in Photo 3.3. The drop needs substantial endwalls.

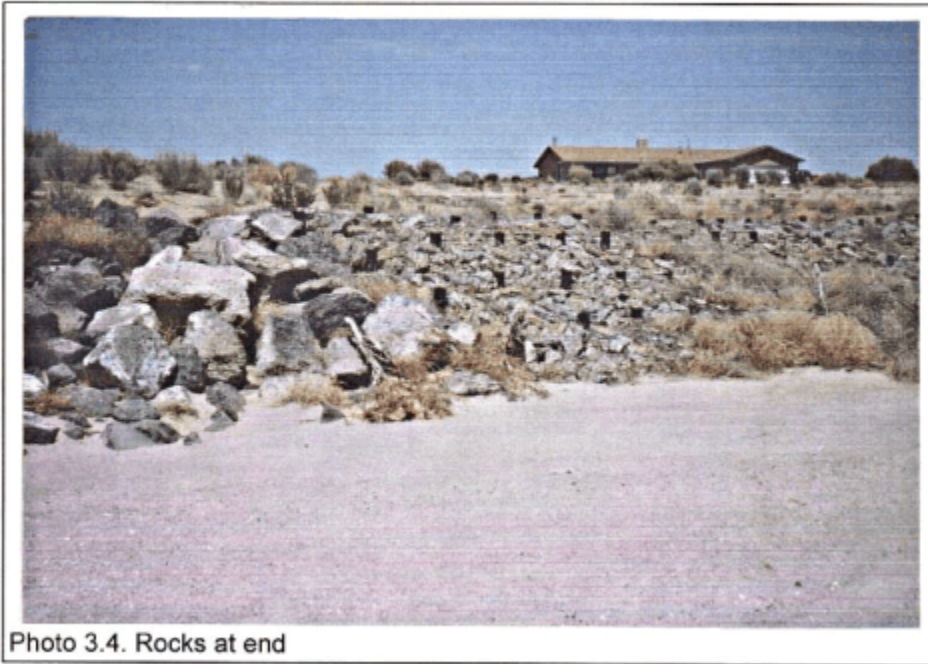
Photo 3.4. Rocks at end

Large riprap protects the end of the wire wrapped riprap in Photo 3.4. While the cost of this protection is significant, the expense of losing the protection is probably greater.

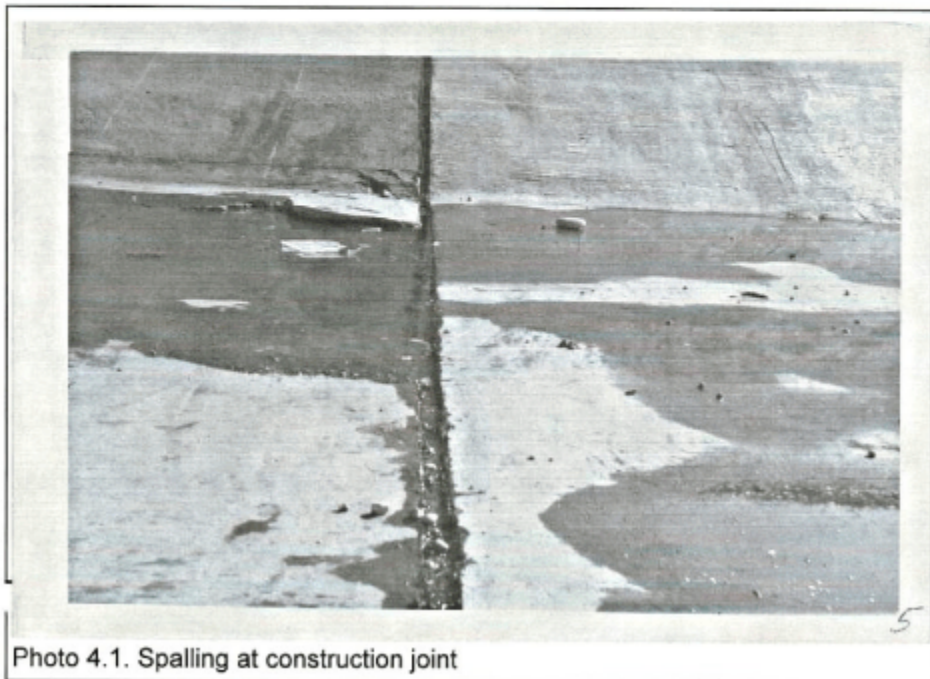
Photo 4.1. Spalling at construction joint

Hydraulic structures are no different. Precursing gross failure are concrete spalls at construction joints, as seen in Photo 4.1. Spalls may have multiple causes: inadequate attention to thermal or curing stresses; lack of construction control; substandard materials; water infusion, etc. Joint problems are not easily remedied retroactively.

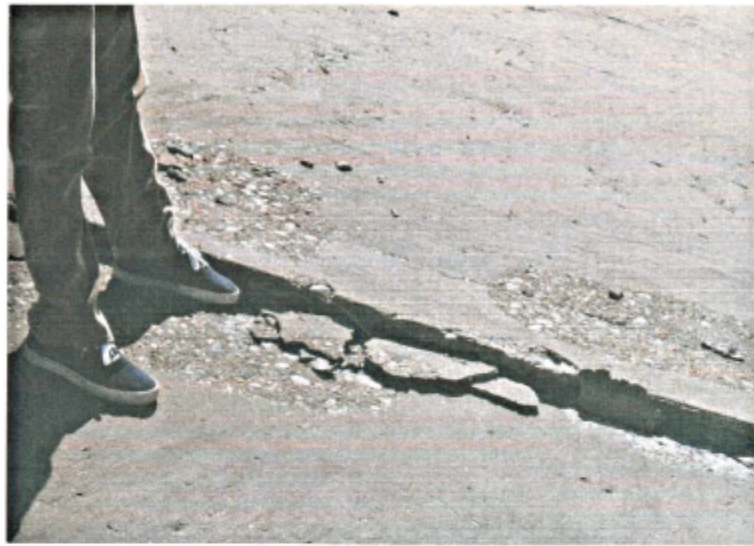
Photo 4.2. Uplift

An open joint leads to subsequent problems. Photo 4.2 shows a 6-inch uplift, mechanism unknown

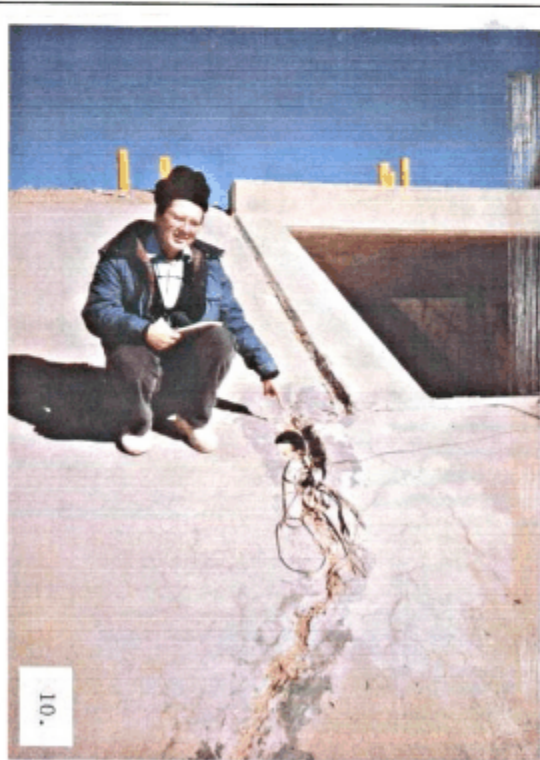
Photo 4.3. Thrust failure

Problems manifest at side channel junctions where there is no mass resistance to concrete working transversely to the wall. Photo 4.3 shows the result.

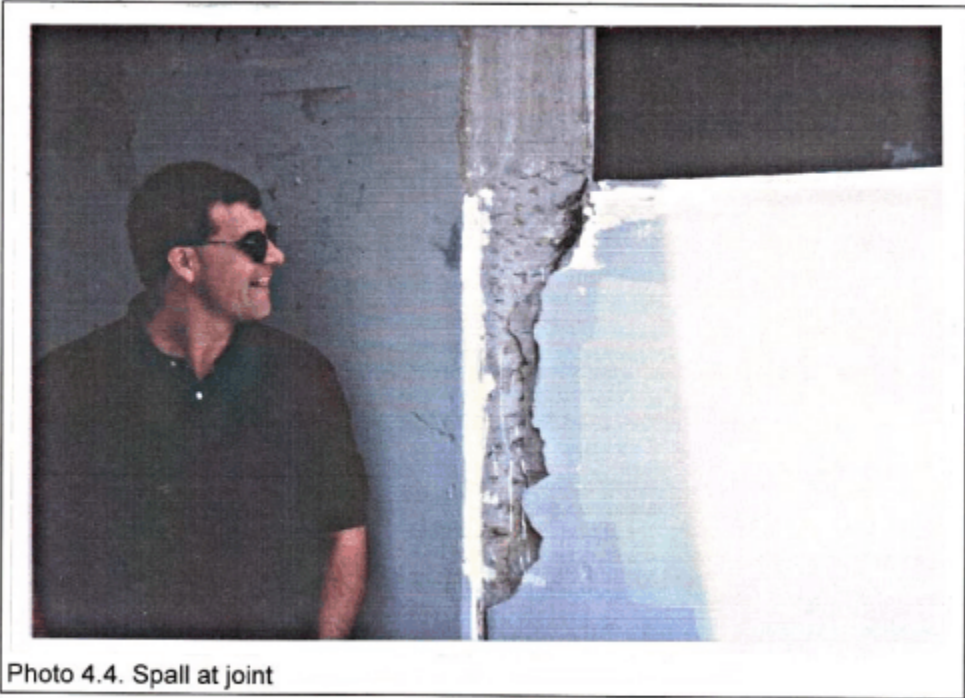
Photo 4.4. Spall at joint

Where concrete faces are perpendicular, Photo 4.4 shows the spall.

For a lasting joint, invest in design detail, material specification and construction inspection.

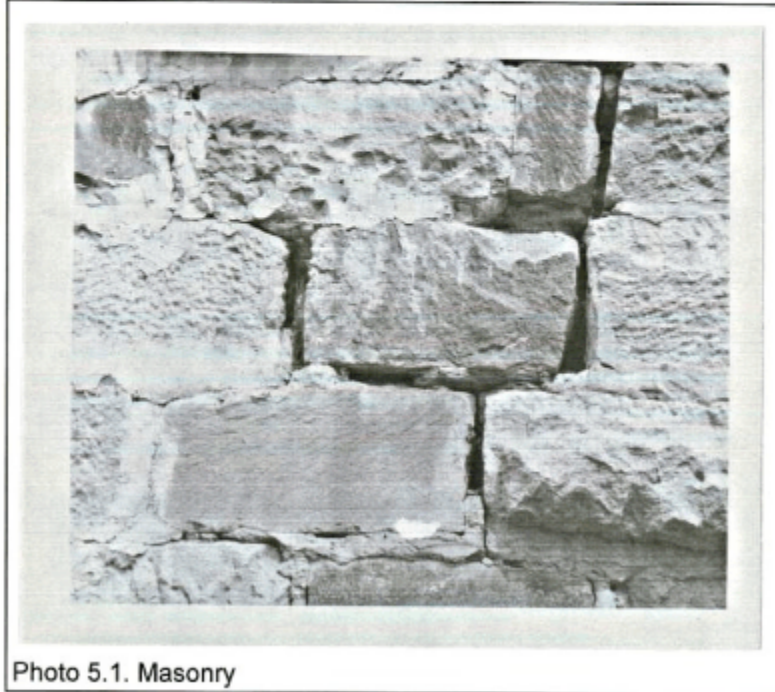
Photo 5.1. Masonry

The material first to fail in mortared construction is typically the grout, demonstrated in Photo 5.1.

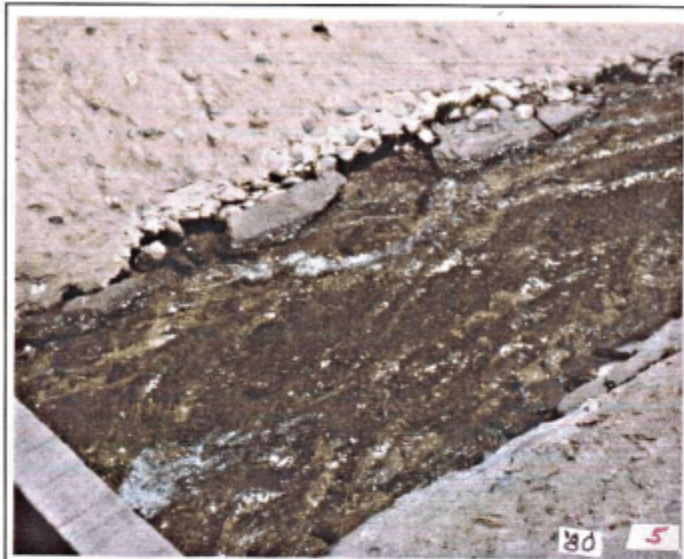
Photo 5.2. Grout failure at waterline

Mortar and grout are rarely long-term successes in harsh environments. Grout has a life of only a few years when frozen and thawed frequently. Photo 5.2 shows the inevitable deterioration.

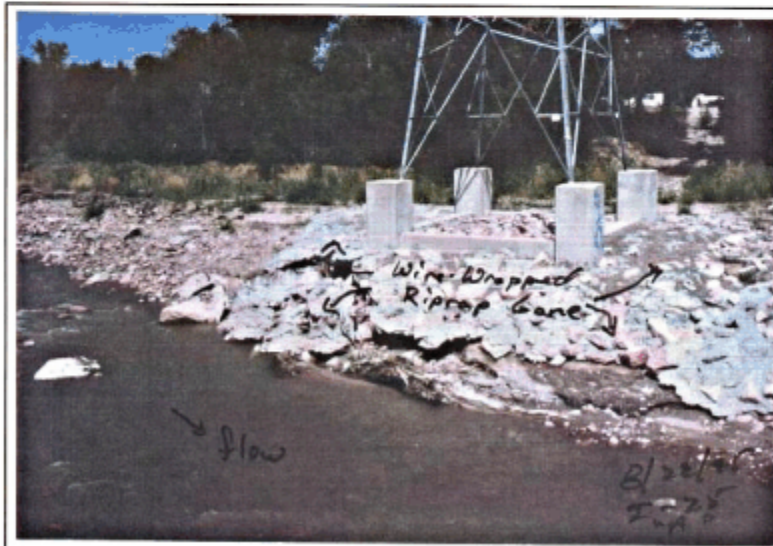
Photo 5.3. Grout over rock

Grout can fill a void or smooth a surface, but contributes little to the long-term stability of rock lining. The grout cover of Photo 5.3 is breaking up as the rocks wash into the channel.

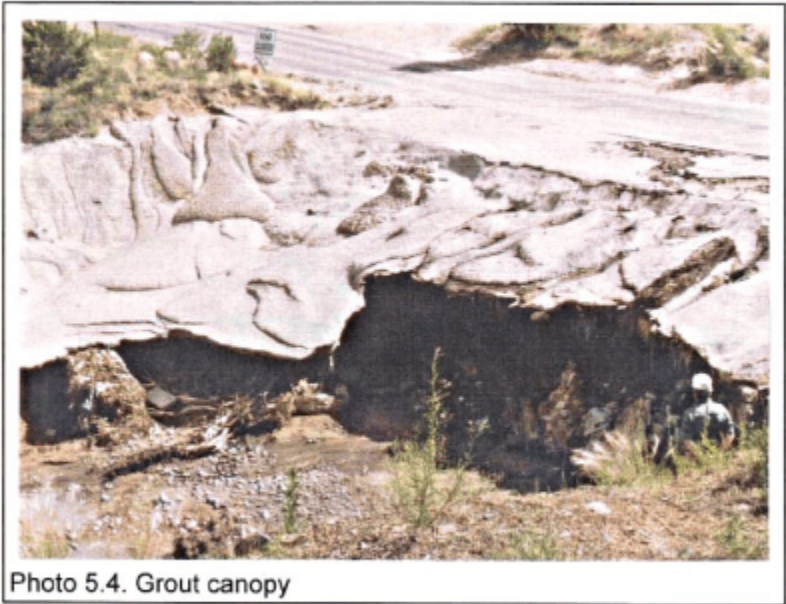
Photo 5.4. Grout canopy

Grout tends to be ugly. Engineering rational for protecting the crossing with grout in Photo 5.4 is illusive. The cavities beneath are dangerous.

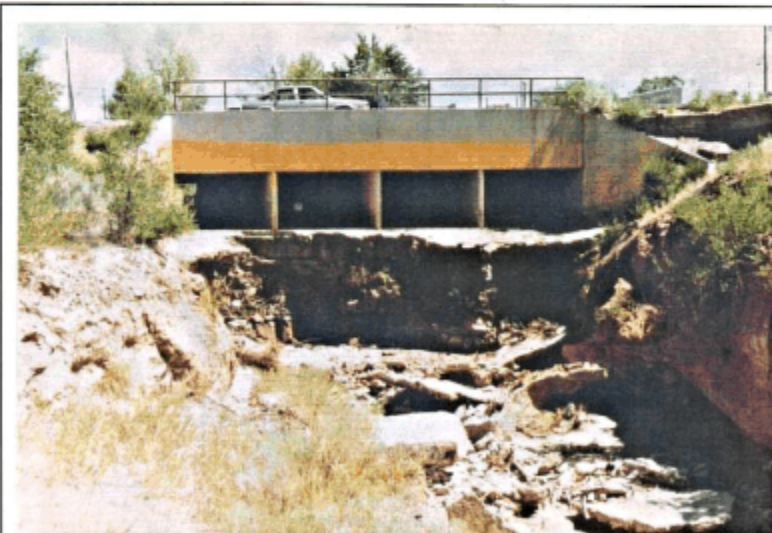
Photo 6.2. Headcut

Photo 6.2 shows that same "desirable" scour, this time headcutting to a culvert crossing. Again, channel management is at cross-purposes.

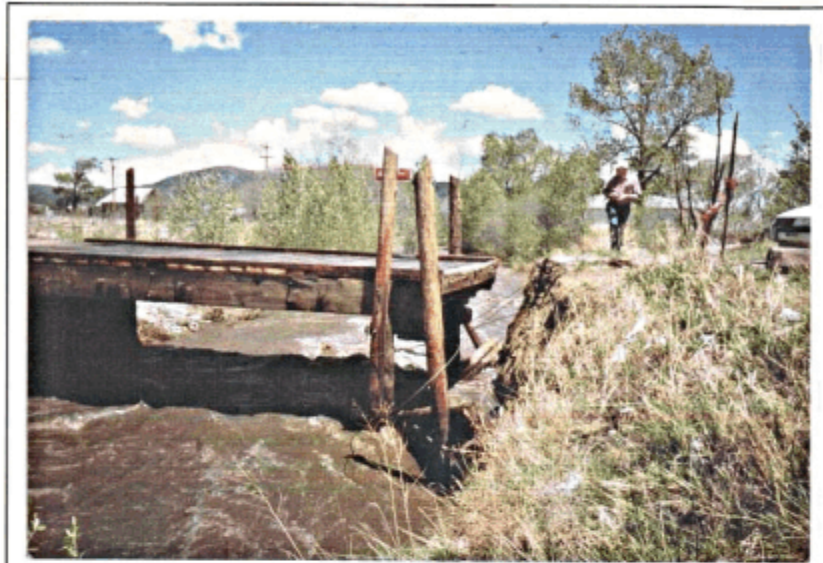
Photo 6.3. Lost abutment

The bridge abutment of Photo 6.3 is completely severed by channel migration. The crossing probably initiated the currents that circumvented the crossing.

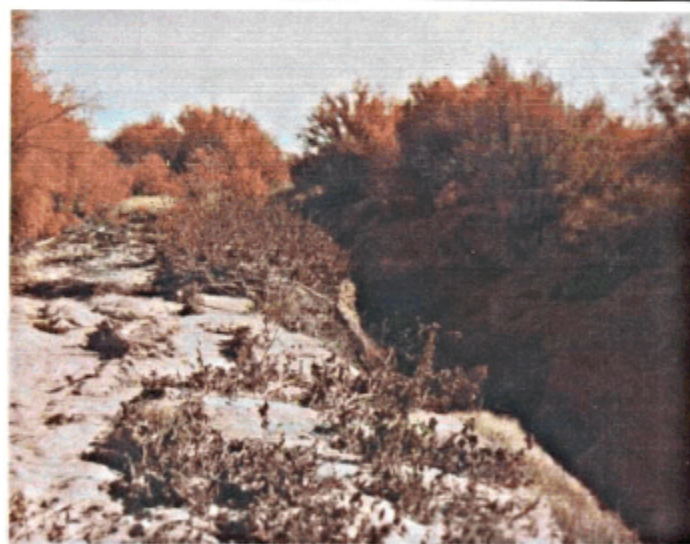
Photo 6.5. Sand on overbank

Mobile channels also aggrade. The floodplain of Photo 6.5 accumulates sand deposits with each overbank event, raising flow depths against the outside levee which eventually ruptured.

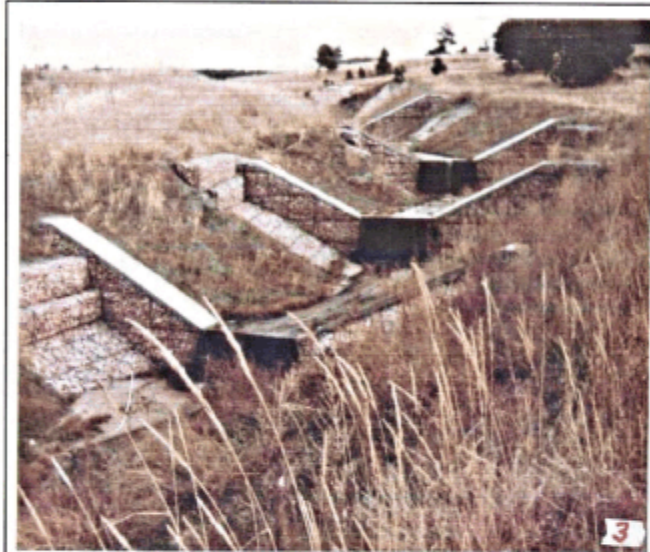
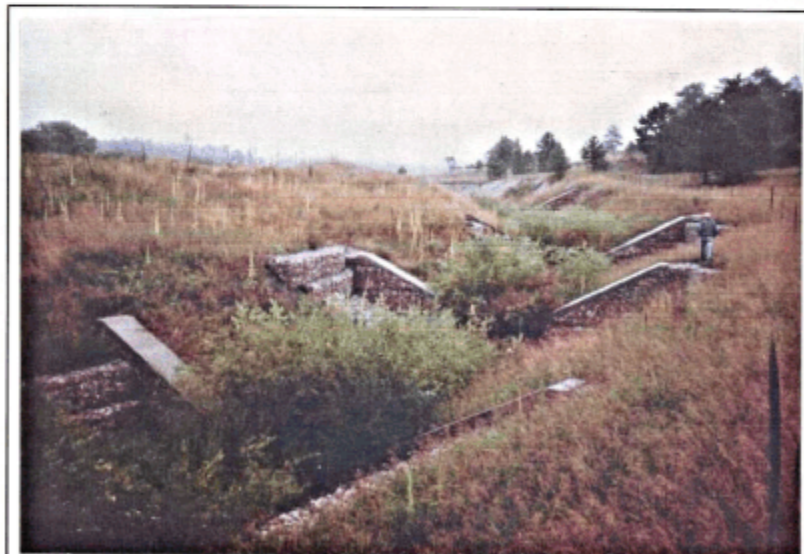
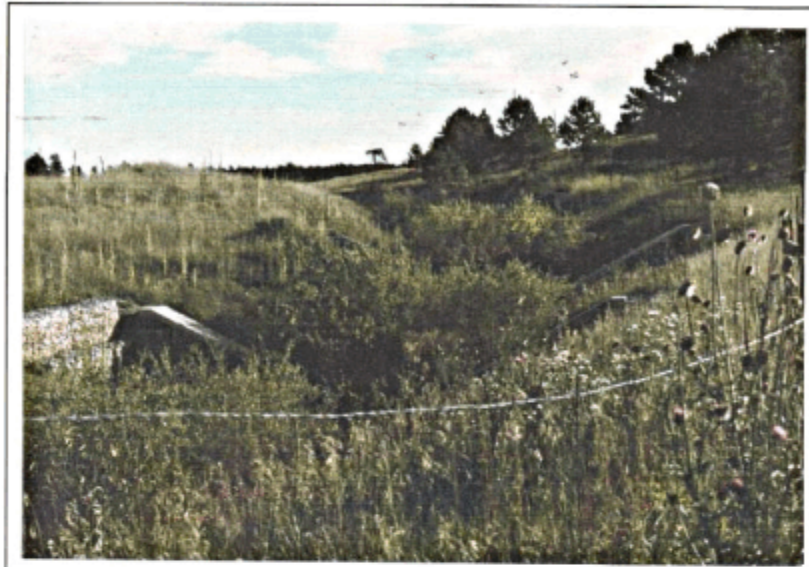
Photos 7.1-7.3 trace the history of a gabion drop structure. Assuming the roots don't damage the gabions (a risky assumption), the energy dissipation is enhanced. The conveyance is diminished.

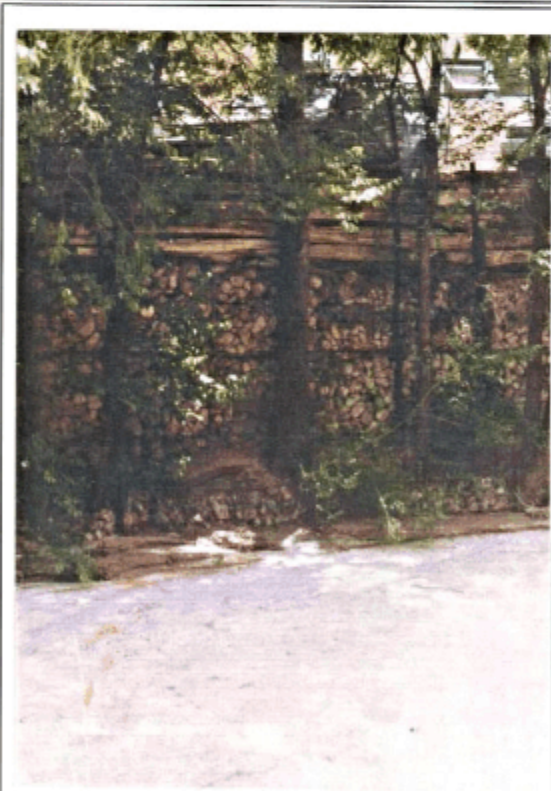
Photo 7.4. Trees holding gabions

The trees in Photo 7.4 relieve the gabions of bank preservation duty. When the trees die, the channel walls may collapse.

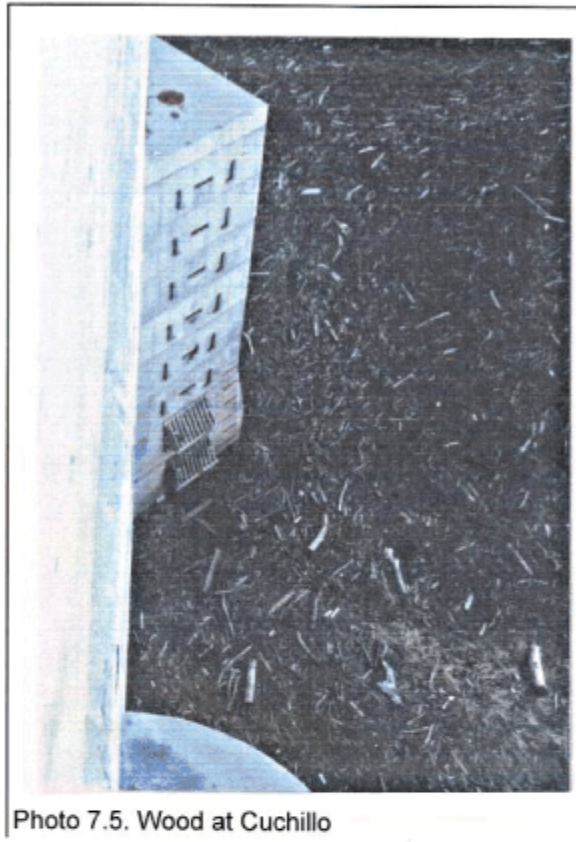
Photo 7.5. Wood at Cuchillo

Vegetation is not only an issue of site conditions. Watershed flotsam accumulates in the reservoir of Photo 7.5, clogging the trashrack. No designer looked upstream.

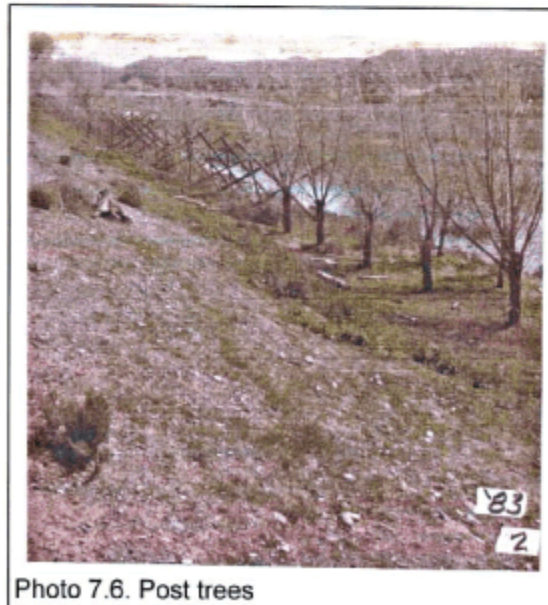
Photo 7.6. Post trees

Effectively used, vegetation can enhance project functionality. The post trees, Photo 7.6, have sufficient space to grow into overbank stabilization without jeopardizing the levee behind.

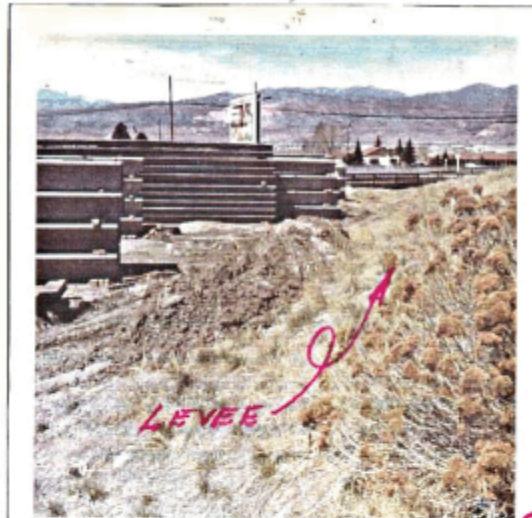
Photo 8.2. Concrete products

Photos 8.2-8.4 illustrate floodway encroachment. Photo 8.2 is of a concrete product plant needing space for its weirs.

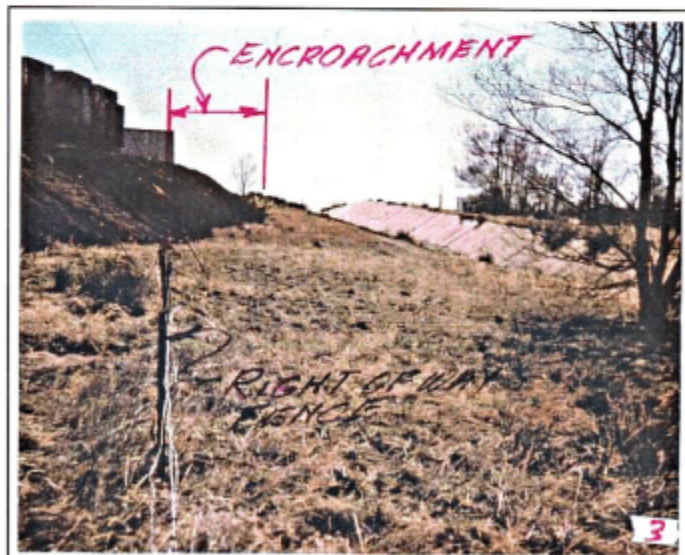
Photo 8.3. Encroachment

Photo 8.3 illustrates loss of floodway conveyance when neighbors dump earth in the easement.

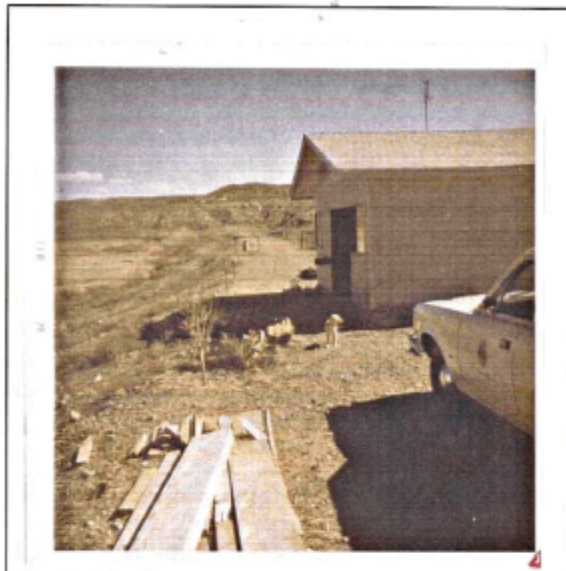
Photo 8.4. House

Photo 8.4 shows a mobile home prudently sited high above the floodplain, unfortunately on the levee top. The mobile home was replaced by a permanent dwelling, compounding the problem.

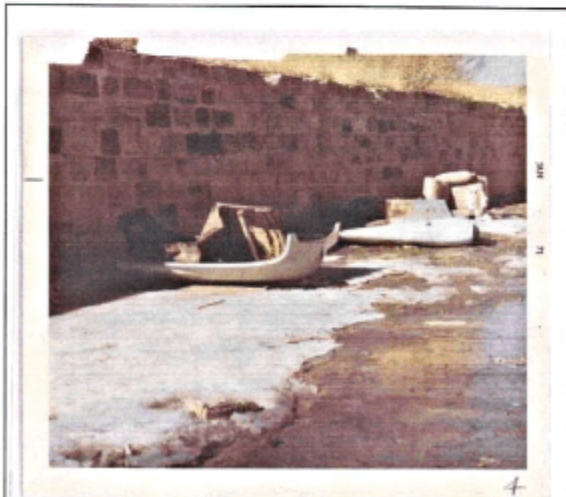
Photo 8.5. Junk in channel

On some occasions, the public acts inexcusably. The channel in Photo 8.5 is a handy site for trash dumping.

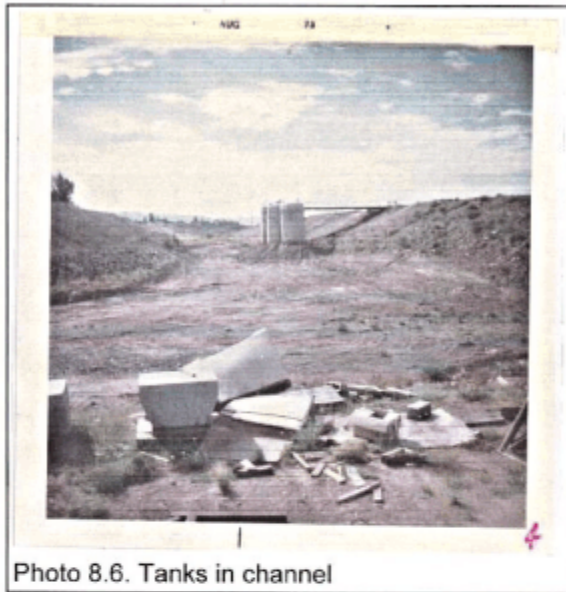
Photo 8.6. Tanks in channel

The same channel is also a handy site for large storage tanks, Photo 8.6. This illegal action is the work of an institution of higher education.

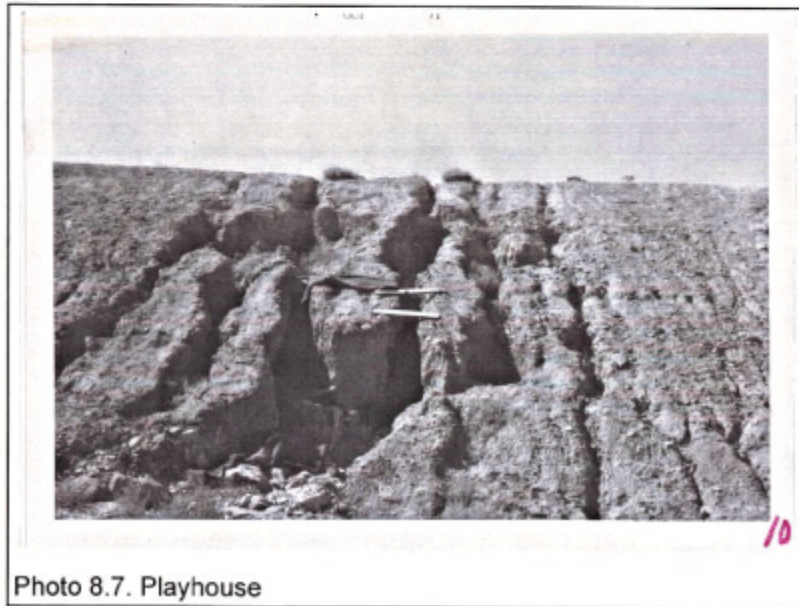
Photo 8.7. Playhouse

Children converted the levee gully into a fort, Photo 8.7. Their endeavor jeopardizes the embankment.

The trespass is potentially more tragic than the flooding which might break through the weakened dike. The children are endangered if the unstable walls slough.

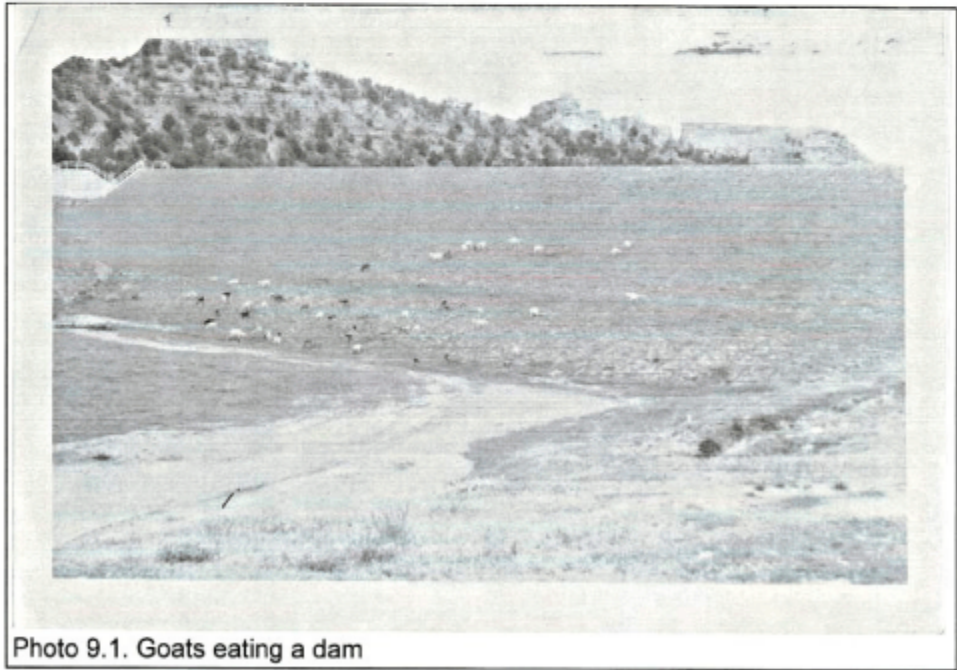
Photo 9.1. Goats eating a dam

Photo 9.1 is pastoral, but not pretty. Goats grazing on the embankment destroy the groundcover and enhance erosion. Fence it.

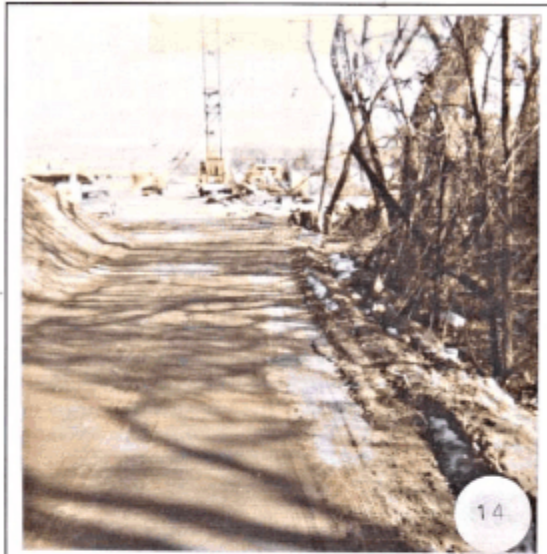
Photo 9.2. Road crossing

Photo 9.2 shows a jackline cut for a road crossing. The cut is convenient for drivers, but jeopardizes the channel.

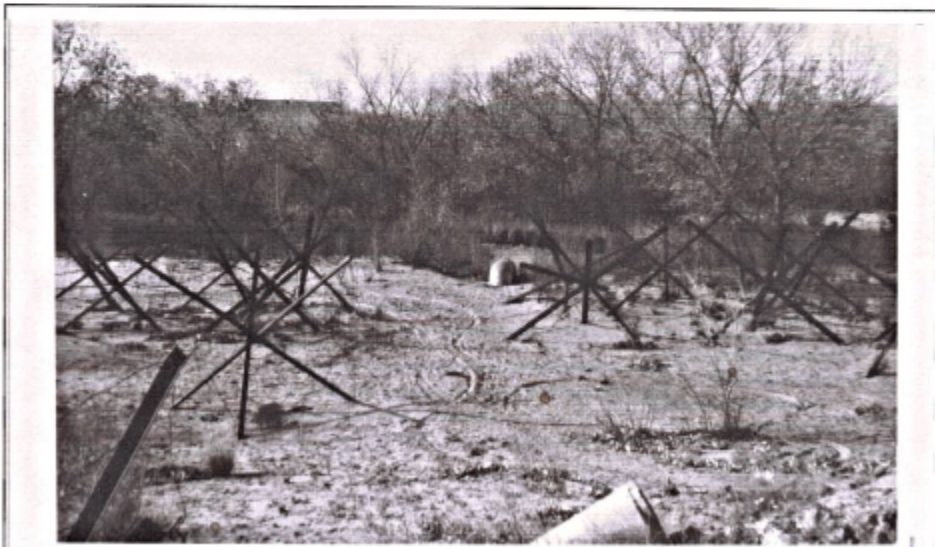
Photo 9.3. Pipeline crossing

Photo 9.3 shows a jackline cut by another government agency. The pipeline path becomes a floodwater crossing.

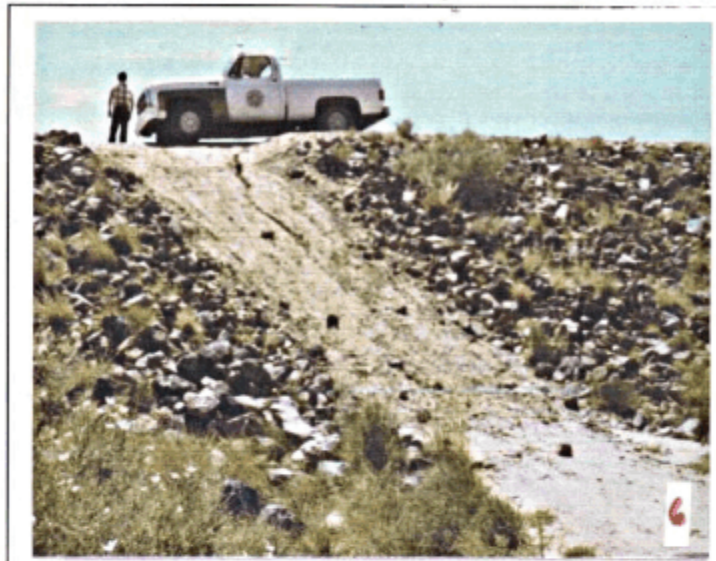
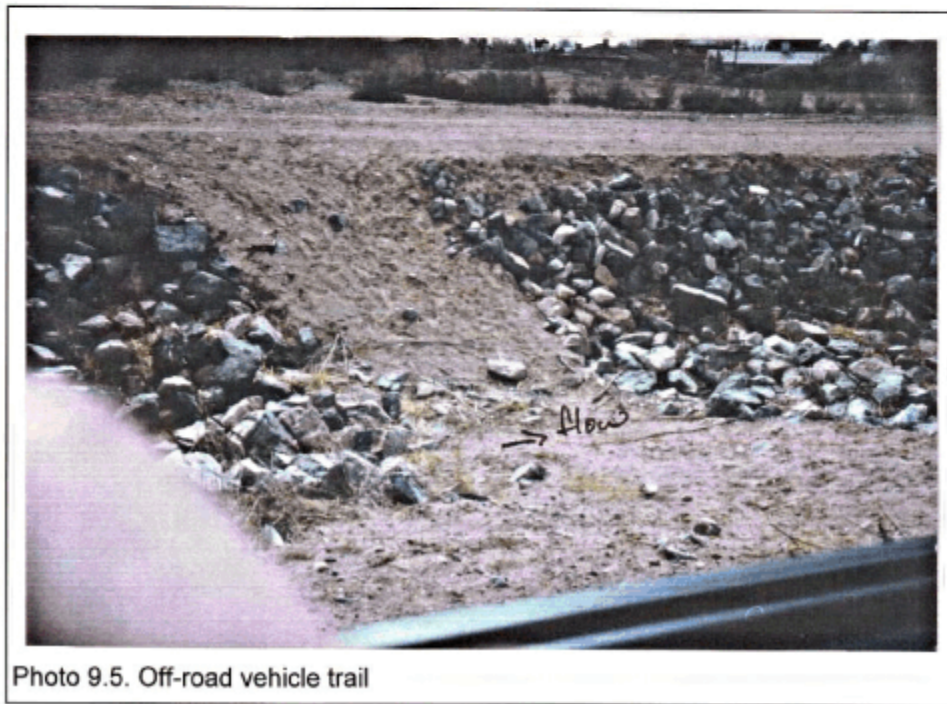
Photos 9.4 and 9.5 show riprap displaced for vehicle access into the channel. Unless trespass can be precluded, it may be wiser to work such access into the engineering.

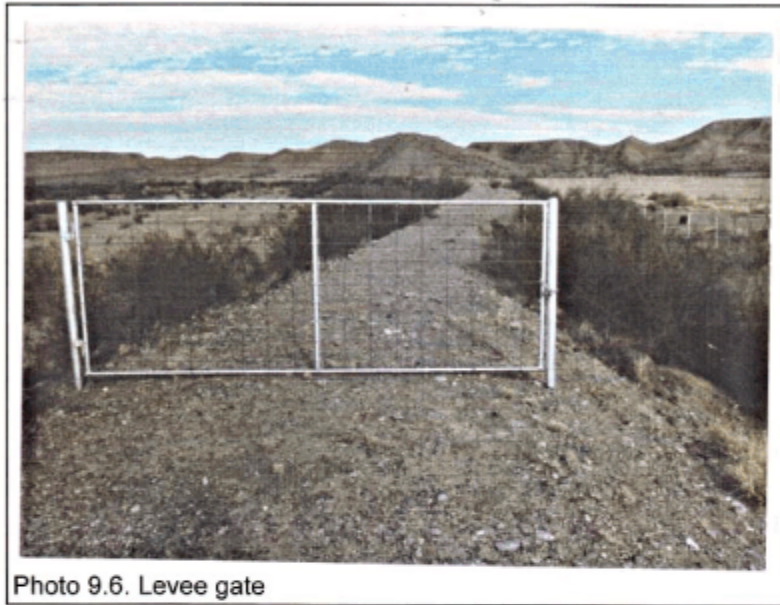
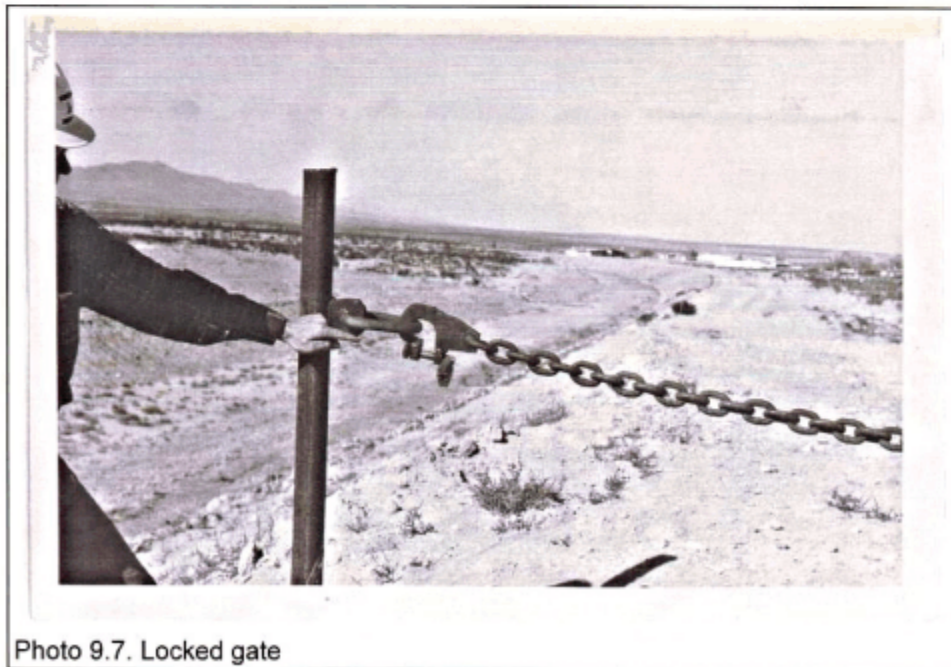
Photos 9.6 and 9.7 show the obvious countermeasure to undesirable access. Lock the gate. Many times, trespassers find another entrance. In some cases, locks bar Corps' inspectors.

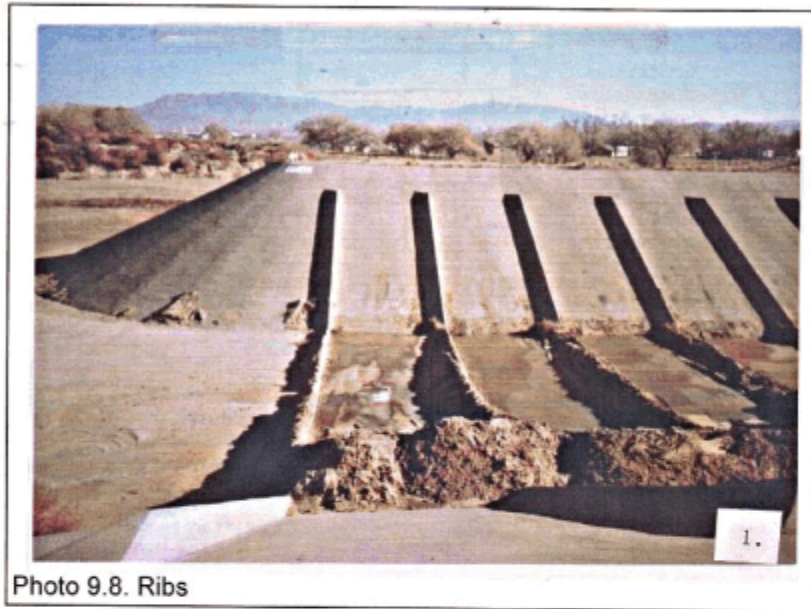
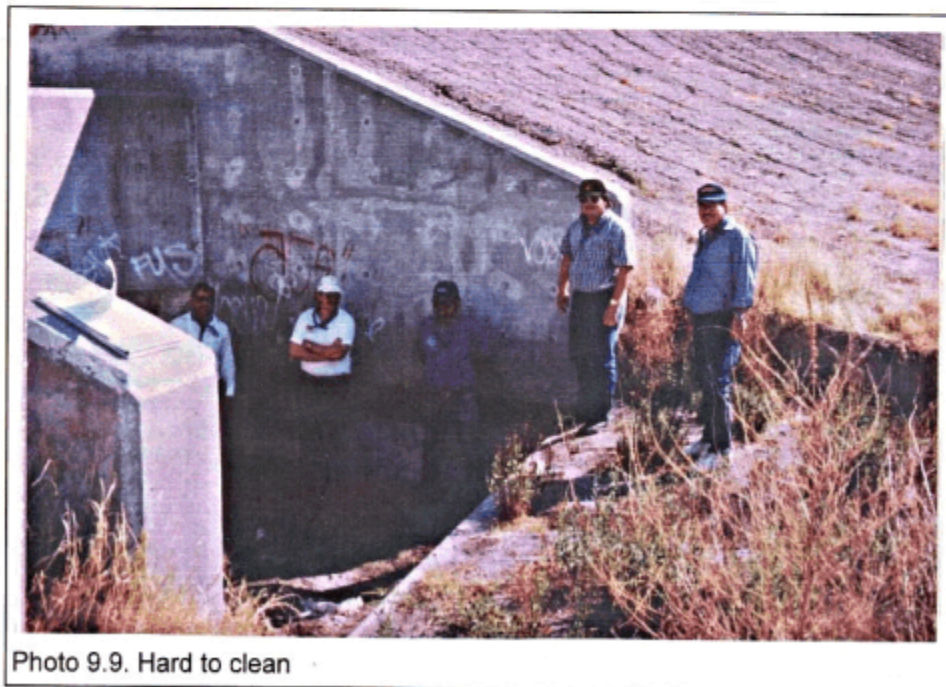
Photos 9.8 and 9.9 show project design hindering maintenance access. The ribs were eventually removed. Cleaning the box culvert remains a challenge.

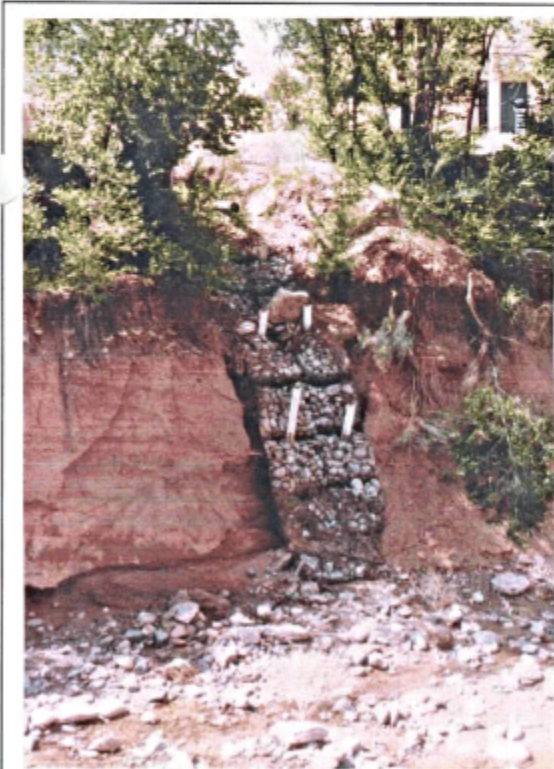
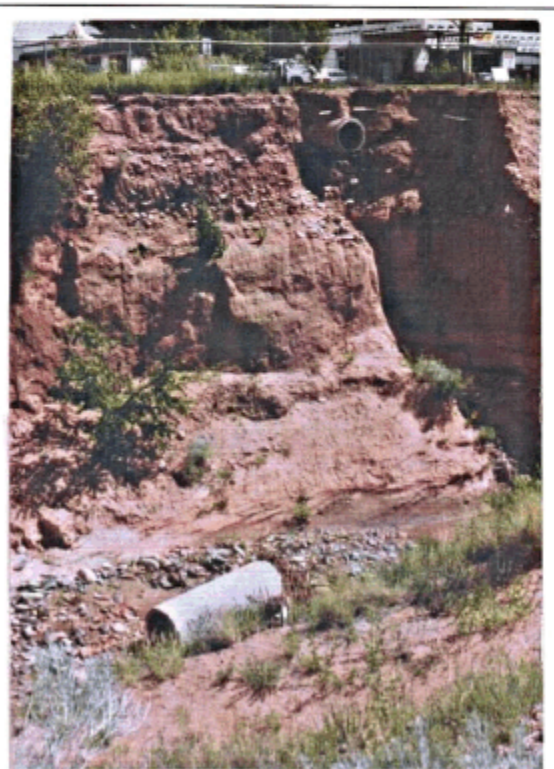
Photos 10.1 and 10.2 illustrate the consequence of inattention to local inflows. Water prefers the path around the wire wrapped rock. Lacking outfall protection, the pipe inlet disassembles itself over time.
