US Army Corps of Engineers

(Albuquerque District)

Floodwater Lessons Learned:

Best of Lessons Learned

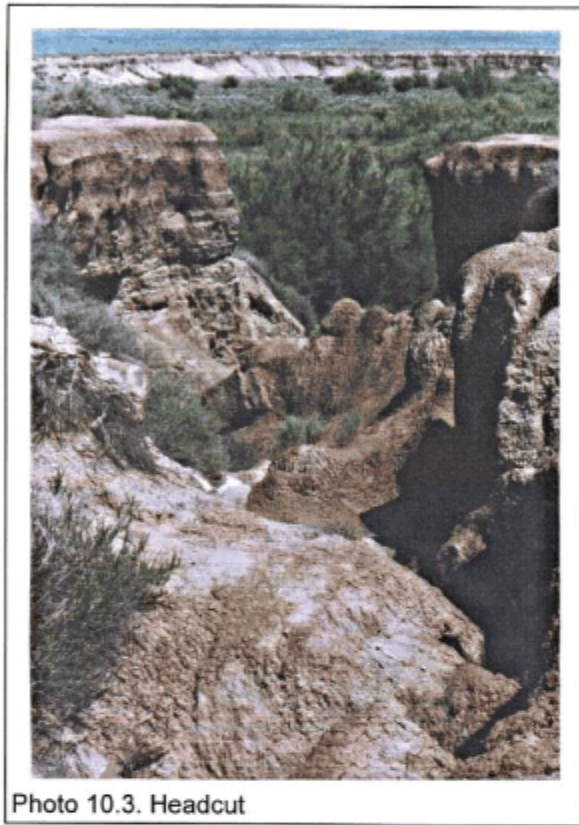
Photo 10.3. Headcut

The headcut in Photo 10.3 began with piping from the high bluff above the project. While the jacks below stand guard, the bank collapses behind.

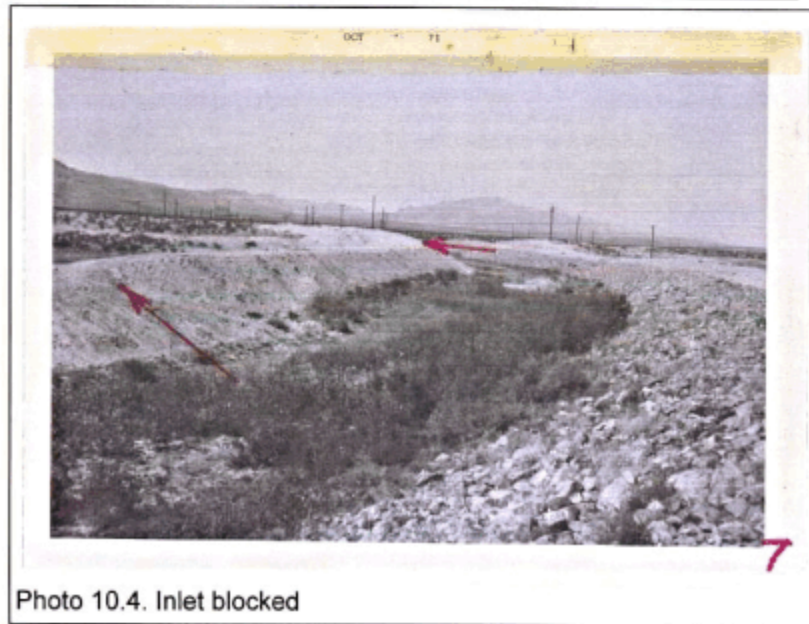
Photo 10.4. Inlet blocked

Photo 10.4 shows a tributary inlet dammed to retain water. At Corps' insistence, the dam was breached.

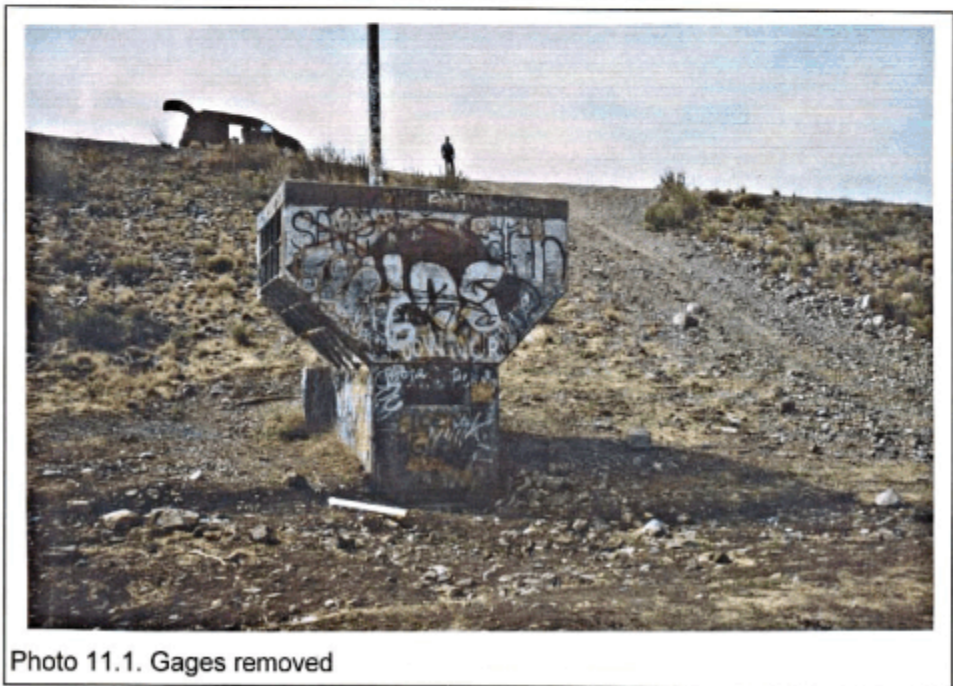
Photo 11.1. Gages removed

The staff gages of Photo 11.1 were vandalized and removed.

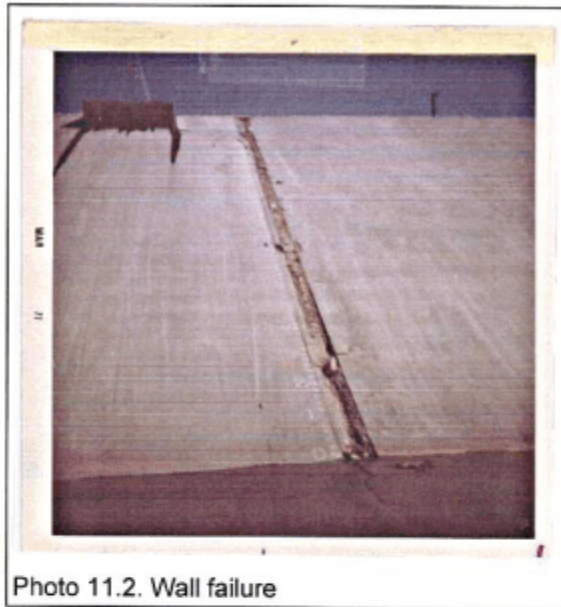
Photo 11.2. Wall failure

The gage was recessed into the channel wall sufficiently to weaken the slab. The wall failed.

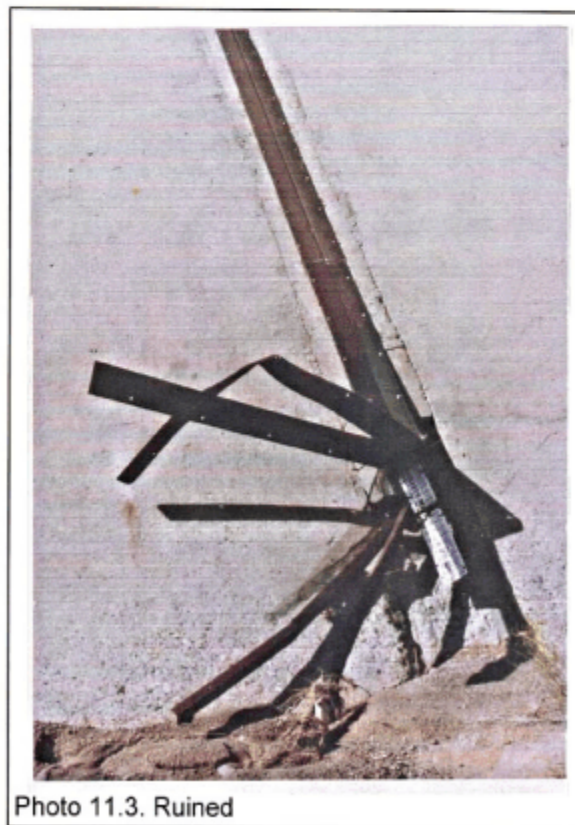
Photo 11.3. Ruined

Flow tore out the gages of Photo 11.3.

Gages have been deleted from project design by Value Engineering, a misnomer in this case.

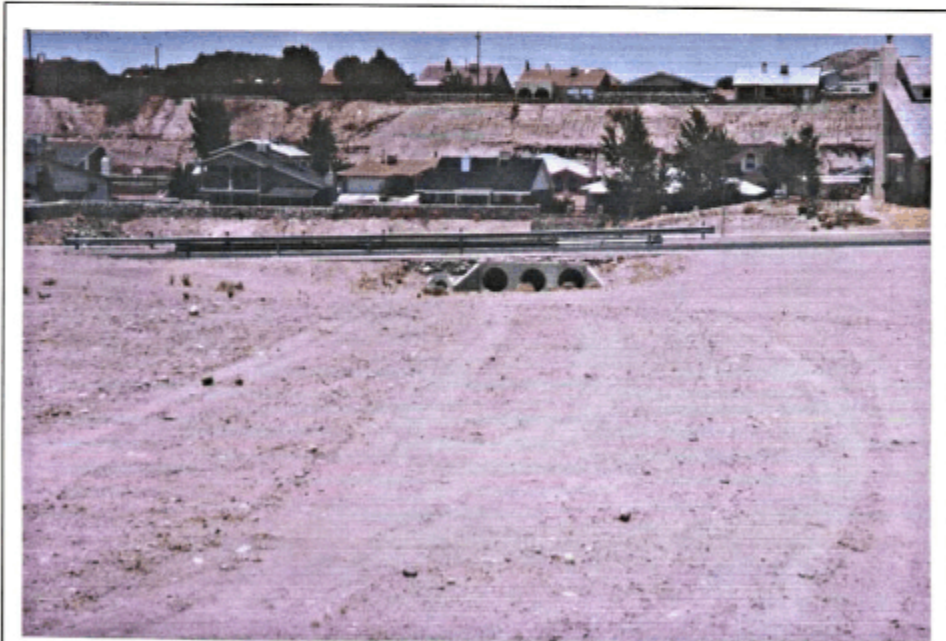
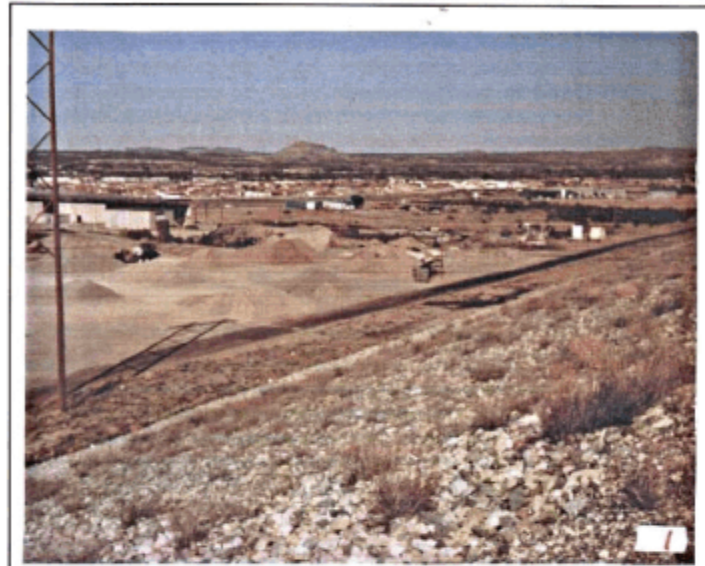
Photos 12.1 and 12.2 reveal a dilemma of urban dams. An engineered conduit or channel contains the 100-year outflow. Emergency spillway overflow is by definition at a greater recurrence interval. That floodplain is not in FEMA mapping, and thus is opened for development. The project invites downstream victims.

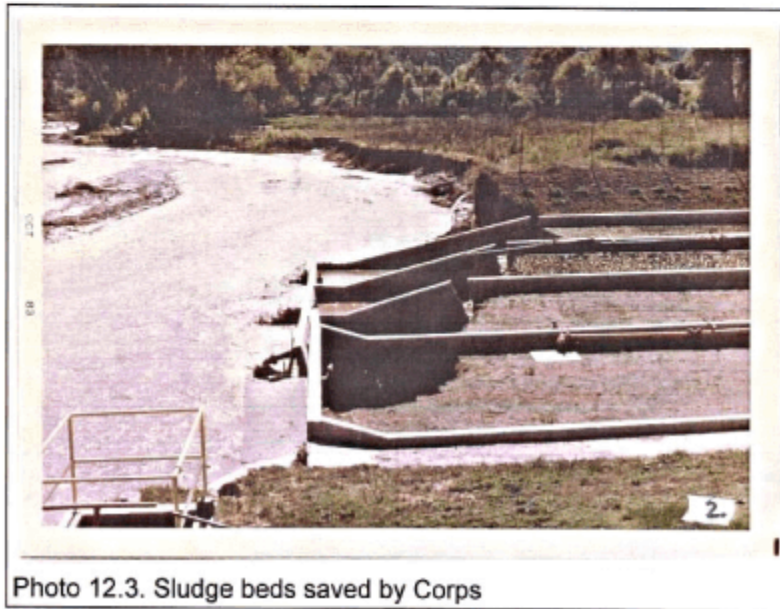
Photo 12.3. Sludge beds saved by Corps

Water and wastewater works tend to be adjacent to channels. If the Corps stands ready to rescue poorly sited facilities, there is little incentive to place them at prudent elevations. Photo 12.3 illustrates the problem.

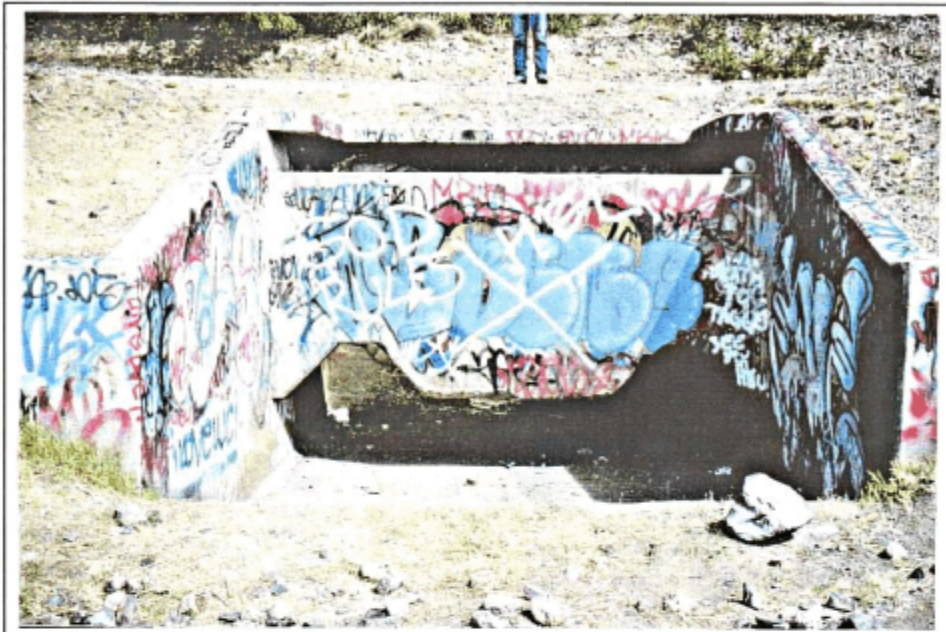
Photo 12.4. Graffiti

Concrete beckons the urban "tags" of Photo 12.4. Riprap or gabions are less inviting than slab construction.
