**Floodwater Lessons Learned:**

**Creede, CO**

**Creede, CO,  
Lessons Learned**

June 12, 1998

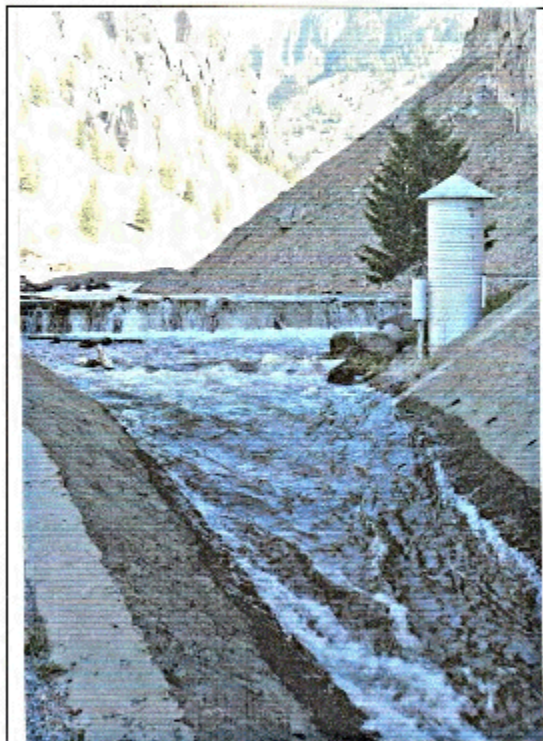
The site had four floods above 1000 cfs before the current channel was constructed, but a maximum of only 330 cfs since. Photo C-5 shows the project gage at the inlet.

Photo C-5. Inlet, 1998

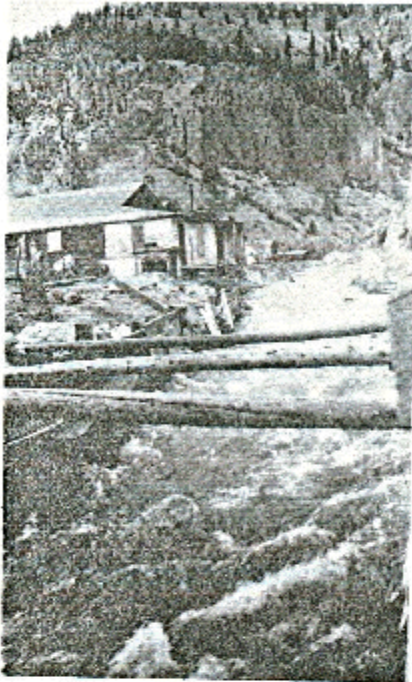
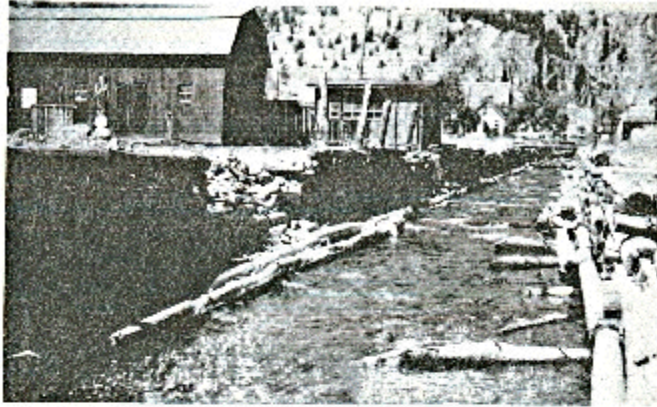
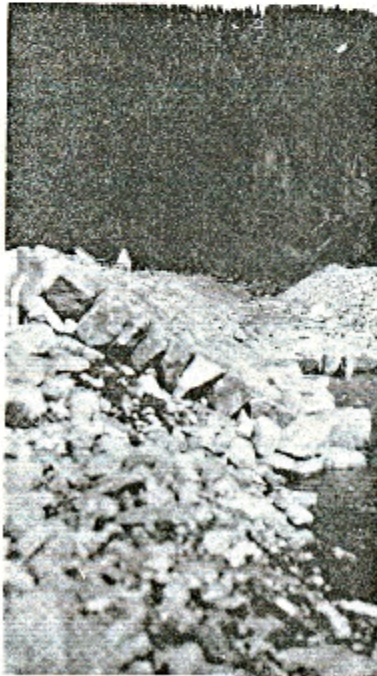
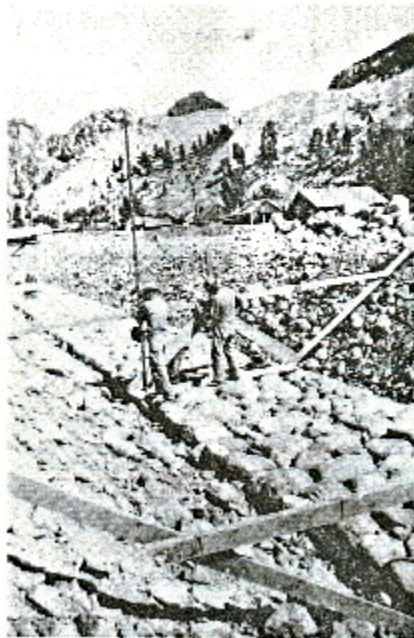
Photos C-1-4. Historical Photos.

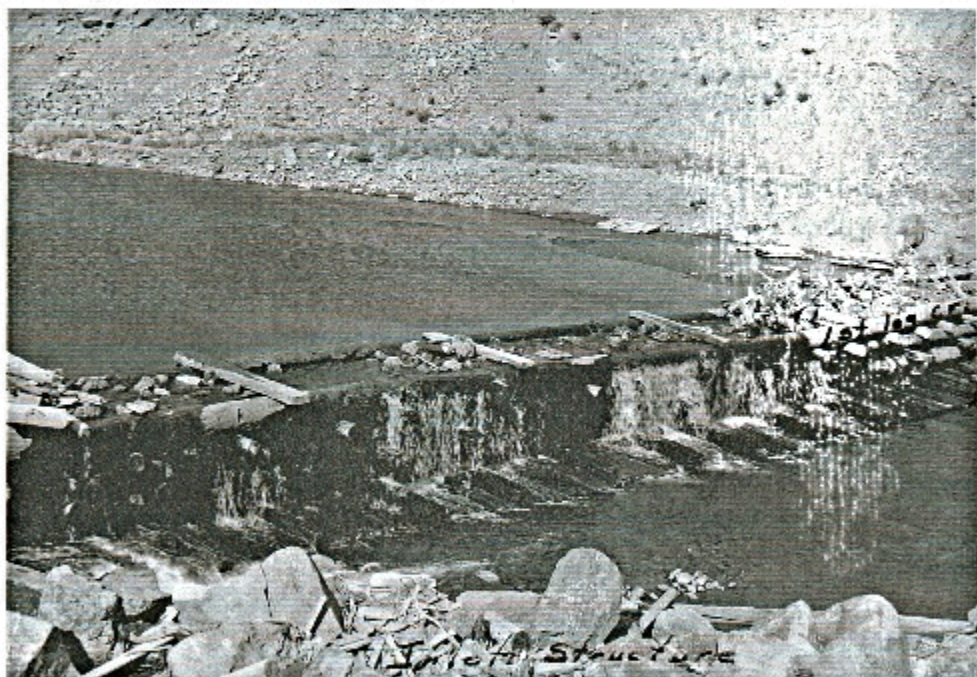
Photo C-6. Bottom Crib, 1957

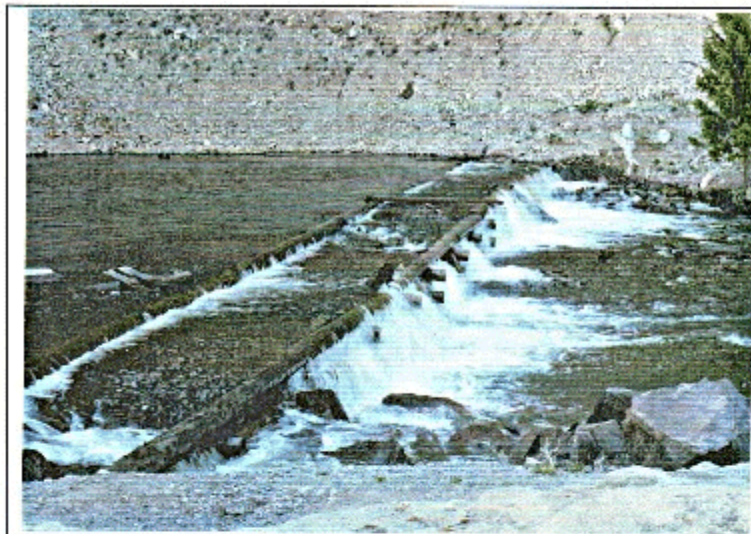
Willow Creek transports extensive material from talus slopes and old mining operations upstream. Four log and rock cribs, approximately 3 feet deep, collect sediment and debris above the inlet. The County periodically excavates the cribs for road building and repair material. The cribs require continued vigilance during the spring runoff; the County has heavy equipment readily available for emergency work. The cribs also provide grade control for the channel. Virtually all inspections mention the structural tenuousness of the cribs. Photos C-6 and C-7 show the crib immediately upstream of the channel inlet. The 1998 photo is approximately 10 years after the last reconstruction.

Photo C-7. Bottom Crib, 1998

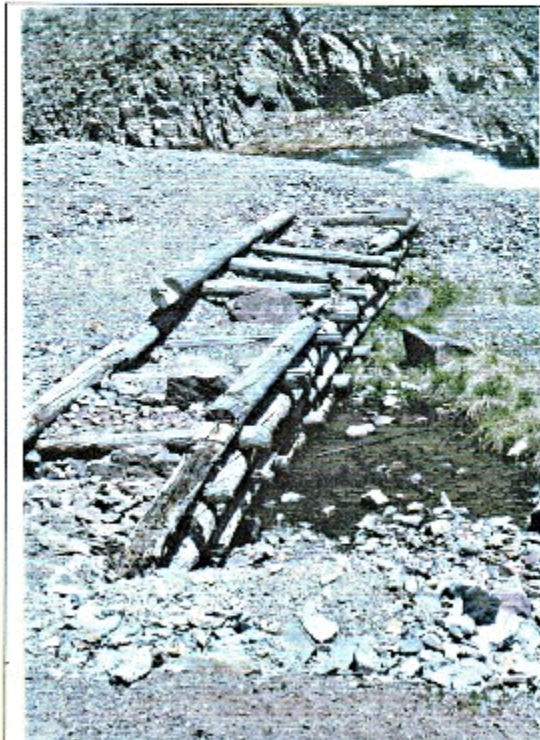
Photo C-8 shows an upper crib in deteriorated condition. Flow has migrated to the left.

Photo C-8. Upper Crib, 1998

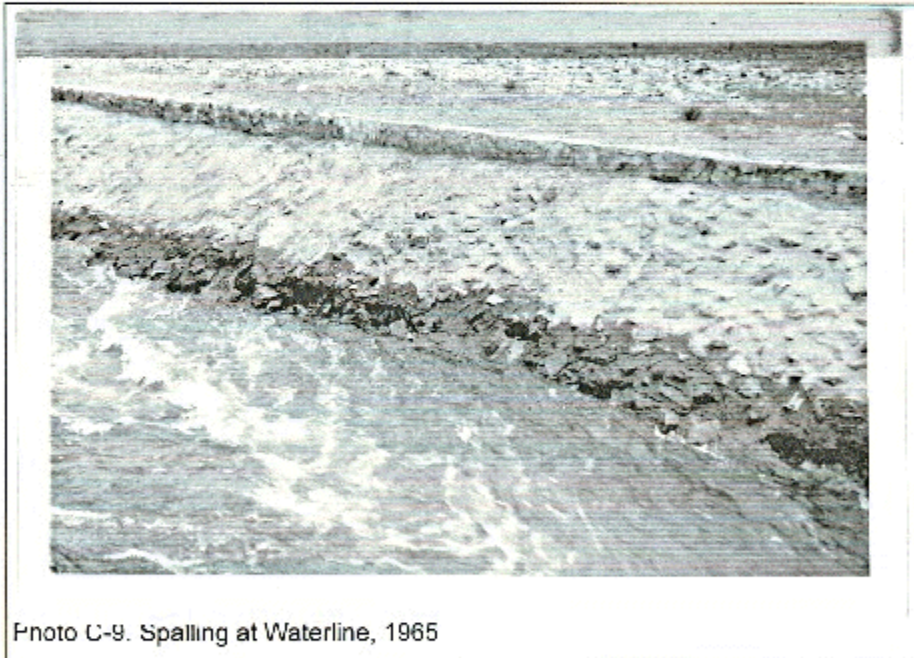
The channel is severely deteriorated along the waterline. Photos C-9-14 document the persistence of the problem.

Photo C-9. Spalling at Waterline, 1965

- (1) Freeze-thaw action where splash occurs. The waterline freezes and thaws with regularity. Creede has over 300 frost days per year. Not only are stones loosened and lost, but the entire channel wall has heaved 1-3 inches in one location.

(2) Mortar and riprap removed by the swift current. Channel velocity is 15 feet per second and greater. Attack is enhanced on the outside of the curve. Analysis indicates that a 12-year event will pull unsupported free stones from the channel bottom.

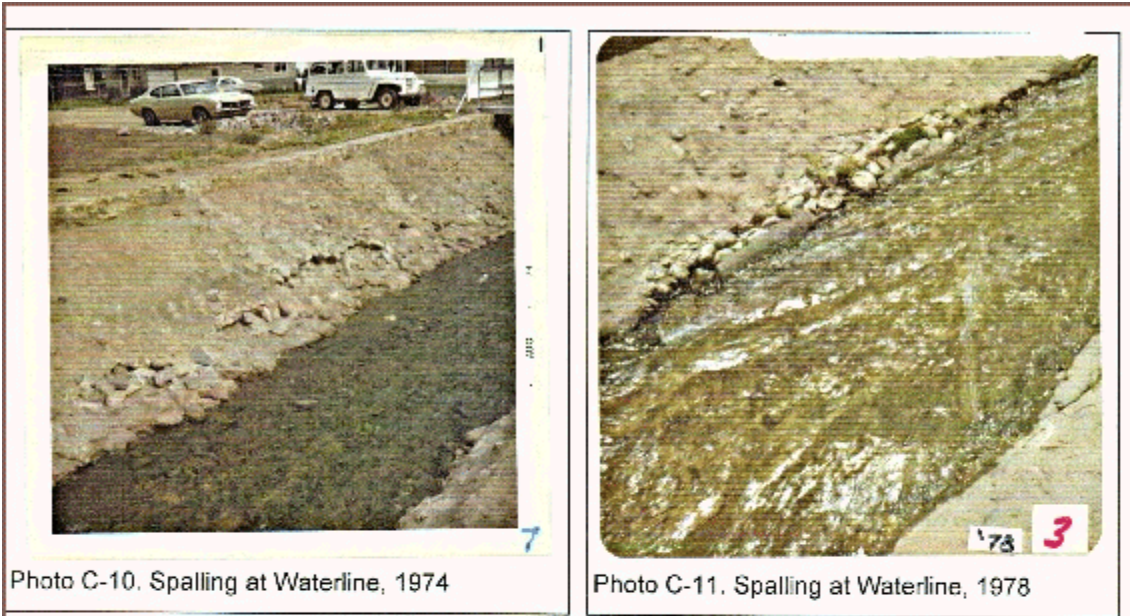
Photo C-10. Spalling at Waterline, 1974

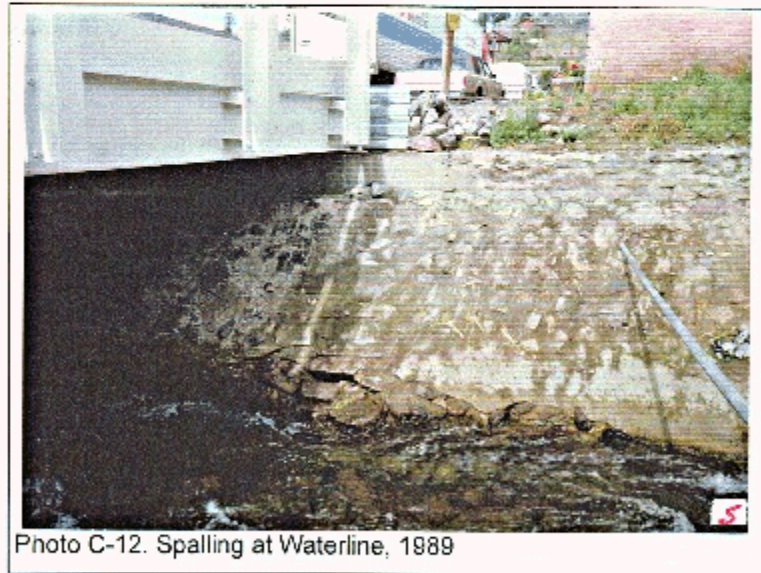
Photo C-12. Spalling at Waterline, 1989

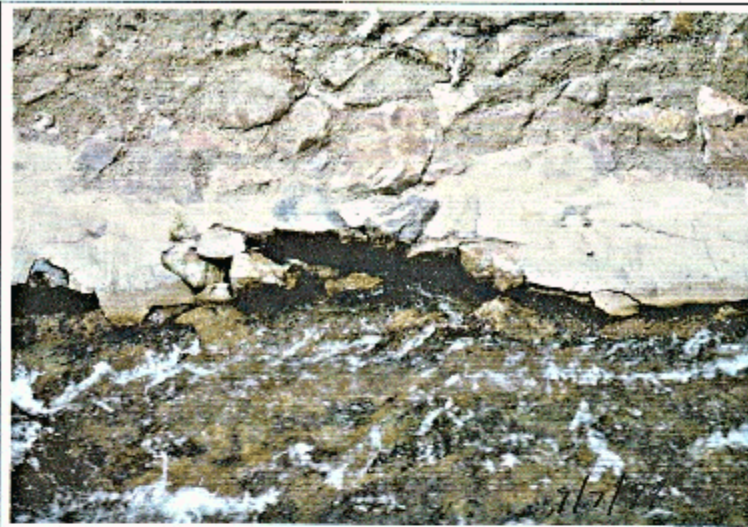
Photo C-13. Spalling at Waterline, 1994

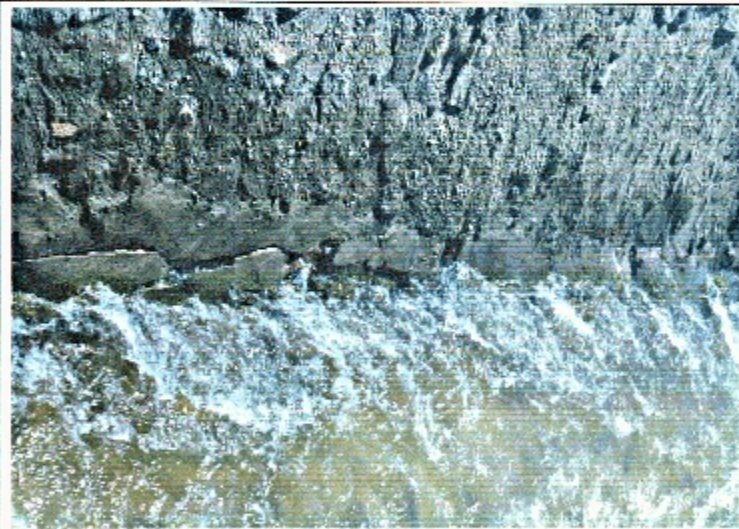
Photo C-14. Spalling at Waterline, 1998

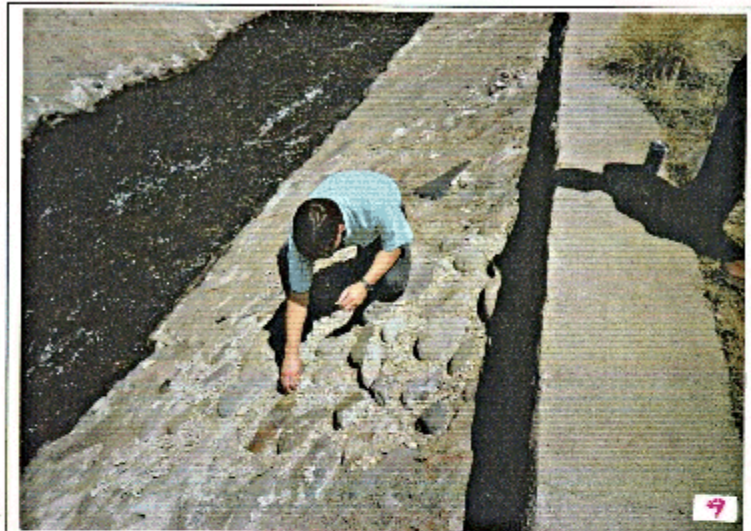
(4) Destructive chemical reaction between acidic volcanic aggregate and mortar. Photo C-15 shows concrete disintegration caused by high acid aggregate.

Photo C-15. Concrete Disintegration

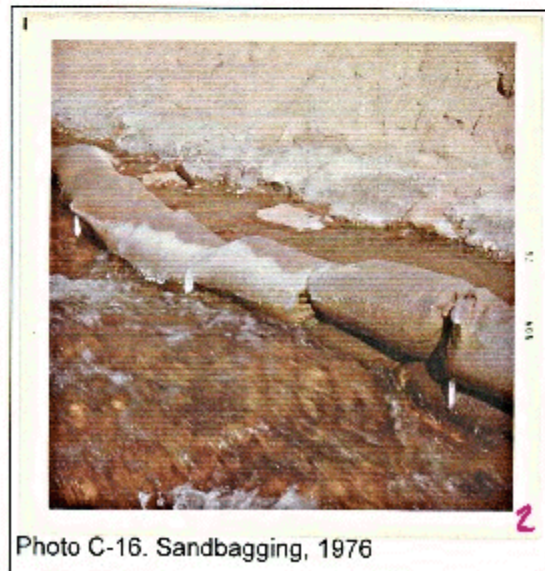
Photo C-16. Sandbagging, 1976

The City has regouted channel portions along the waterline on many occasions. About 20 feet of channel can be patched in one day. The work area is sealed off from streamflow by sandbags. Repair is limited to the low-water months, August to October.

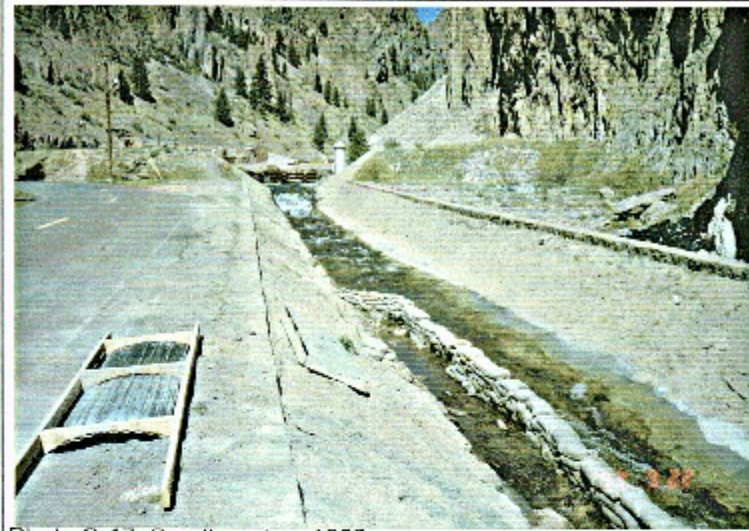
Photo C-17. Sandbagging, 1992

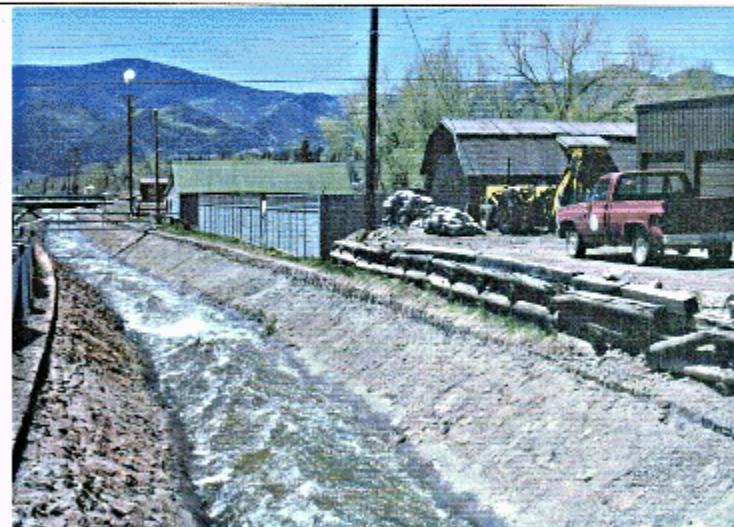
Photo C-18. Ready for Sandbagging, 1998

Noticeable in the center of Photo C-18 is a wave caused by a hole in the bottom of the channel. Sandbagging this area is more difficult than sandbagging along the sideslope.

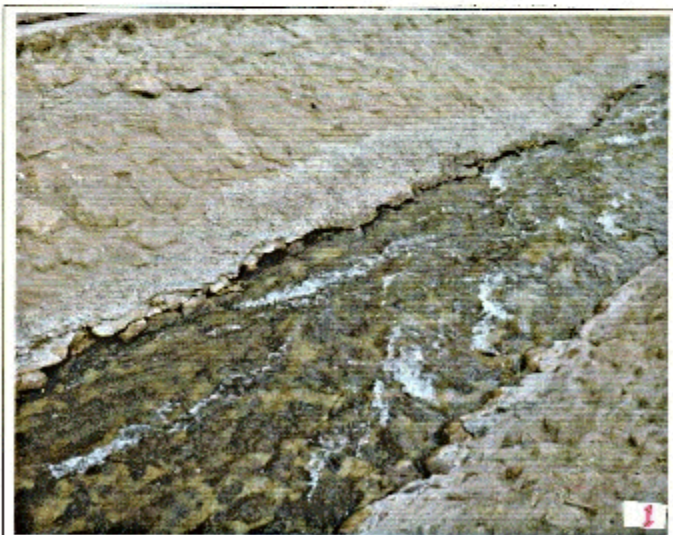
Photos C-19 and C-20 show a patch and its fate.

Photo C-19. Fix

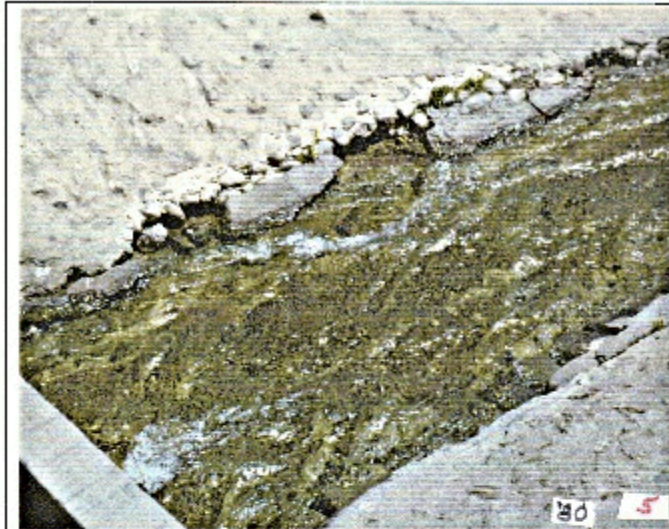
Photo C-20. And Fail

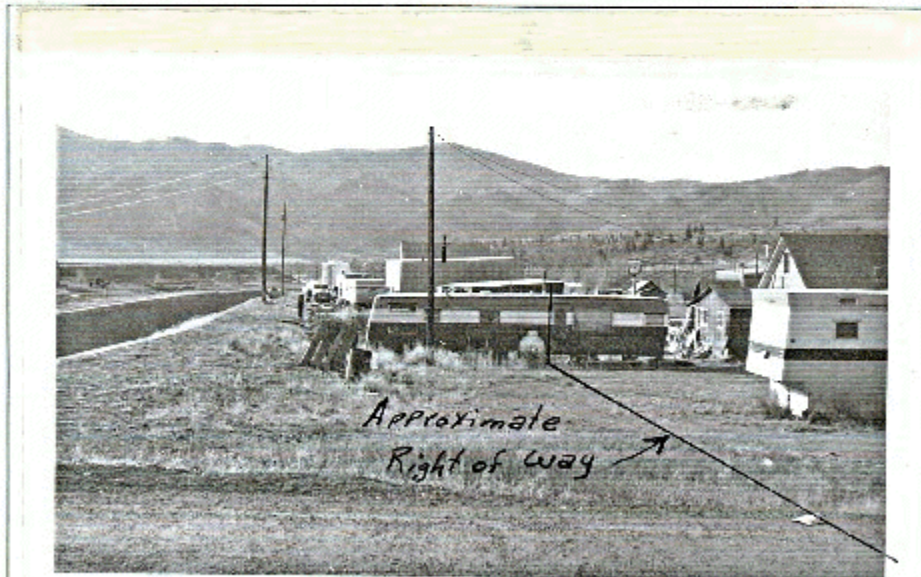
The project suffers the attack of encroachment. Photo C-21 shows the problem. The City has moved against violators, but the problem persists.

Photo C-21. Encroachment

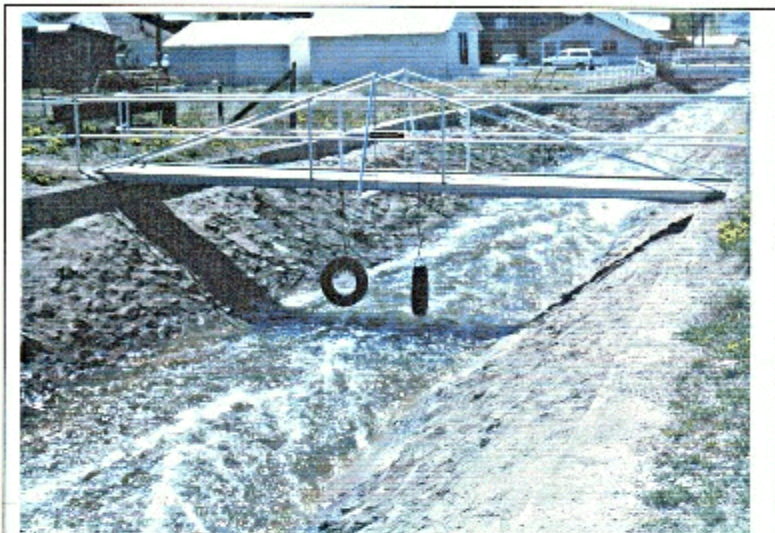
The project poses a substantial safety challenge. Photo C-22 shows a possibility of self-rescue, but as flow is fast and cold and the rocks are rough, the victim will be injured.

Photo C-22. Grab on if you can.
