US Army Corps of Engineers
(Albuquerque District)
Floodwater Lessons Learned
Socorro Diversion Channel

Floodwater Lessons Learned Socorro Diversion Channel

Socorro Diversion Channel

Title: Socorro Diversion Channel Project, Socorro, New Mexico
Sponsor: City of Socorro
Contract: DA-29-005-CIVENG-63-2
Final Inspection: 1964

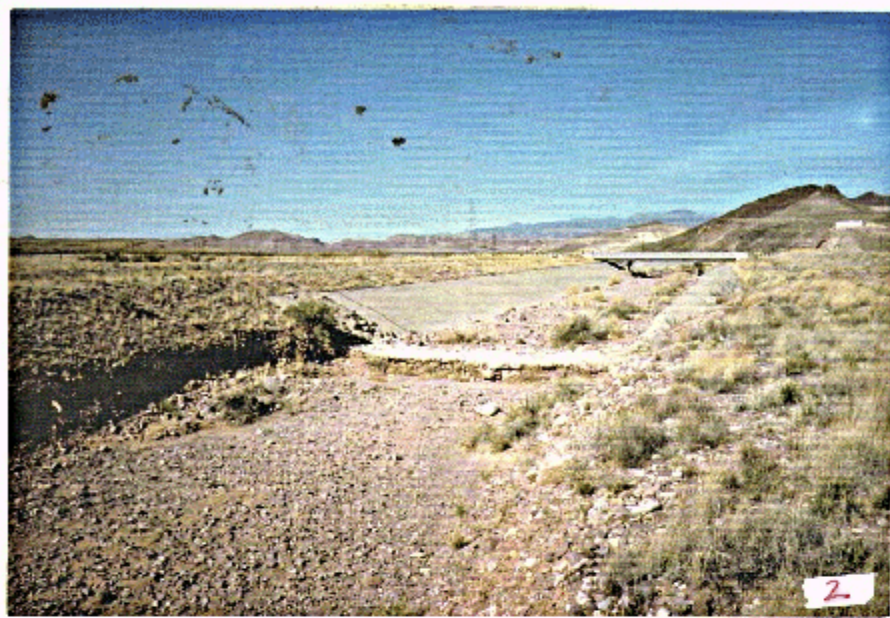
Photo 1. Toe of lined channel

Photo 1 shows the transition from lined to unlined sideslopes. The sill of grouted boulders, which drops roughly 3 feet, has never been undercut.

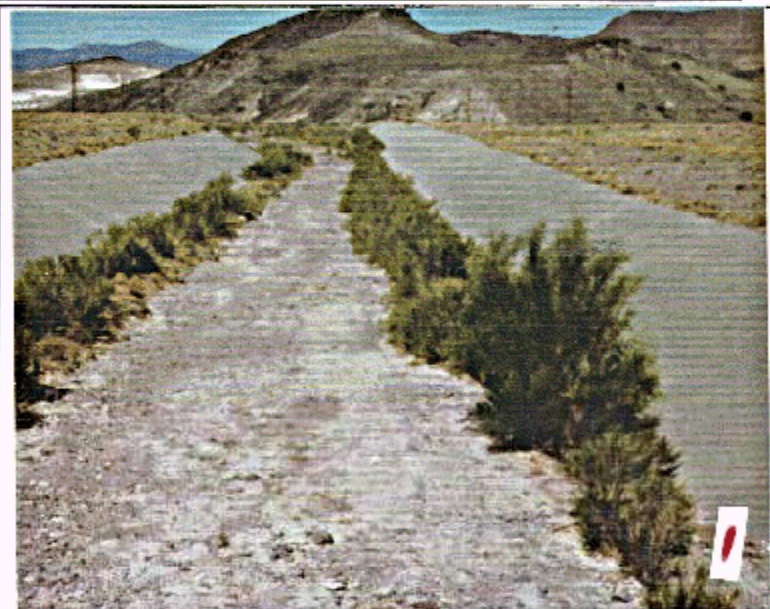
Photo 2. Acceptable vegetation

The “seep willow” in Photo 2 has lined the wall edges for the life of the project, never jeopardizing conveyance capacity.

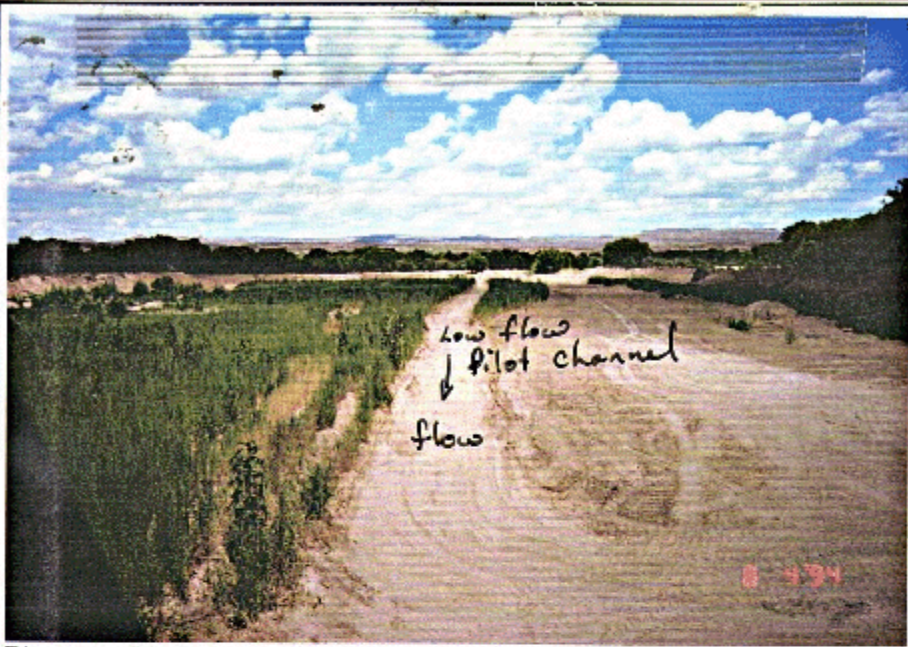
Photo 3. Pilot channel

Sediment deposition in the Socorro Diversion outfall is a perpetual problem (see the subsequent section *Outfall Channel*). Pilot channels keep the outflow moving for at least a short term. Silt disposal by water is preferable to silt disposal by diesel. Pilot channels are an effective component of channel management.

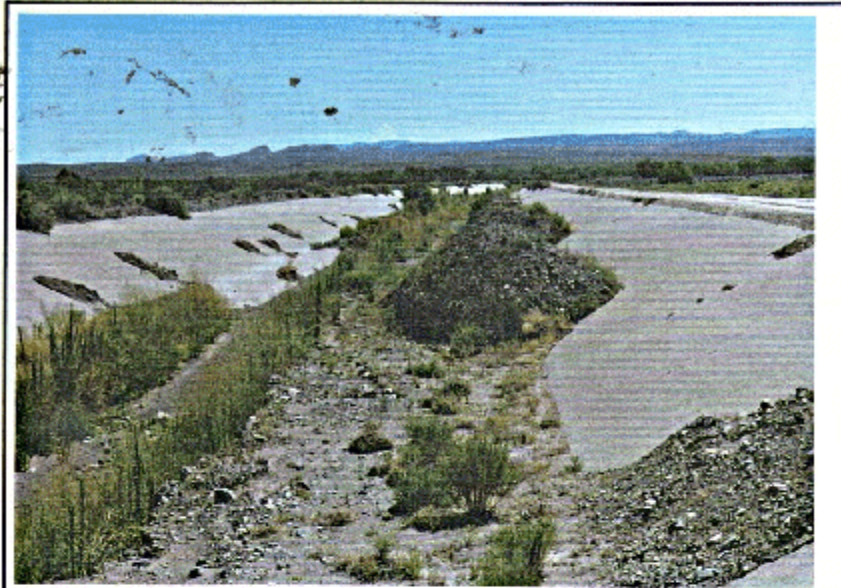
Photo 5. Pilot channel results

Photo 5 documents the result pilot-induced headcutting. Sediment filled the channel to the level of the remaining patches on the left bank. Deposition on the right bank has yet to be eroded.

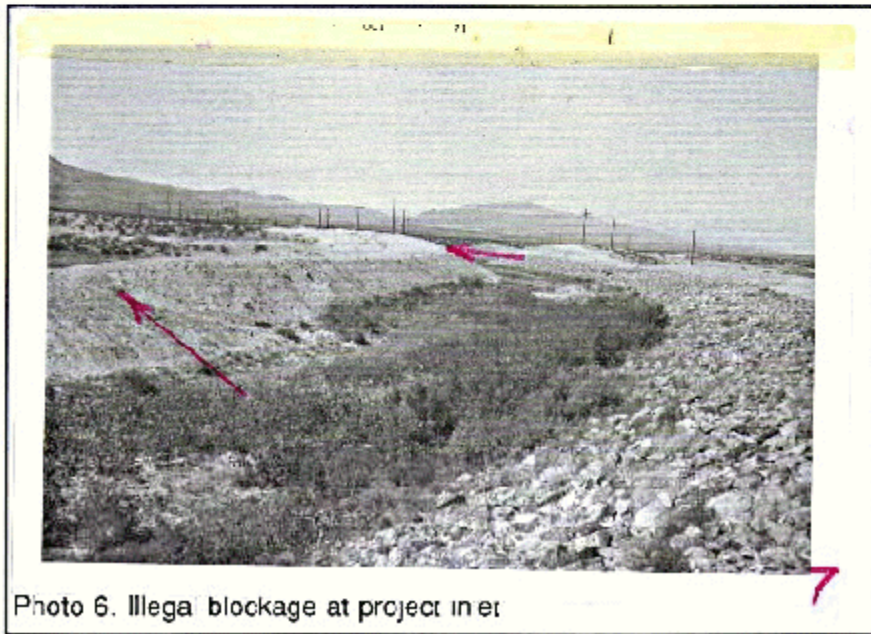
Photo 6. Illegal blockage at project inlet

The City illegally dammed the Smelter Arroyo at its confluence with the Socorro Diversion. The encroachment, shown in Photo 6, is summarized at the 7-year point in two-page *Information Summary* appended to this report.

- a. Is an encroachment.
- b. Probably has insufficient spillway capacity.
- c. May be of inadequate design.
- d. Was built in violation of Corps regulations.
- e. Was built in violation of State regulations (probably).
- f. May severely impair the design performance of the Socorro Diversion Channel.

I recommend we take a stiffer posture in this matter, and explore new paths of remedial action.

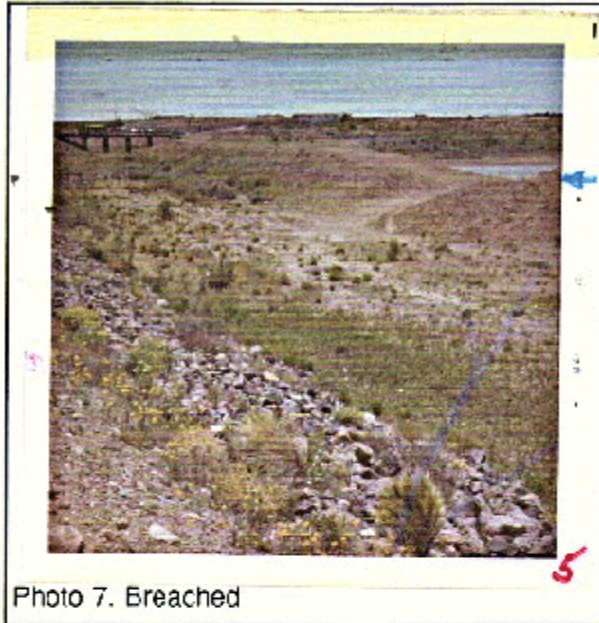
Photo 7. Breached

The City eventually breached the dam, Photo 7.

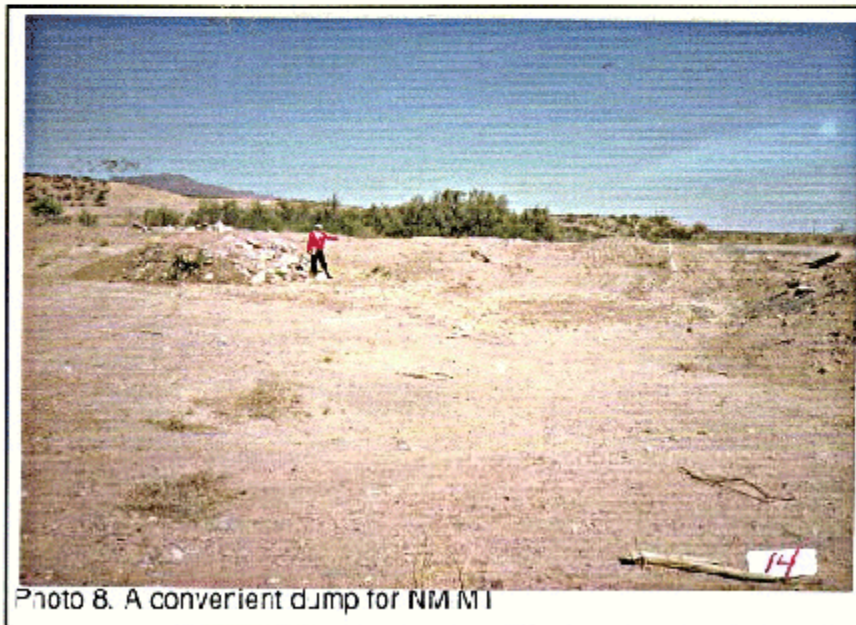
Photo 8 shows a 4 foot NMIMT landfill in the channel. The institution of higher education knew better.

Photo 8. A convenient dump for NMIMT

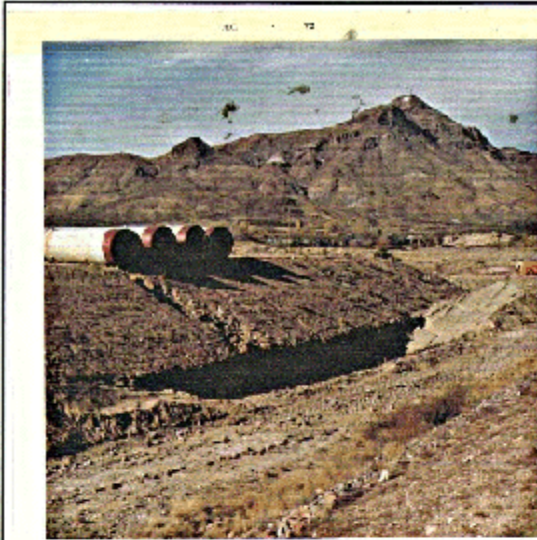
Caught in the act, NMIMT denied that the tanks of Photo 9 would be placed in the channel. Photo 10 testifies to denial's veracity.

Photo 9. "We wouldn't do that", 1972

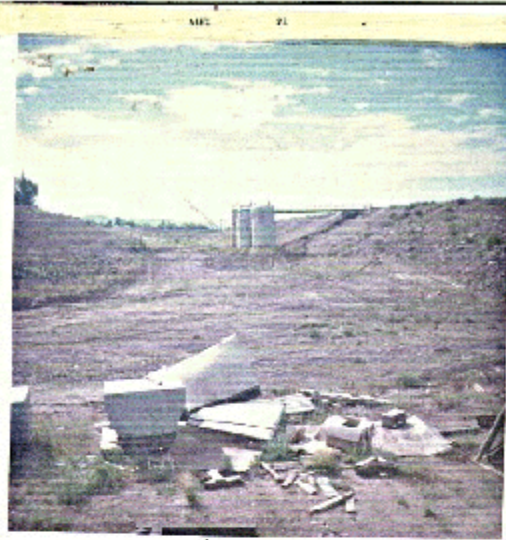
Photo 10. "Focled you!", 1973

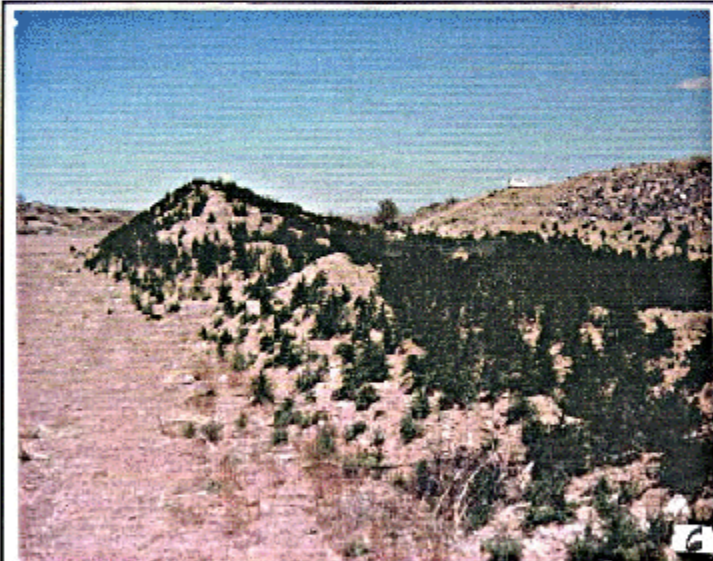
Cut exceeded fill for a nearby road. Photo 11 shows the solution.

Photo 11. Earth pile in channel

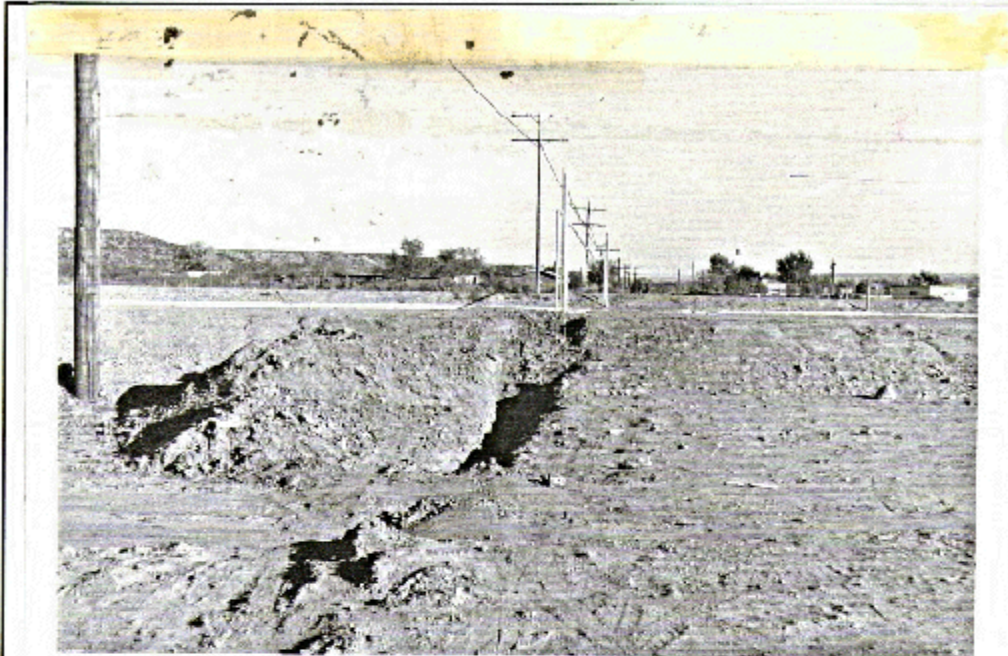
Photo 12 shows bank damage by an unapproved gas line crossing of the channel.

Photo 12. Unauthorized utility crossing

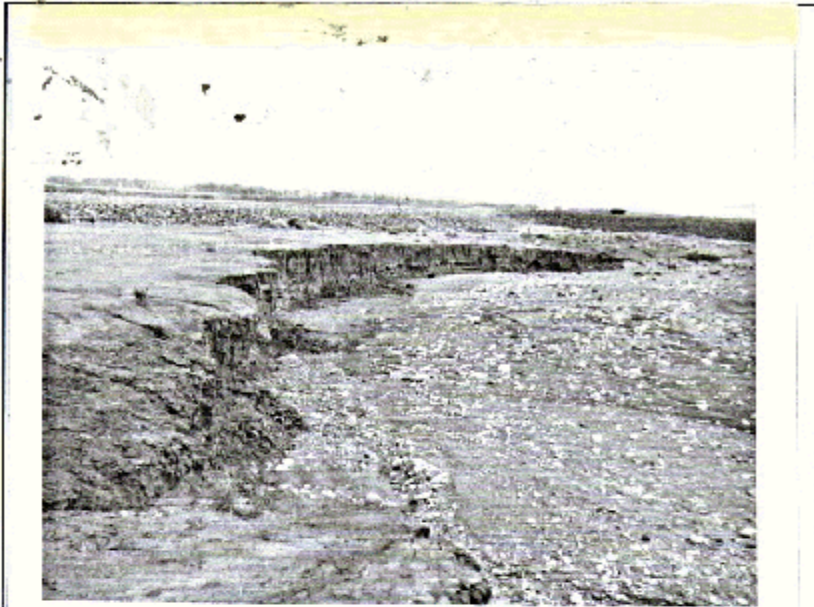
Inspection notes document the steady migration of the Nogal channel towards, and now into, the levee that ties down the confluence. Photos 13-15 trace the history.

Photo 13. 75 feet to levee, 1966

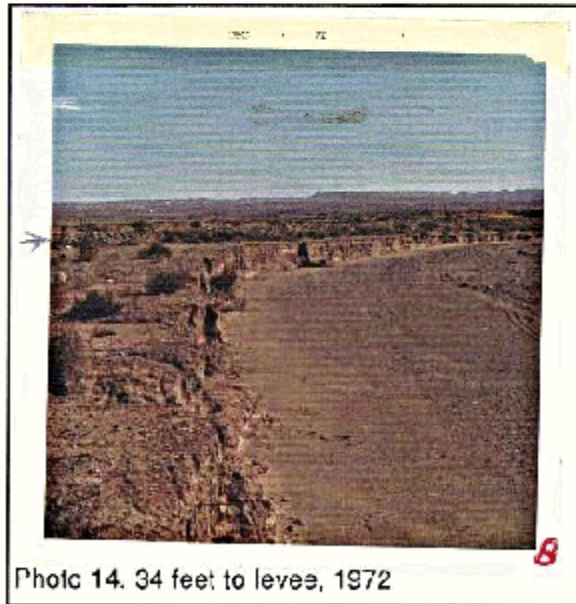
Photo 14. 34 feet to levee, 1972

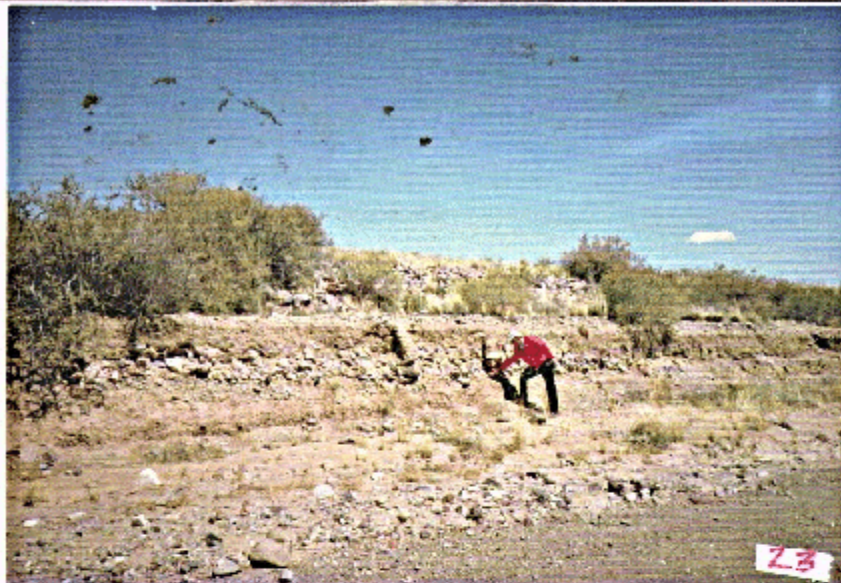
Photo 15. Levee attack, 1991

City rock dumping to protect the levee has been ineffective. As with most engineering effort in fluvial geomorphology, a lasting solution requires survey, analysis of design conditions (as opposed to response to yesterday's flow) and integration with the larger project.

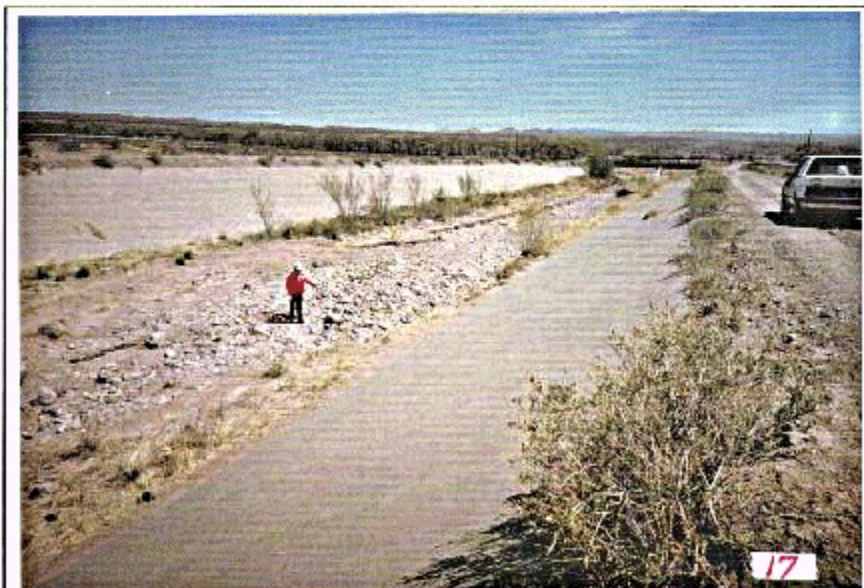
Grade is negligible in the outfall's lower reach. An inspection note spells the reach as "sediment trap". The outfall exemplifies stream competence, the geomorphologic expansion of particle size decrease in the downstream direction. See Photos 16-17.

Photo 16. Rocks as large as 3 feet below Nogal confluence

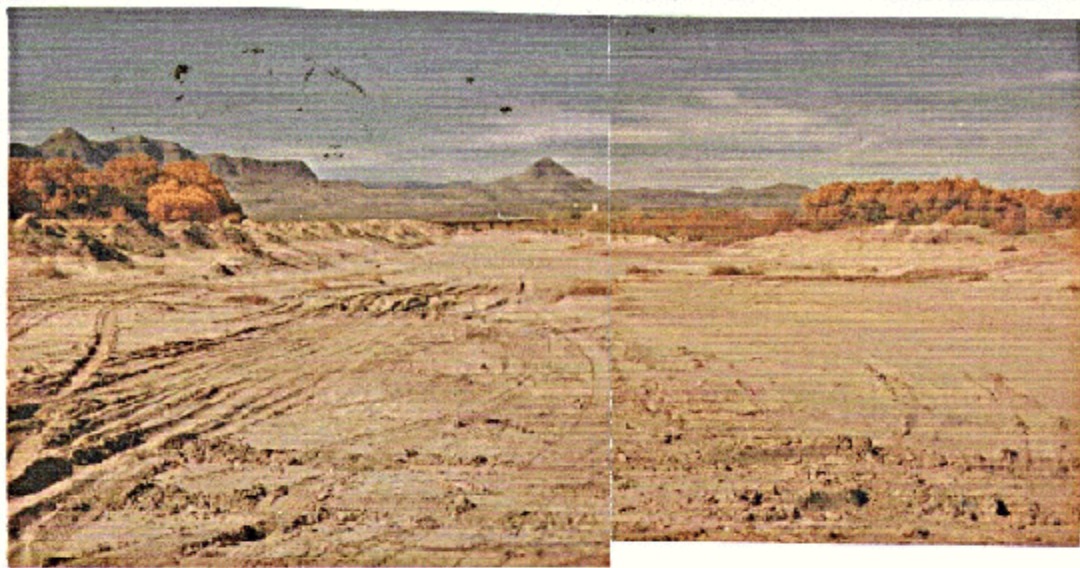
Photo 17. Tens of thousands of cubic yards of silt in outfall to Rio Grande

It is not clear if the original designers hoped that the channel would clean itself. The channel crossings are not sized for extensive accumulation.

Sediment transport at the outfall should be assessed, a task for which the Corps is now better equipped than at the time of initial design. Several alternatives merit thought:

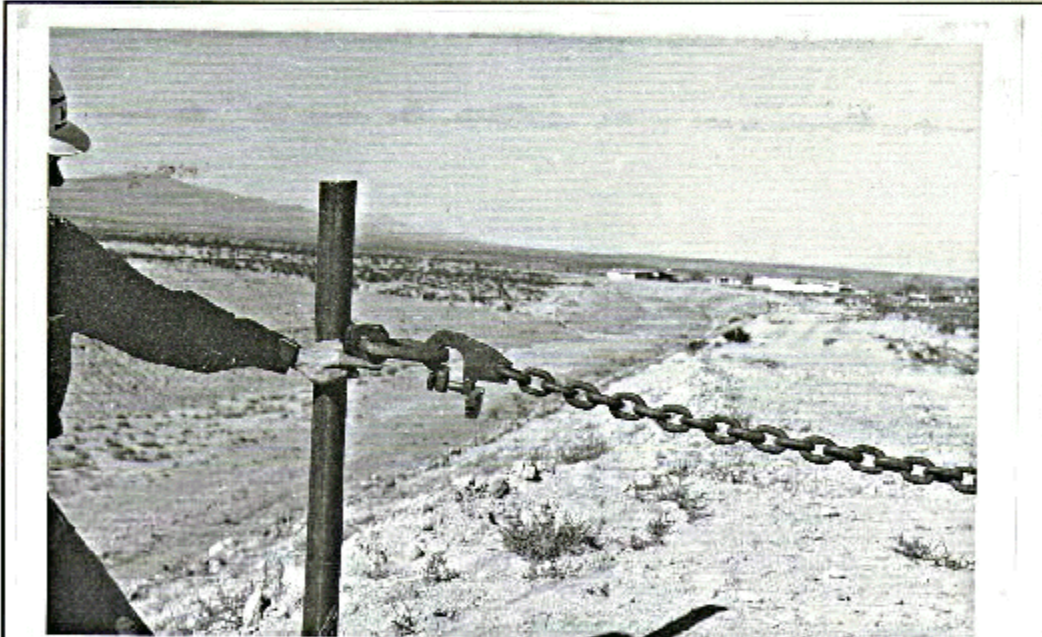
Locked gates appear to which the City lacks a key. Roadway berms by others discourage vehicular trespass. In other places, access is enhanced by those who remove riprap to ramp to drive in and out of the channel. Oriental wisdom warns against of too little or too much of a thing. Photos 19-20 illustrate the extremes.

Photo 19. Can't get in. NMINT has the key

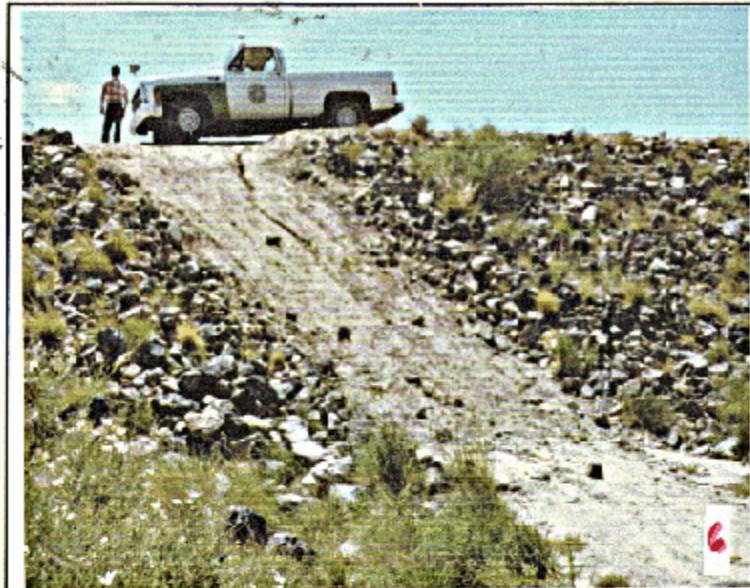
Photo 20. Everyone gets in. Riprap removed.

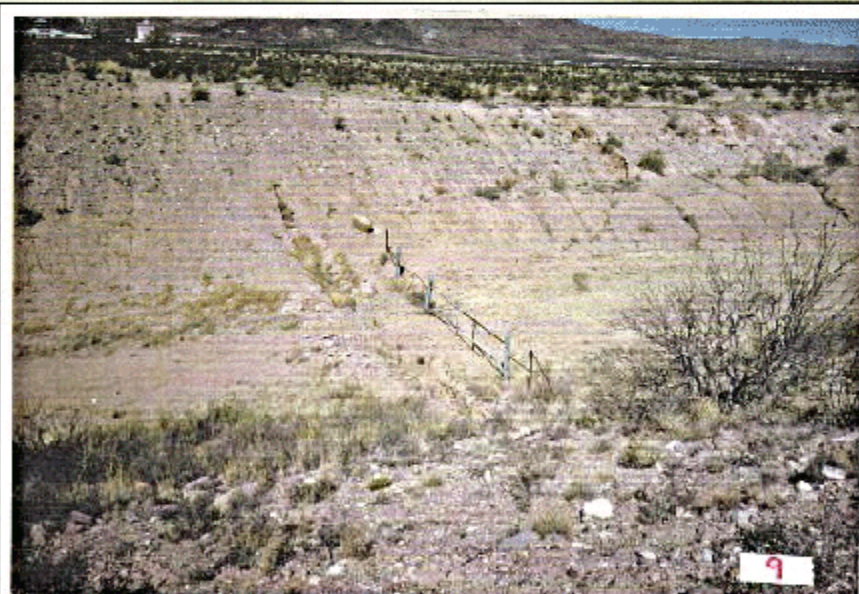
Photo 21 is an access issue that will be resolved by a large storm.

Photo 21. Access blocked, but not restricting conveyance

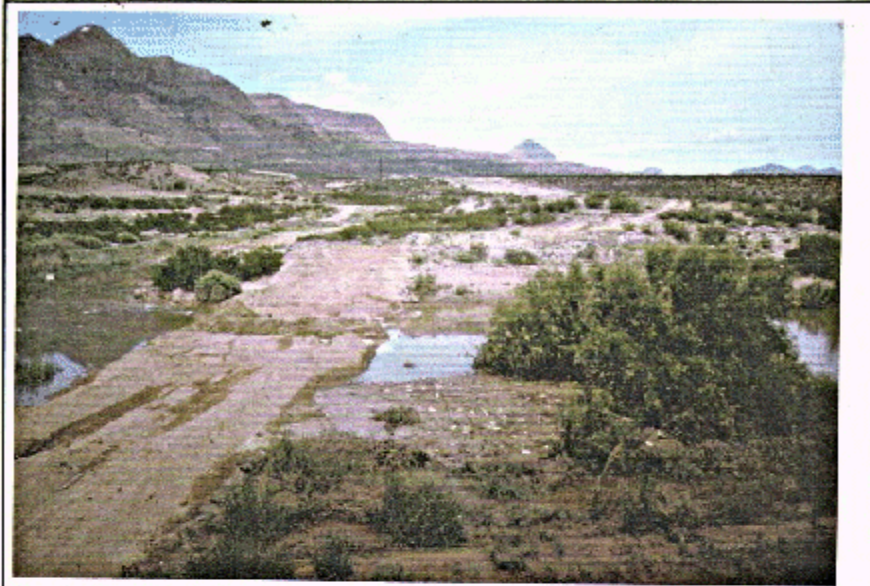
The head has been from minor local ponding, not flood flow. Photo 22 shows a temporary crossing pending runoff that piped.

Photo 22. This is the berm that led to the pond that led to the pipe.

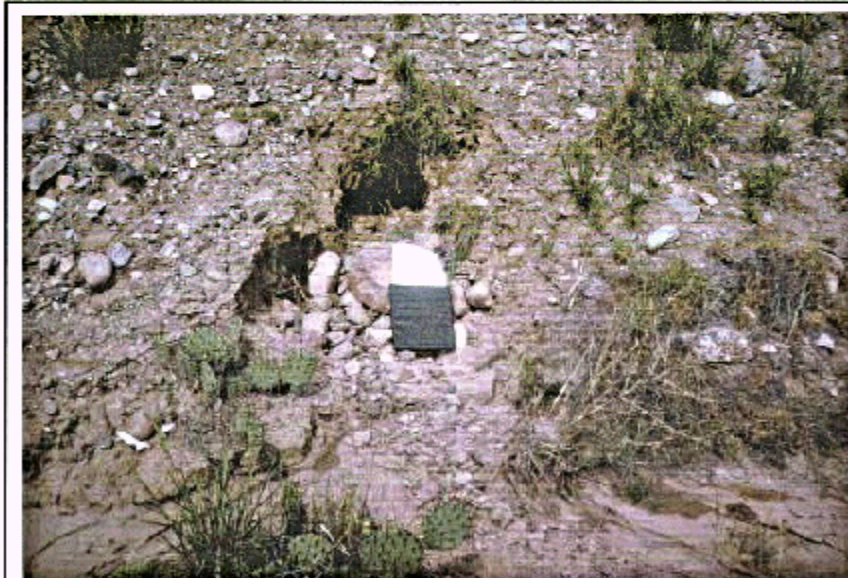
Photo 23. Piping

Photos 23-24 show a pipe outlet; and a sink hole, probably over a pipe.

The few reported instances do not appear to relate to poor construction compaction. Animal burrowing is probably involved.

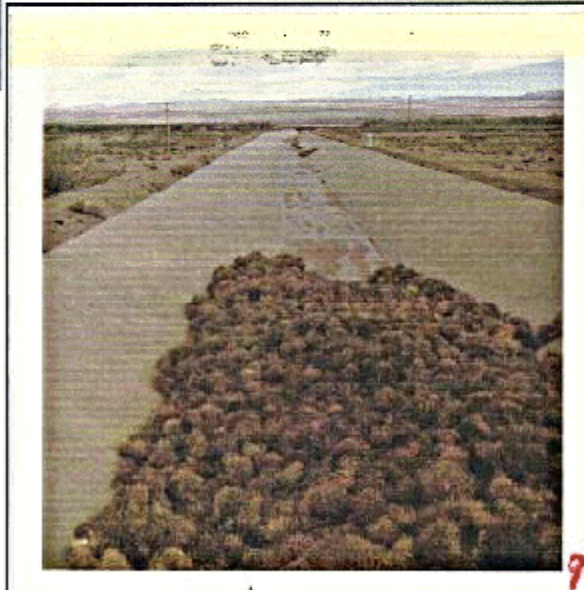
Photo 25. USGS bubbler gage

No aspect of the project has a record as sorrowful as that of gaging. Photo 25 shows a USGS bubbler gage that might have bubbled through 8 feet of tumbleweeds in the foreground, but couldn't bubble through sediment that followed.

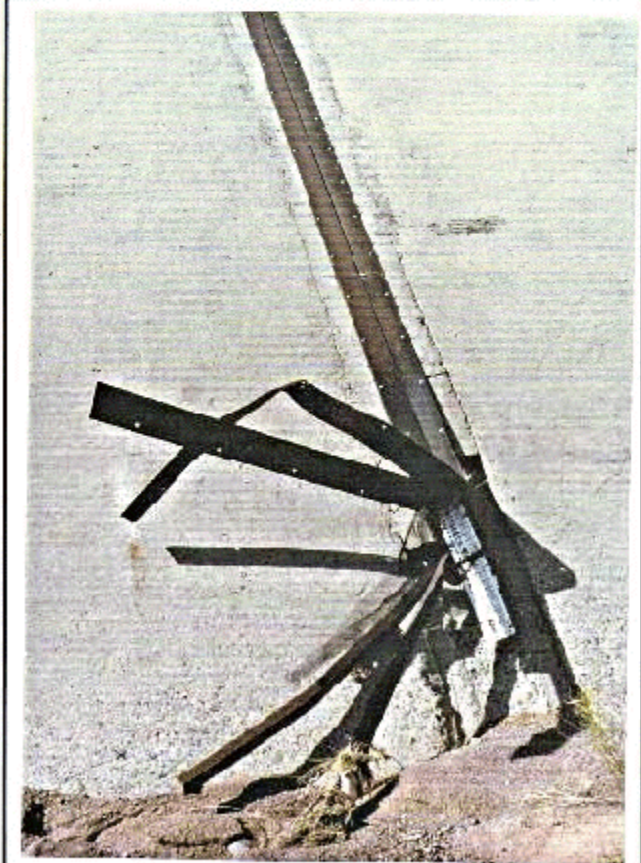
In an inclined peak stage gage, the plate is removed after runoff to inspect the high silt mark. Photos 26-27 speak for themselves.

Photo 27. Hey, Mayor! Chief! We had flow!

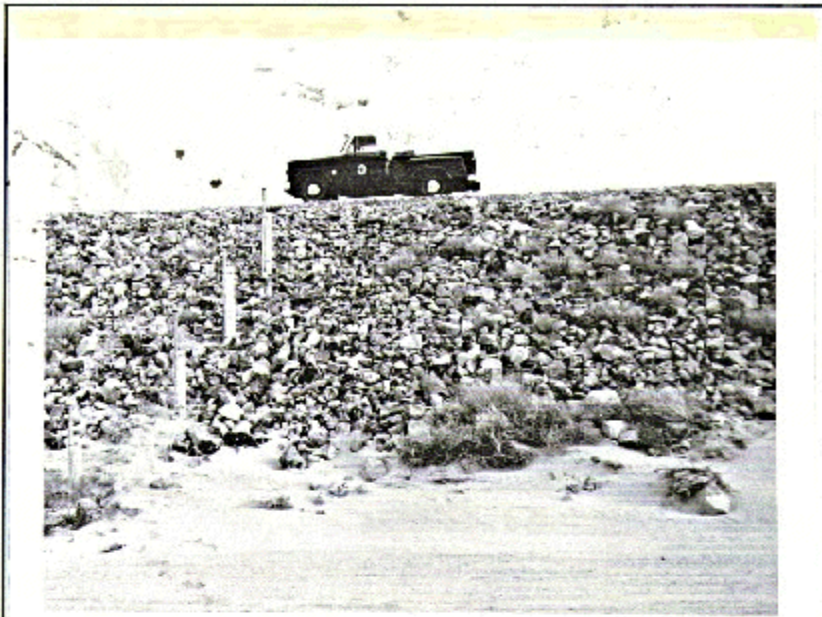
Photo 28. USGS peak stage gages, 1966

In a vertical peak stage gage, the pipe cap is removed and a staff gage is removed for signs of silt. Photos 28-29 show such gages in 1966 and 1997.

It is unknown if these gages have been read. Rust speaks to the negative. Boulders in a major event would render them into horizontal peak stage gages.

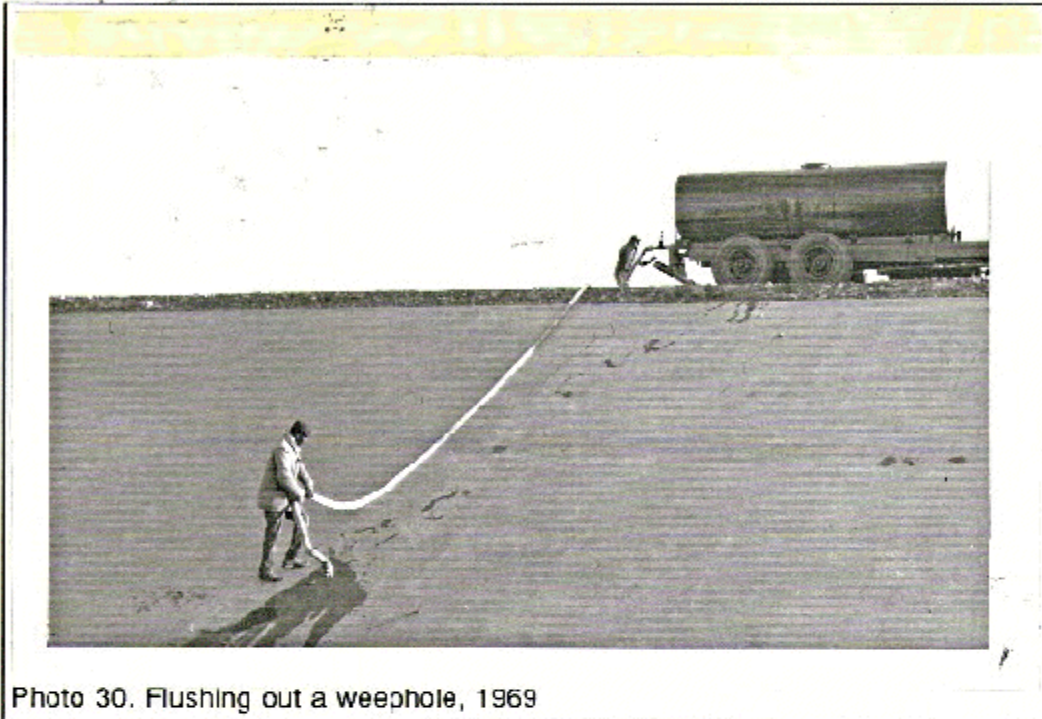
Photo 30. Flushing out a weephole, 1969

Weephole brass caps are prone to theft (as many as 44 at a time) and they require backwashing, as shown in Photo 30. The backwashing has not been continued.

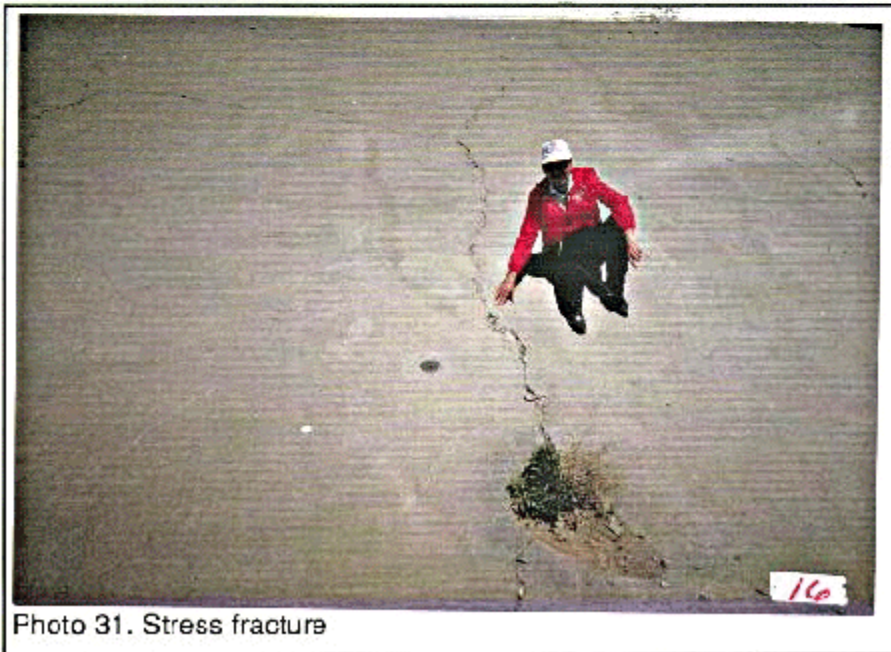
Both weepholes and French drains cause local stress in the concrete, as shown in Photo 31.

As most weepholes are plugged and the channel walls remain, weepholes may be unneeded

Photo 31. Stress fracture

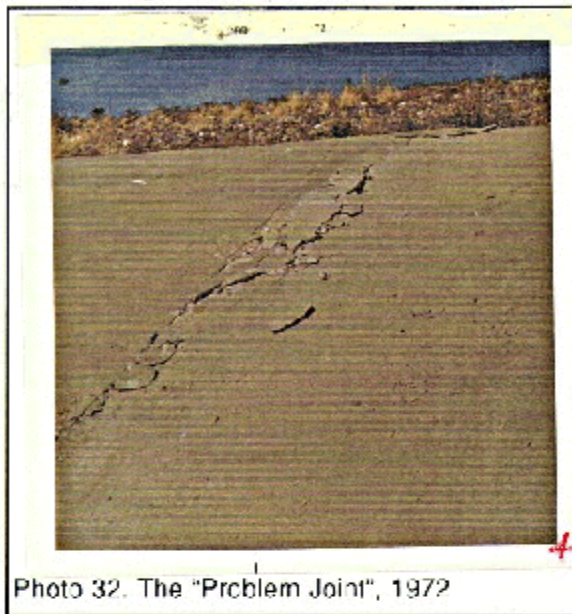
Concrete on the north sidewall of the Socorro Diversion and at one expansion joint in the Matanza Channel has spalled due to thermal working.

The Matanza landmark "Problem Joint" has been particularly irksome, as repeated repairs have not alleviated the problem. Photos 32-34 show the situation.

Photo 32. The "Problem Joint", 1972

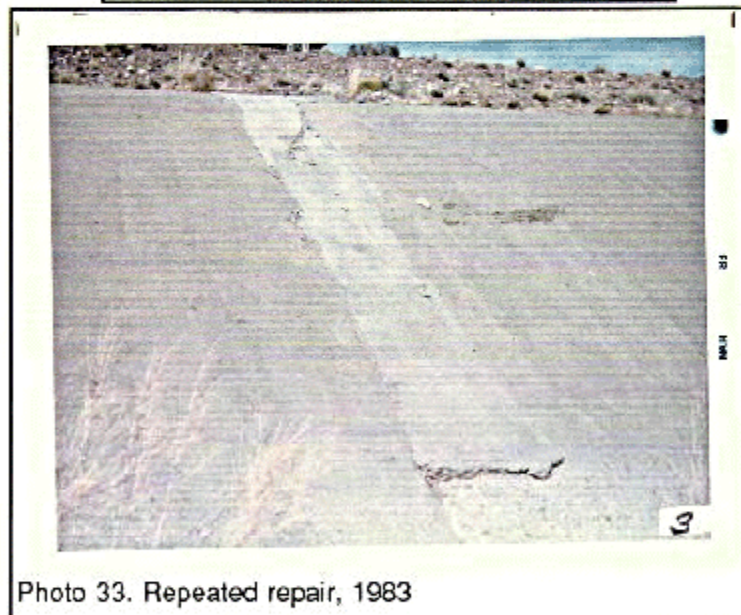
Photo 33. Repeated repair, 1983

While concrete should be expected to need redressing on occasion, the repair should last. For recurrent spalling, the Corps may need a joint specification for enhanced reconstruction.

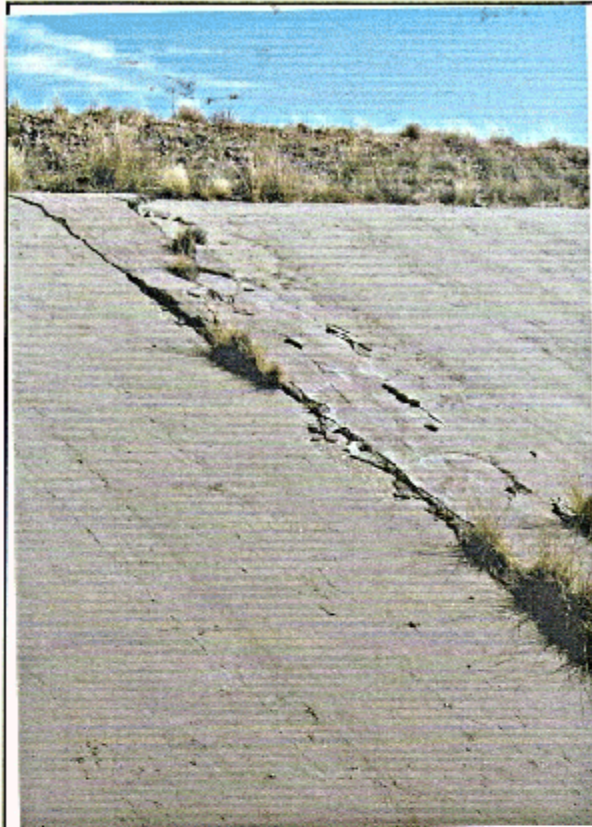
Photo 34. Repeated failure, 1997

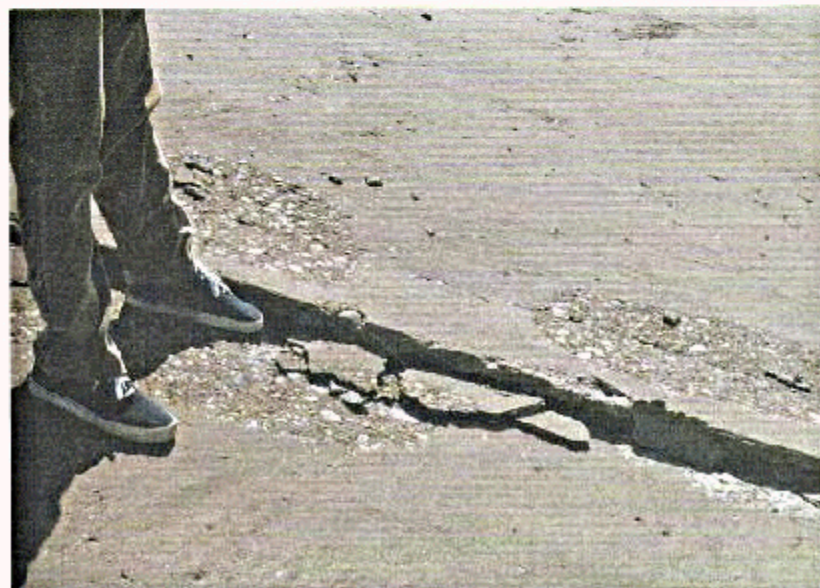
A clue to the failure mechanism may lie in the 4-inch vertical differential shown in Photo 35. Differential settling may have initiated the crack, or water through a crack may have caused settlement or heave.

Photo 35. 4-inch displacement

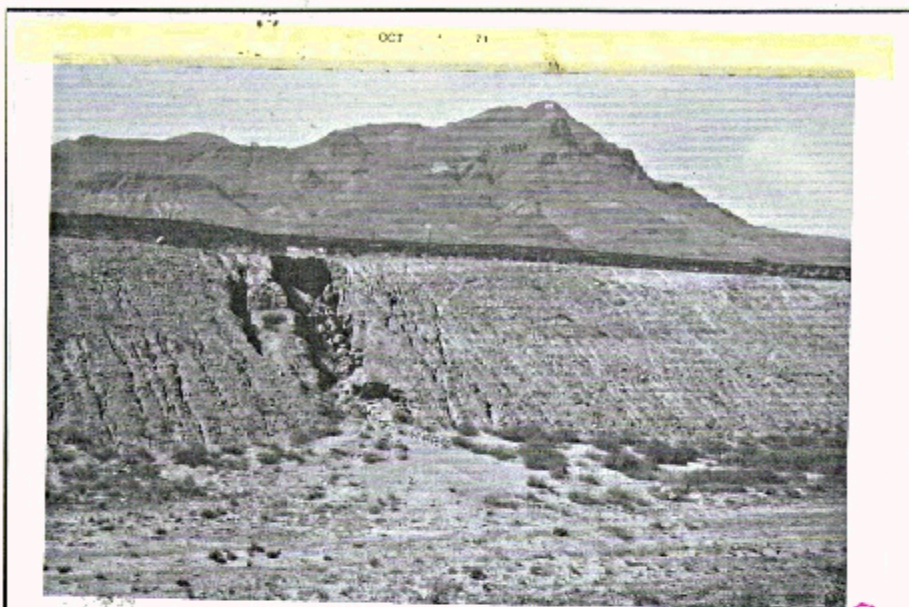
Photos 36 and 37 show the inevitable gullies where local flow runs over an embankment. The latter photo is a particular concern, however, as the gully serves as a playhouse.

Photo 36. Local erosion

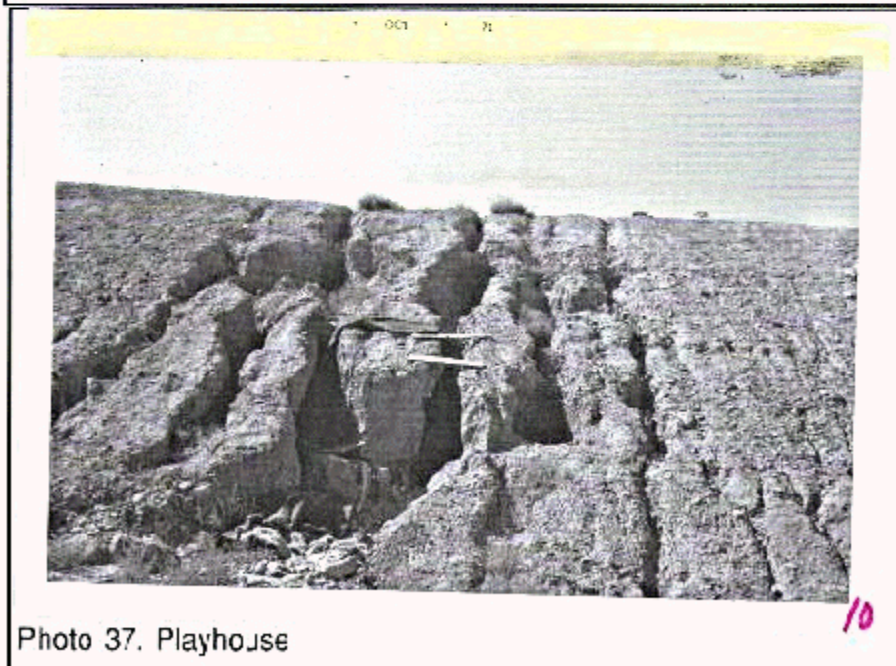
Photo 37. Playhouse
