## **Engineering Ethics: Kansas City Hyatt Walkway Collapse**

PDH Now, LLC.  
[www.PDHNow.com](http://www.PDHNow.com)

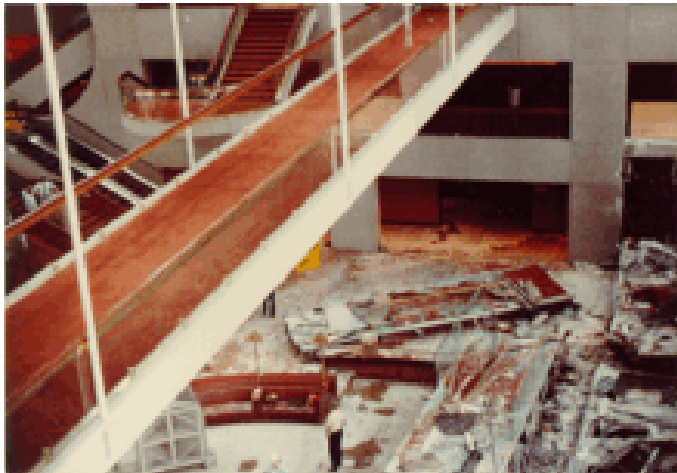
Photo of still-hanging third floor walkway. Note the free-standing stairs from the second to the third floor in the background. With its columnless design, the stairs seem to be floating in air. The lobby was indeed a masterpiece of architecture and engineering which, had it been executed properly, would have provided its owners with profit and the public with a stunning atmosphere for years.

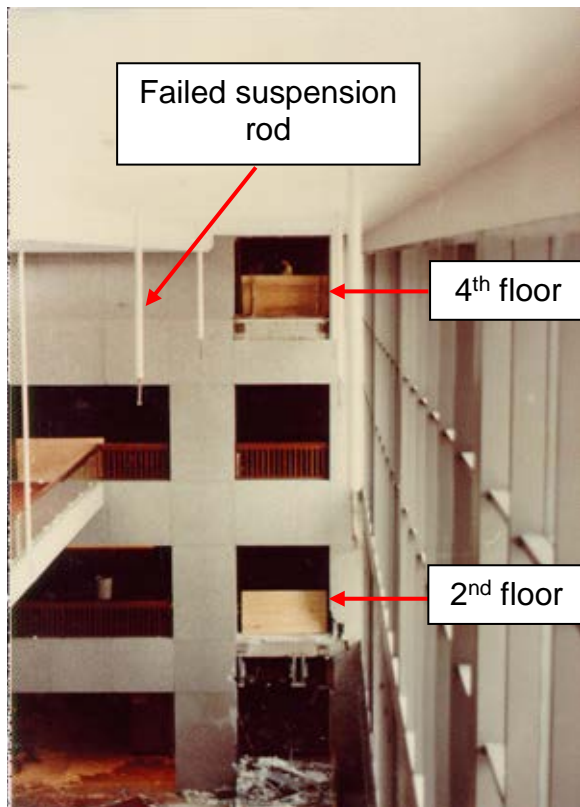
Photo of intact hanger rods from fourth floor walkway opening.

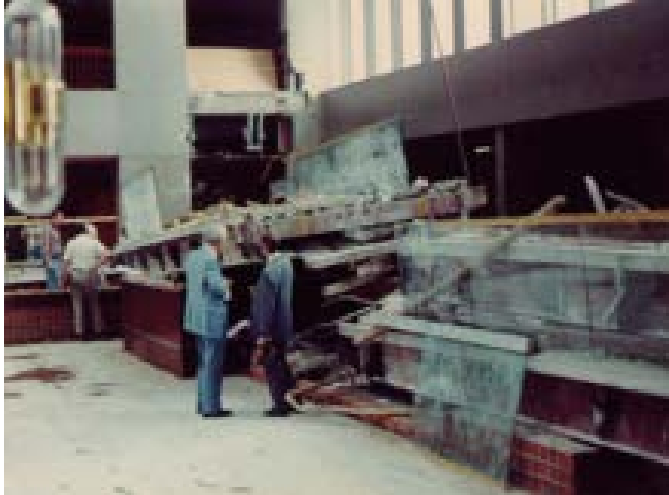
General view of the lobby floor, during the first day of the investigation.

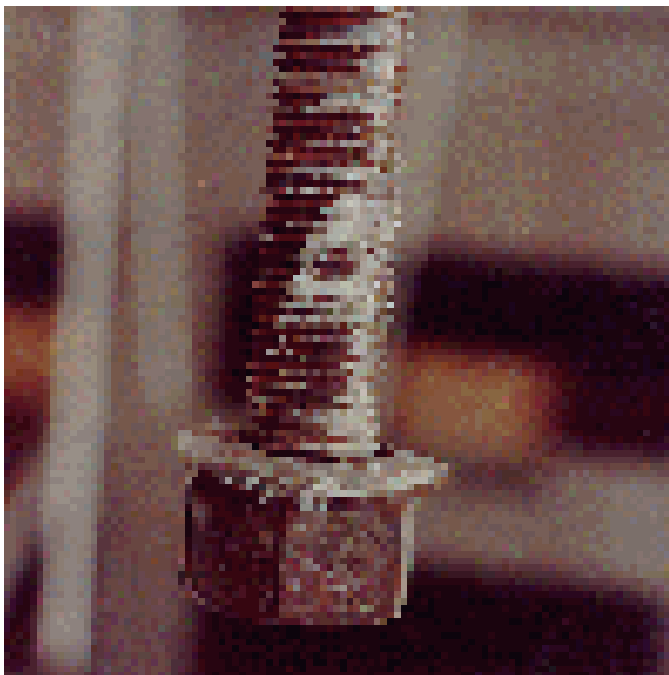
Close-up photo of the hanger rod threads, washer and supporting nut. Note the deformation caused in the washer as the beam slipped around it.

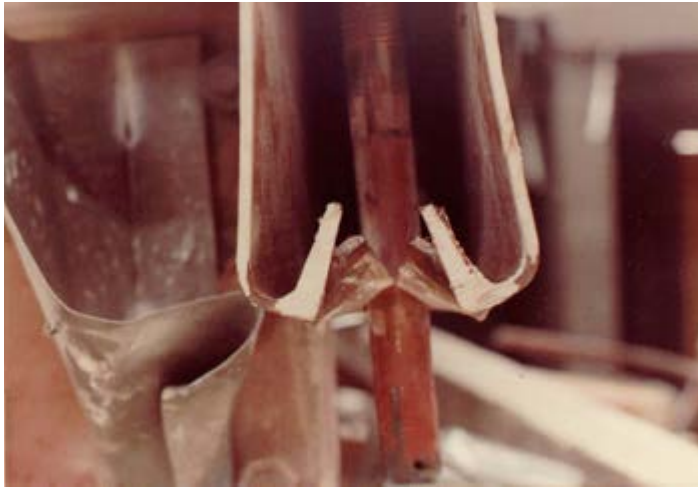
Close-up of one of the fourth floor beams.

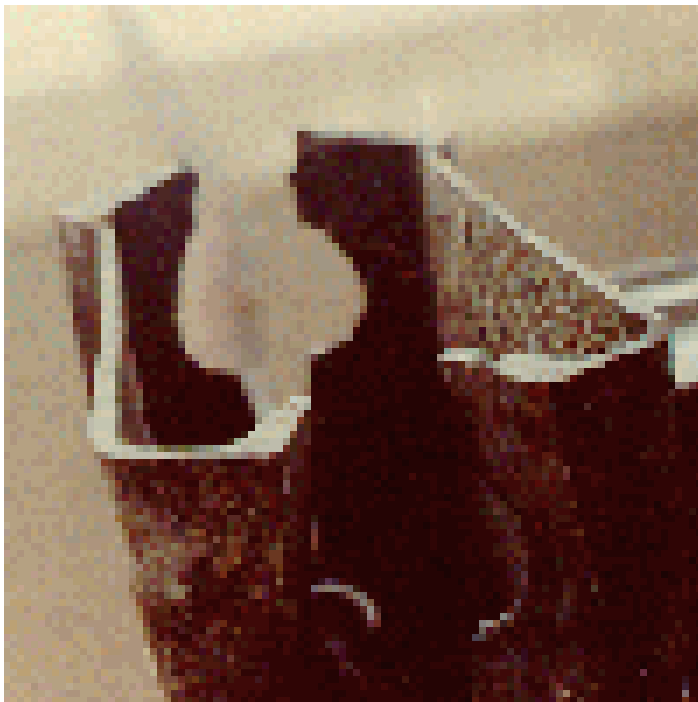
Underside view of one of the fourth floor beams.

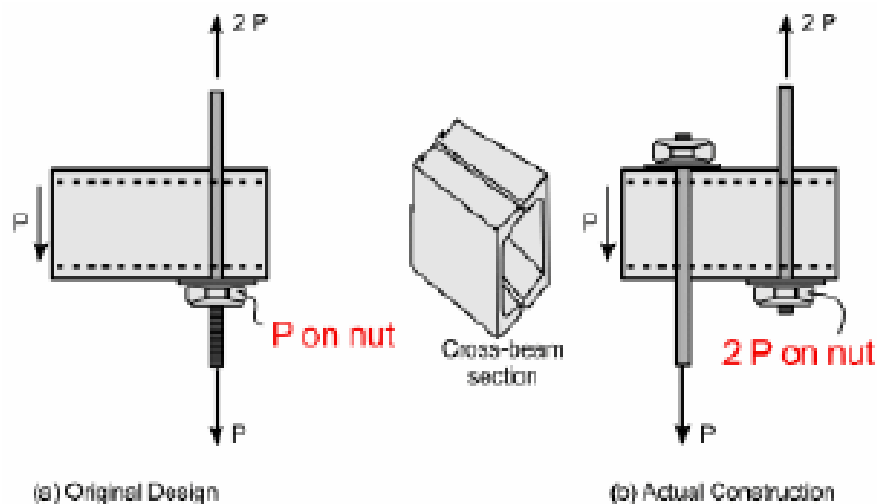
Fourth Floor Box Beam Connection Detail

*The hanger rod detail actually used in the construction of the second and fourth floor walkways is a departure from the detail shown on the contract drawings. In the original arrangement each hanger rod was to be continuous from the second floor walkway to the hanger rod bracket attached to the atrium roof framing. The design load to be transferred to each hanger rod at the second floor walkway would have been 20.3 kips (90 kN). An essentially identical load would have been transferred to each hanger rod at the fourth floor walkway. Thus the design load acting on the upper portion of a continuous hanger rod would have been twice that acting on the lower portion, but the required design load for the box beam hanger rod connections would have been the same for both walkways (20.3 kips (90 kN)).*

*The hanger rod configuration actually used consisted of two hanger rods: the fourth floor to ceiling hanger rod segment as originally detailed on the second to fourth floor segment which was offset 4 in. (102 mm) inward along the axis of the box beam. With this modification the design load to be transferred by each second floor box beam-hanger rod connection was unchanged, as were the loads in the upper and lower hanger rod segments. However, the load to be transferred from the fourth floor box beam to the upper hanger rod under this arrangement was essentially doubled, thus compounding an already critical condition. The design load for a fourth floor box beam-hanger rod connection would be 40.7 kips (181 kN) for this configuration. ...*

*Had this change in hanger rod detail not been made, the ultimate capacity of the box beam-hanger rod connection still would have been far short of that expected of a connection designed in accordance with the Kansas City Building Code, which is based on the AISC Specification. In terms of ultimate load capacity of the connection, the minimum value should have been 1.67 times 20.3, or 33.9 kips (151 kN). Based on test results the mean ultimate capacity of a single-rod connection is approximately 20.5 kips (91 kN), depending on the weld area. Thus the ultimate capacity actually available using the original connection detail would have been approximately 60% of that expected of a connection designed in accordance with AISC Specifications.*
