US Army Corps of Engineers

**Floodwater Lesson Learned
Channel Stabilization in Santa Fe, NM**

**CHANNEL STABILIZATION
IN SANTA FE, NEW MEXICO**

July 1997

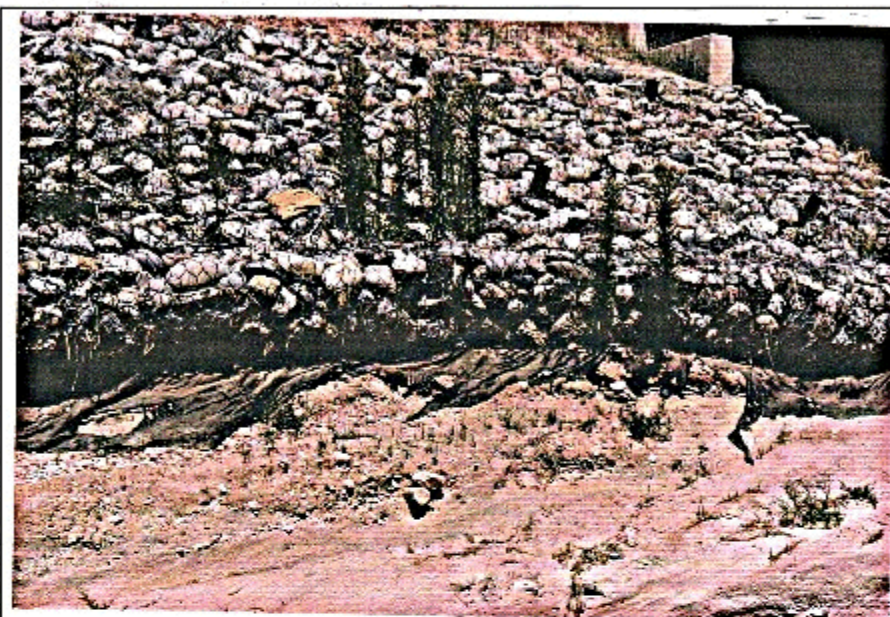
When a gabion or rock mattress is undercut, the wire bears the weight of the rockfill, as shown in Fig. 3. Rupture follows.

Figure 3. Eminent rupture

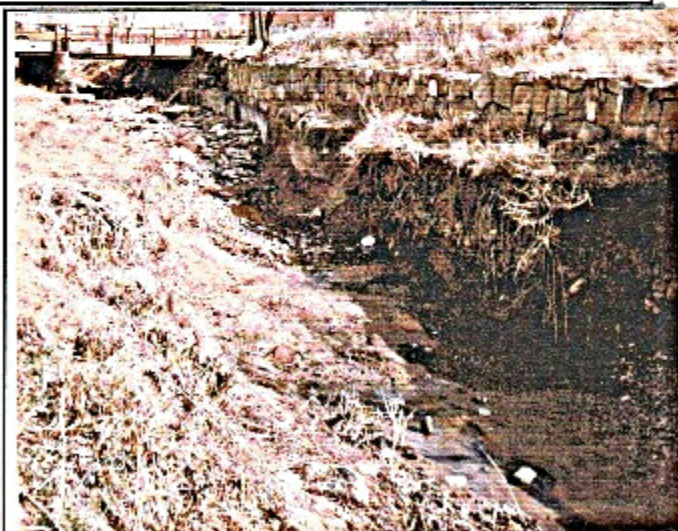
Fig. 4 illustrates a severely undercut wall footing. The bridge pier upstream already has been replaced. The wall will fail as scour continues.

Figure 4. Undercut footing

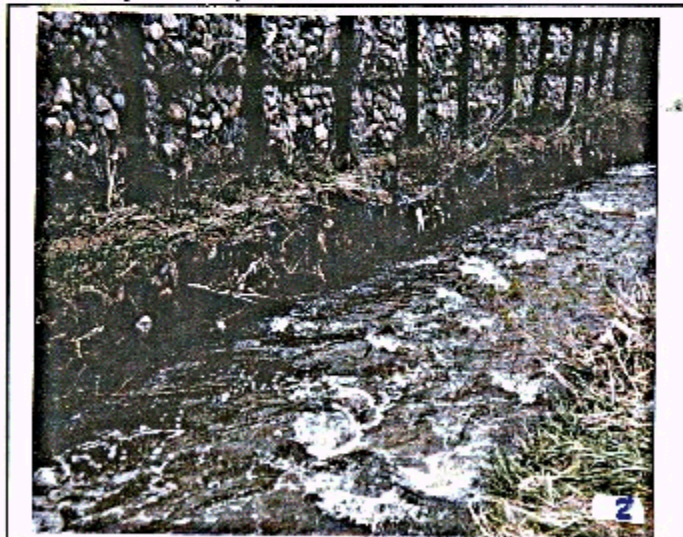
High velocities in Fig. 6 have pulled rocks from the sidewall.

Figure 6. Sidewall damage by high velocity flow

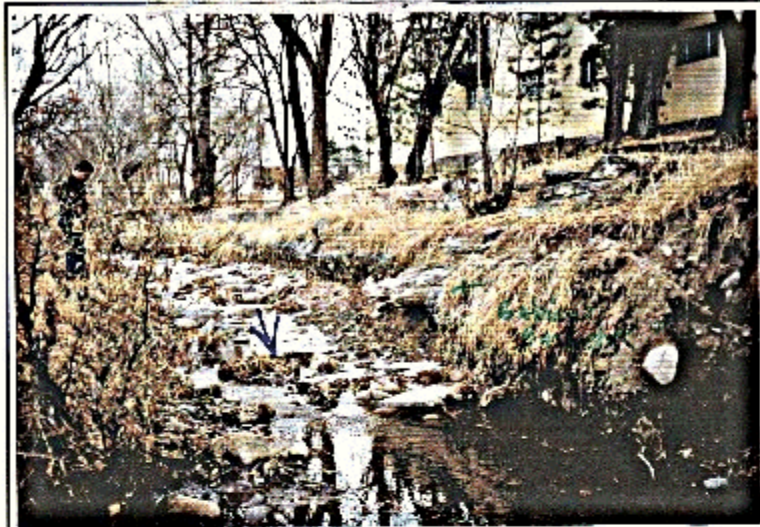
Fig. 7 illustrates the rotation of sidewall gabions into the channel as the bed degrades.

Figure 7. Rotated gabions

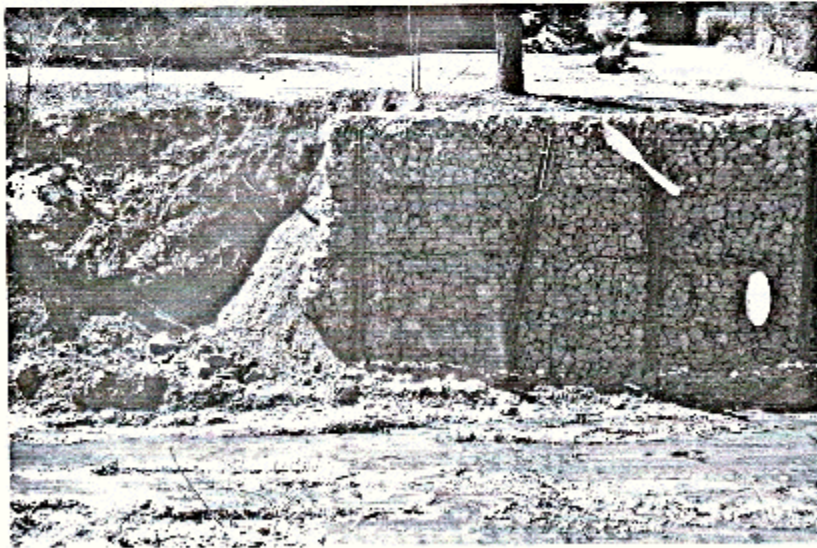
Endwalls are vulnerable to erosion. The wall in Fig. 8 needs a tieback.

Figure 8. Exposed endwall

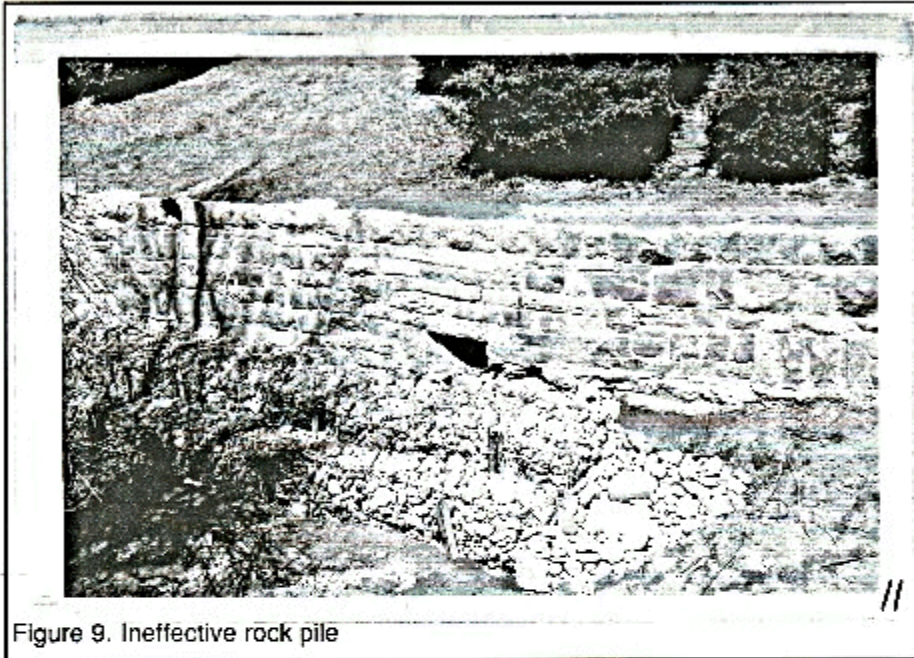
Dumping extra rock at the end of a structure, the Fig. 9 effort, is not a satisfactory endwall termination.

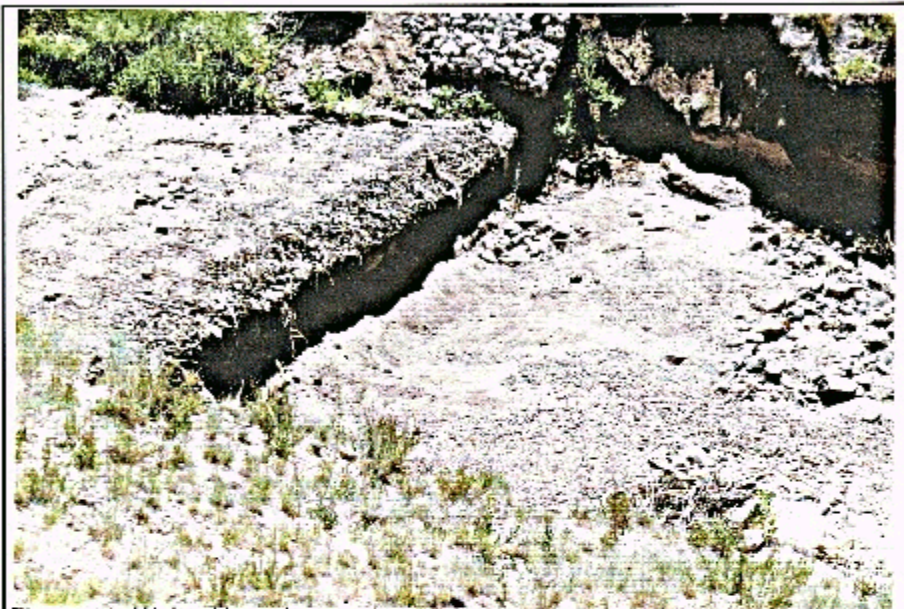
The weir of Fig. 10 has end protection, though it appears to be too superficial

Figure 10. Weir with end protection

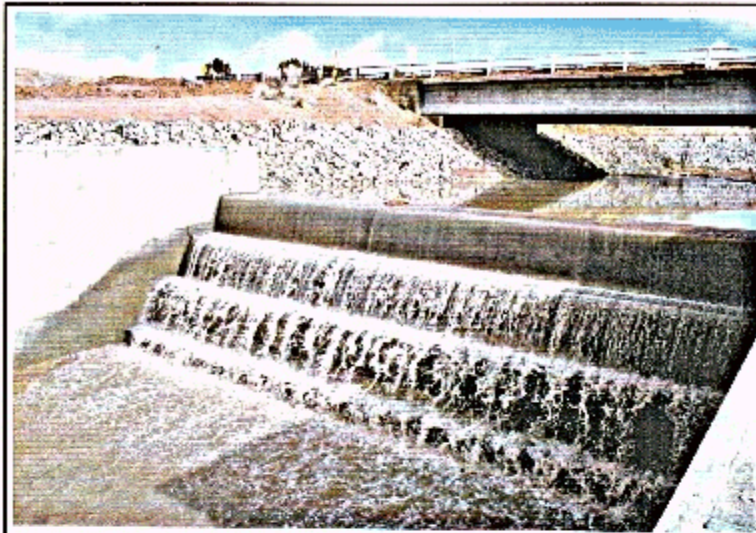
Figure 12. Tested by nature

While the grade control structure of Figs. 11 and 12 functions well hydraulically, its rock mattress wall is vulnerable to undercutting, as seen in Fig. 13. Specified toe burial was not done.

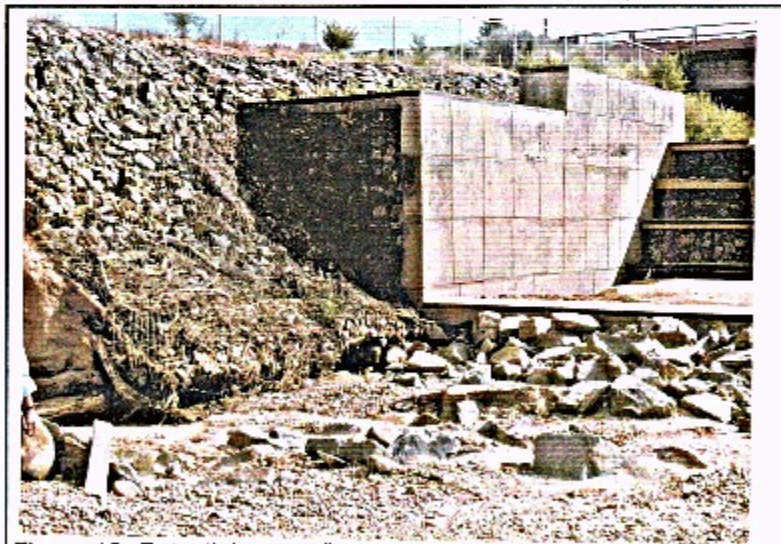
Figure 13. Potential unraveling

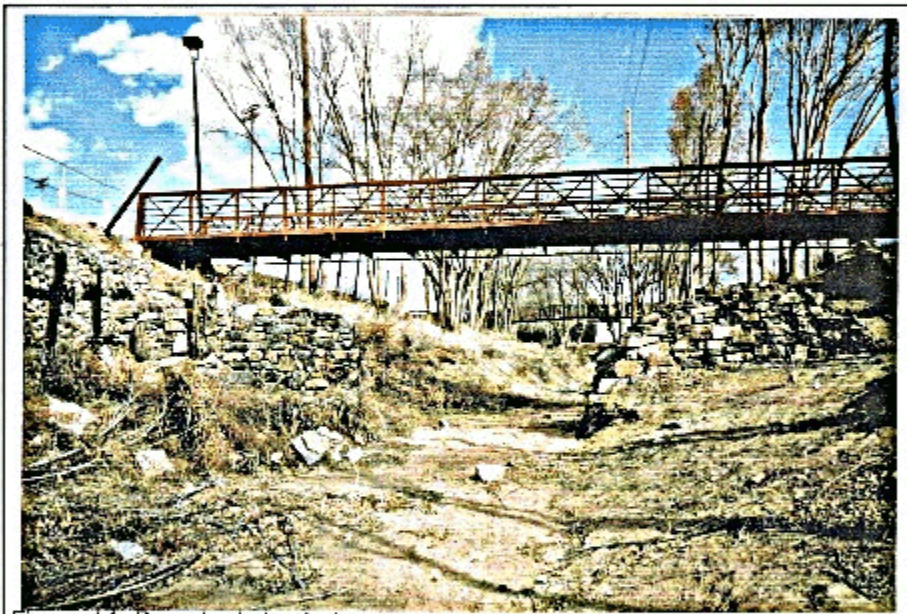
Fig. 14 is a breached check dam. The fitted masonry construction indicates that the construction is old. The channel has since degraded. From the perspective of increasing flood conveyance, this works well, although without much benefit to the community because of inconsistent employment.

Figure 14. Breached check dam

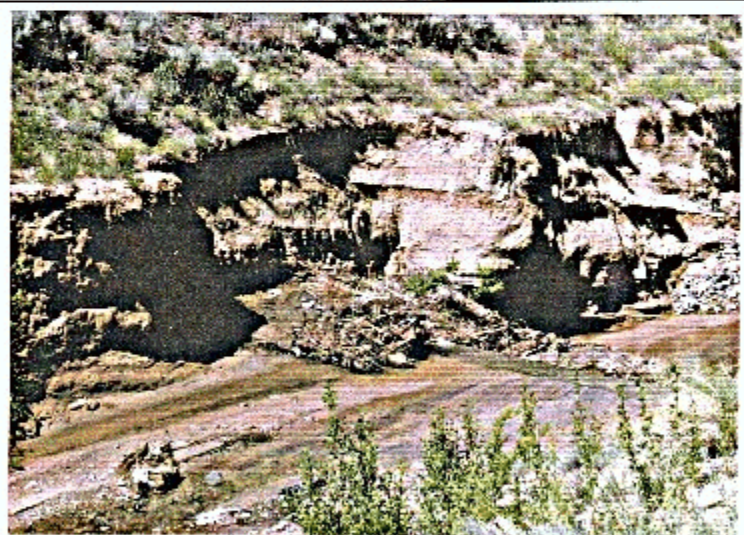
Fig. 16 illustrates the consequence of lateral migration around a grade control structure. End protection better than that of Fig. 10 is required.

Figure 16. End erosion

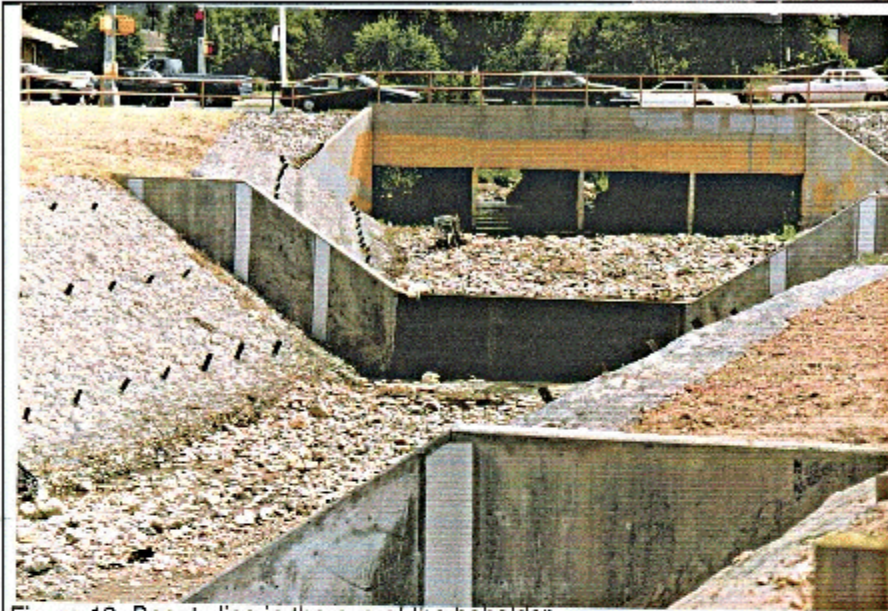
Road crossings in degrading reaches require extensive channel protection. Unfortunately, such protection is does not satisfy all aesthetic tastes. Fig. 19 is the New Mexico State Highway and Transportation Department's solution to Fig. 17.

Figure 19. Beauty lies in the eye of the beholder.

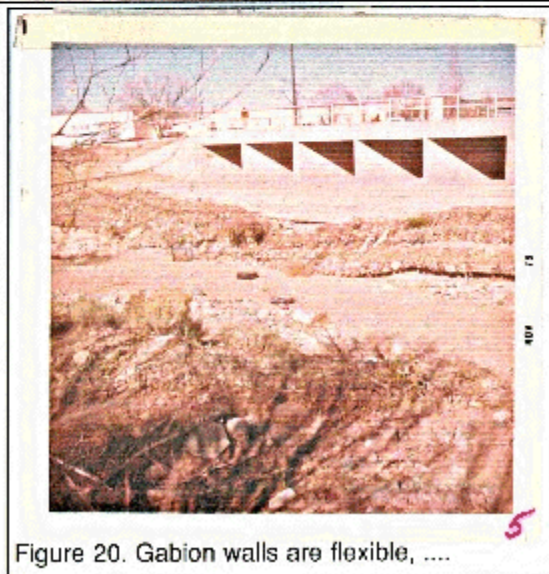
Local fixes tend to fail. Figs. 20 and 21 show the beginning and end of a three-tier gabion drop at a crossing.

Figure 20. Gabion walls are flexible,

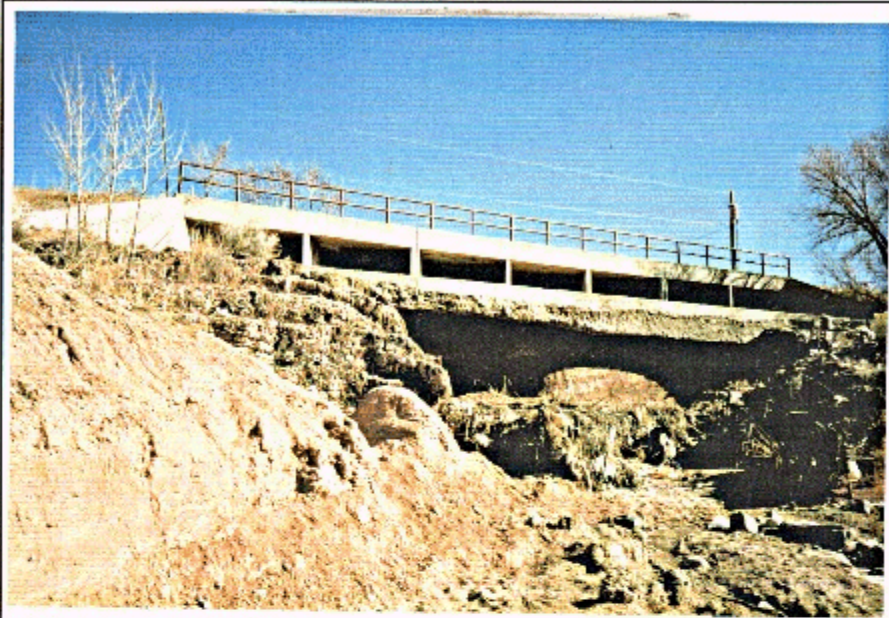
Figure 21. ... but only so far.

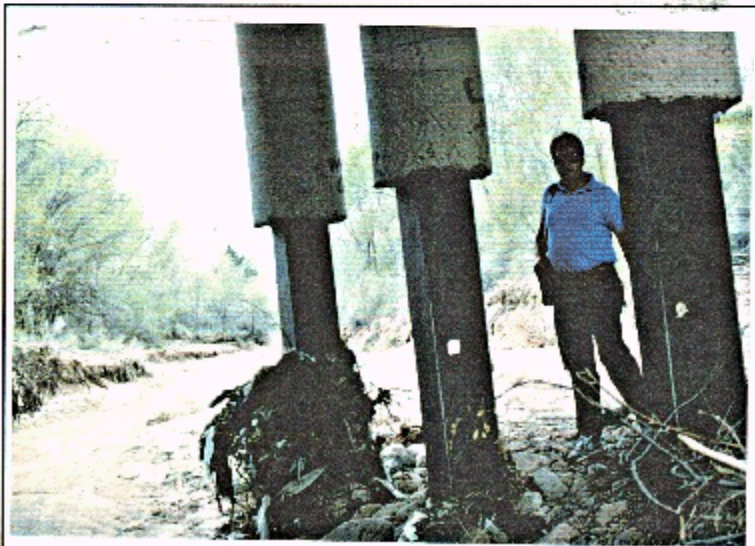
Piers allow headcuts to march upstream, as seen in Fig. 22. While concrete casing around an I-beam may provide little structural strength, exposed steel is perceived as unsafe.

Figure 22. Public confidence can erode with the channel bed.

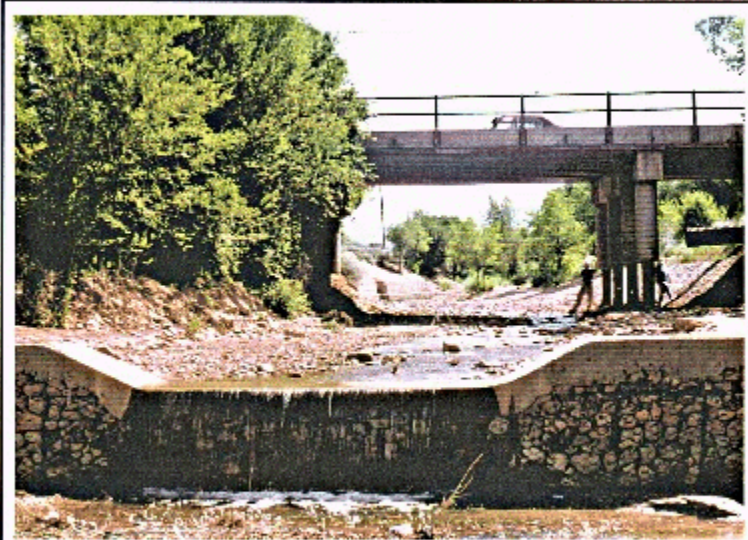
A deep enough drop structure can protect a crossing from scour. More often, this strategy just moves the problem.

Figure 23. Another local fix

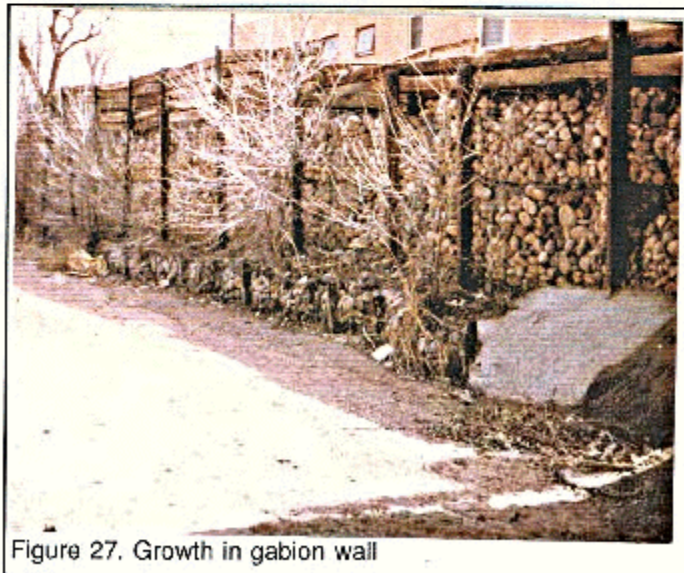
Shrubs and saplings rooted within gabions will eventually compromise the structure. The City generally removes the type of growth shown in Fig. 27.

Figure 27. Growth in gabion wall

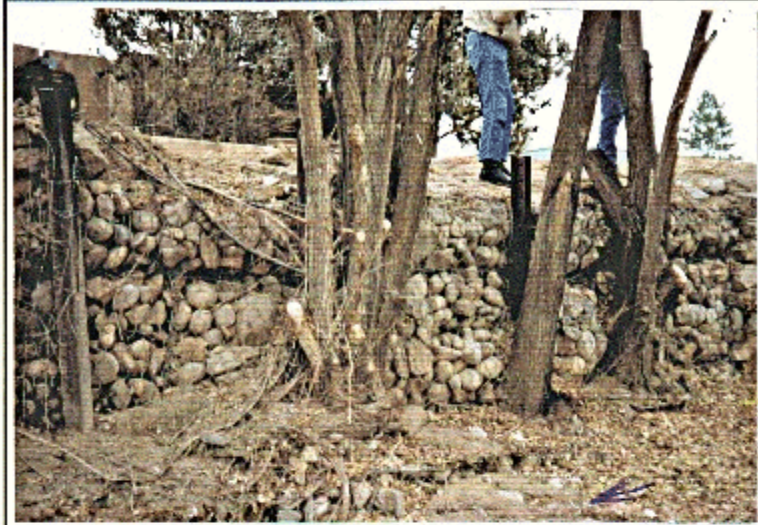
Fig. 28 shows wall damage by trees left to mature.

Figure 28. Tree damage

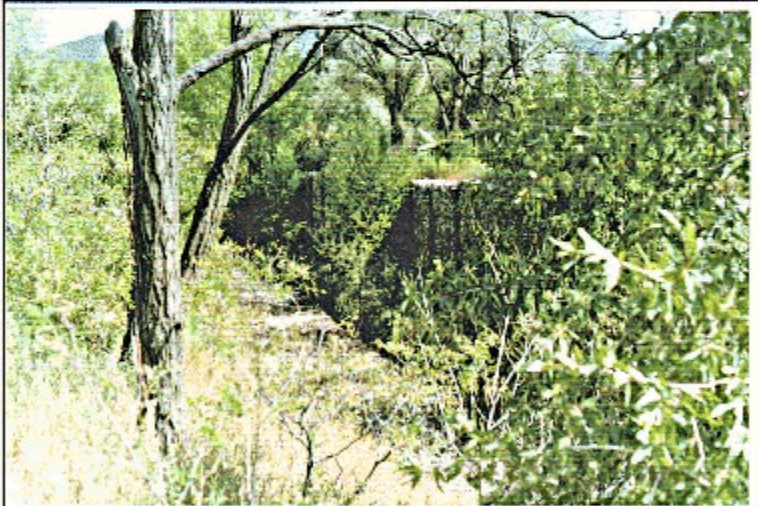
Channel overgrowth including several-inch diameter trees, seen in Fig. 29, has not always been removed in a timely manner.

Figure 29. Overgrowth

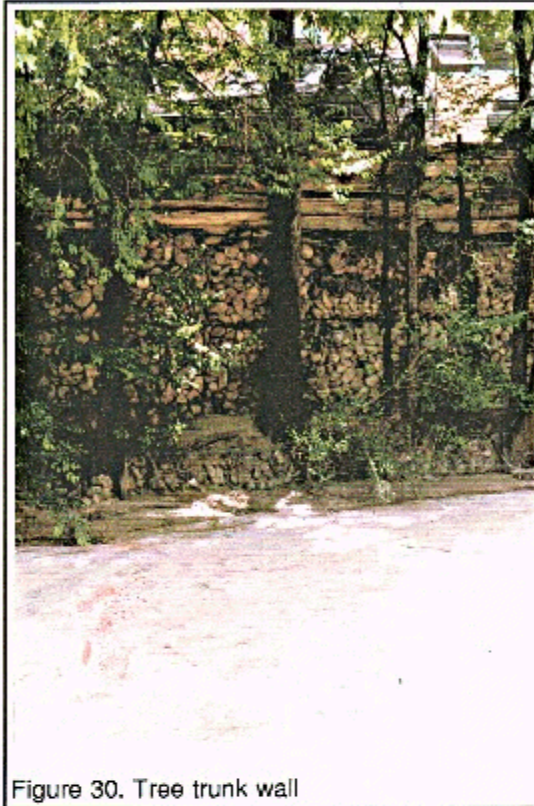
Figs. 30 and 31 demonstrate an over-reliance on vegetation. Tree trunks can resist wall rotation and tree roots can hold up foundations. When the vegetation dies, however, so will the structure

Figure 30. Tree trunk wall

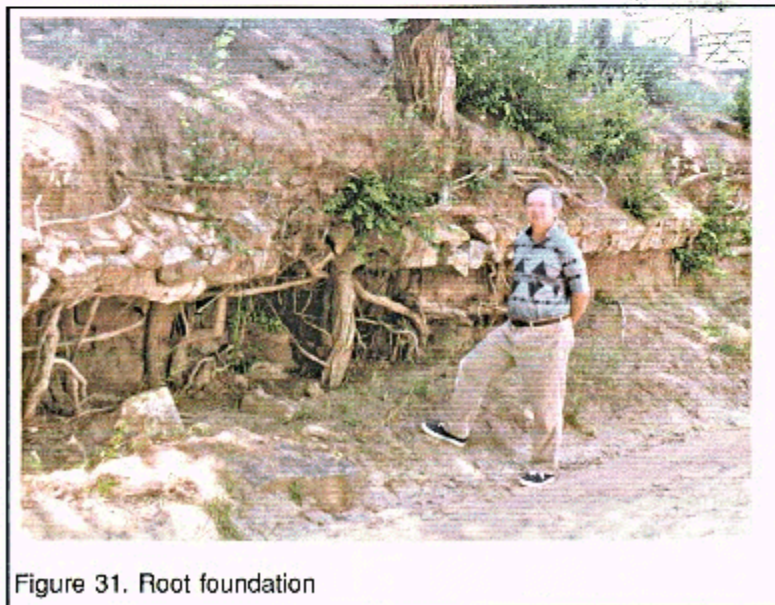
Figure 31. Root foundation

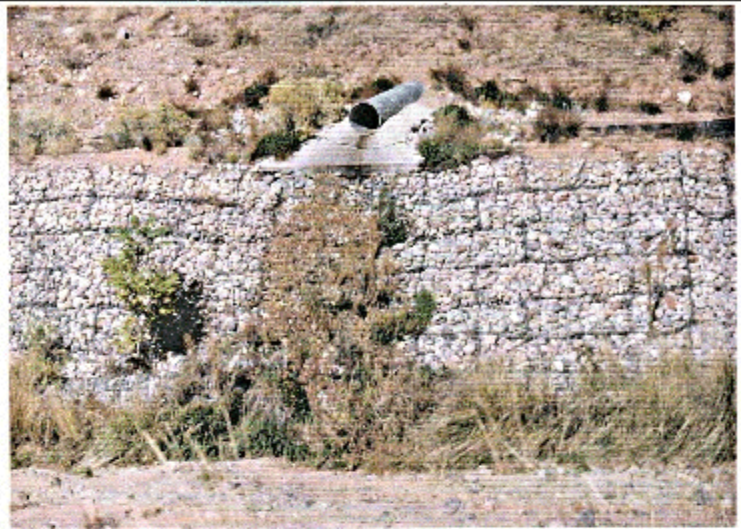
The Fig. 32 outfall serves its purpose, despite a crack in the concrete lip.

Figure 32. Stormwater rundown

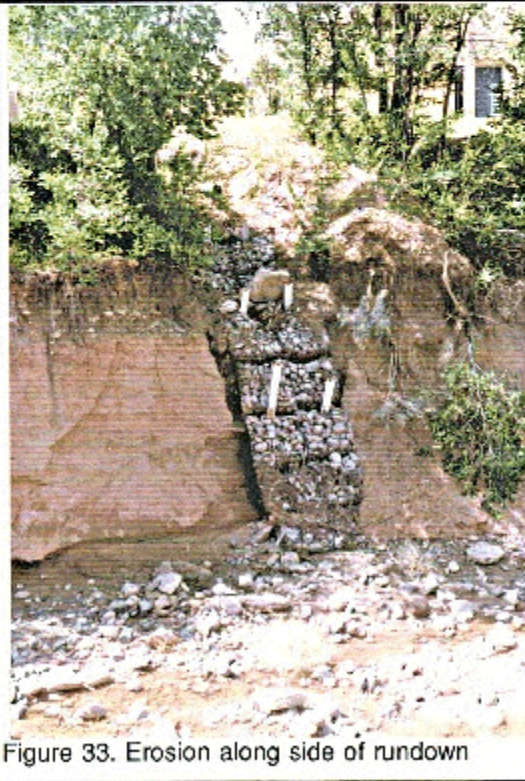
Fig. 33 shows the consequence of a flowpath down the side of a rundown. The initial culprit was more likely local flow than the design discharge from the outfall.

Figure 33. Erosion along side of rundown

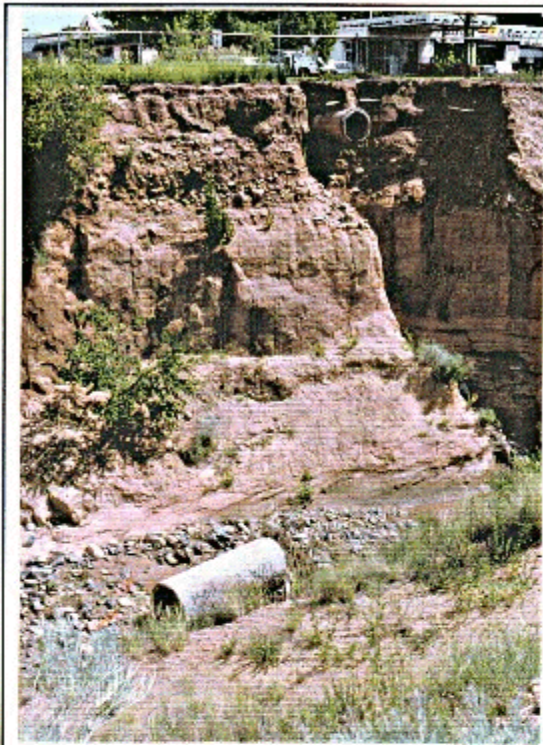
The stormwater outfall of Fig. 34 lacked a rundown.

Figure 34. Self-consuming outfall

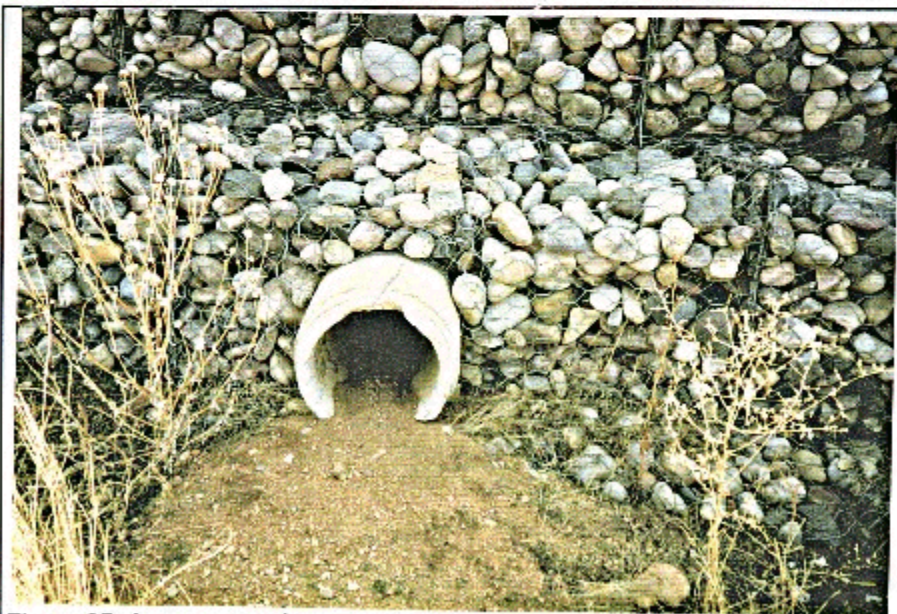
The source of the drain of Fig. 35 is unknown. A preconstruction survey should have identified the location.

Figure 35. A mystery outlet

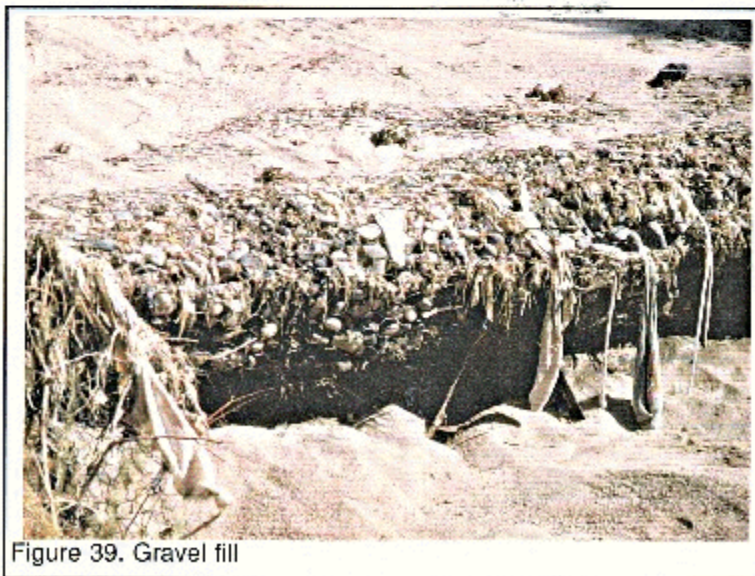
Many rockfill structures appear to push the lower end of the diameter specification. The rocks of Fig. 39 appear to be large gravel.

Figure 39. Gravel fill

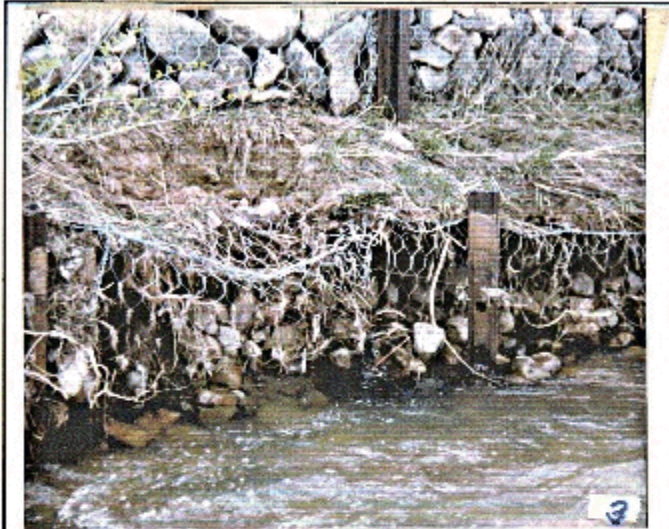
Fig. 40 shows the consequence of small and rounded rockfill. When the wire corrodes, the contents escape.

Figure 40. Damaged gabions

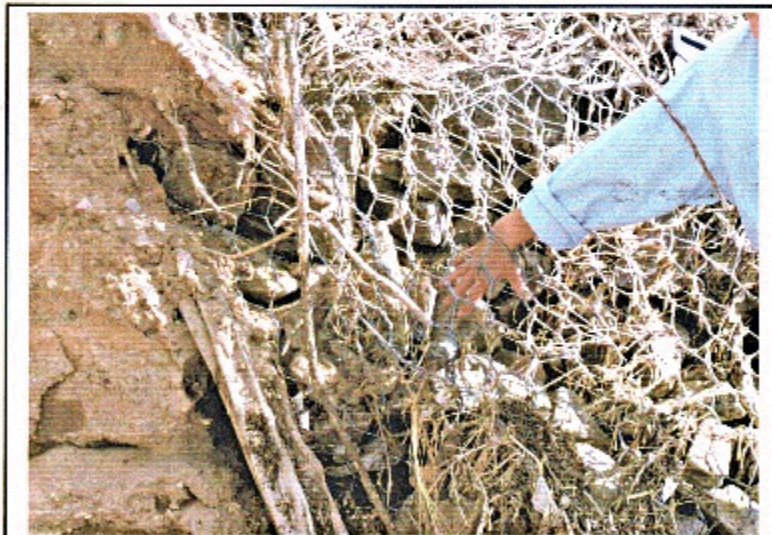
Rockfill has washed out of the Fig. 41 gabion.

Figure 41. Lost rockfill

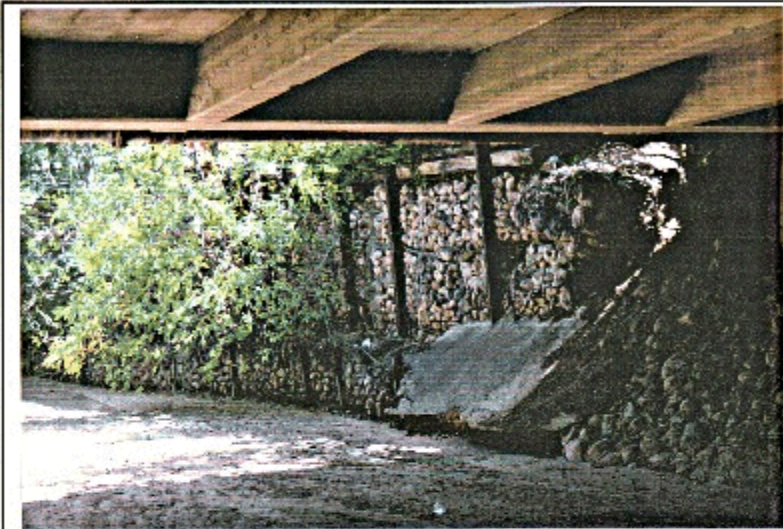
While grouting slows some undercutting, the practice appears to be stop-gap at best. Grouting in Figs. 42 and 43 is undercut.

Figure 42. Grouting failure

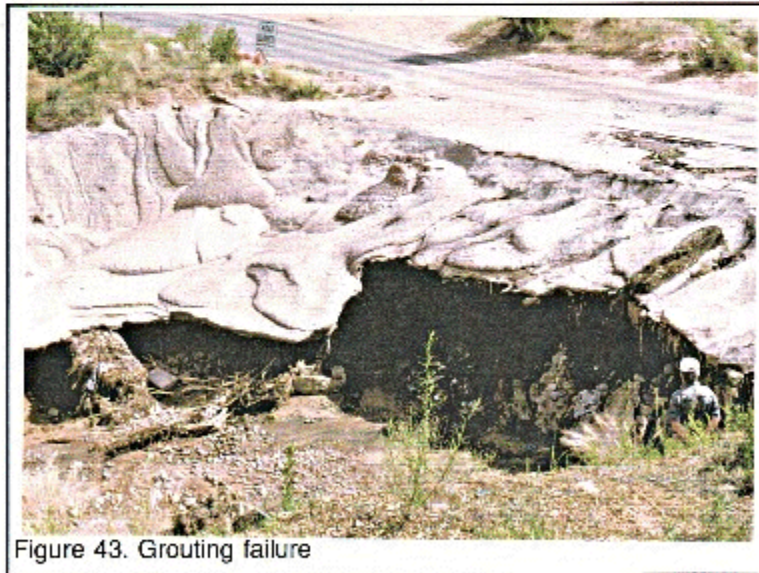
Figure 43. Grouting failure

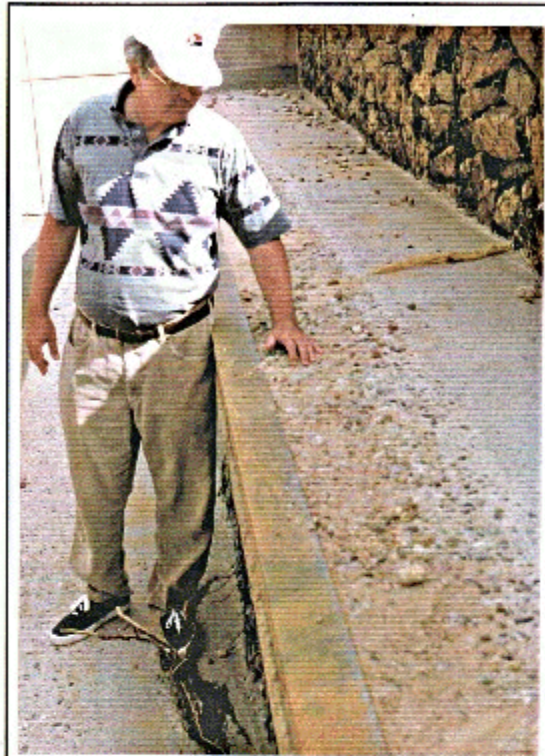
Abrasive sediment-laden flow can consume concrete. Fig 44 shows two years worth of wear.

Figure 44. Worn concrete

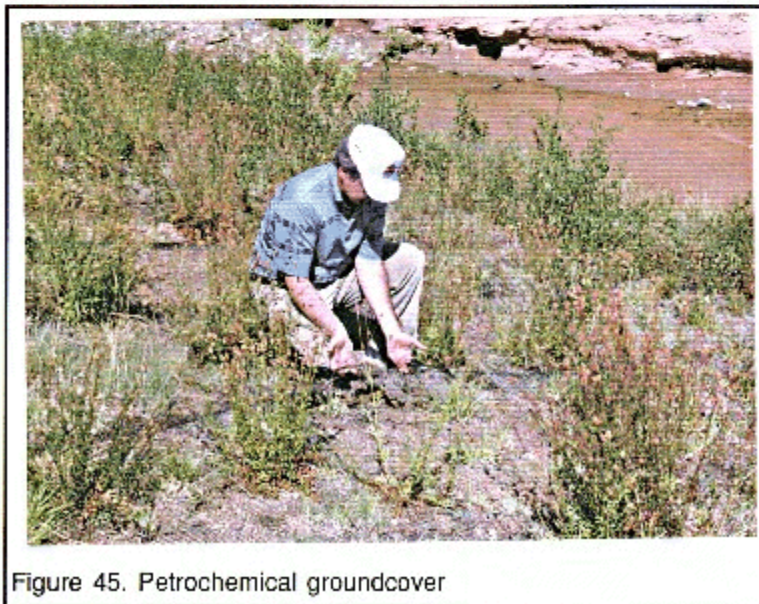
Five years of Santa Fe ultraviolet light cannot degrade the "degradable" plastic mesh used for revegetation in Fig. 45.

Figure 45. Petrochemical groundcover

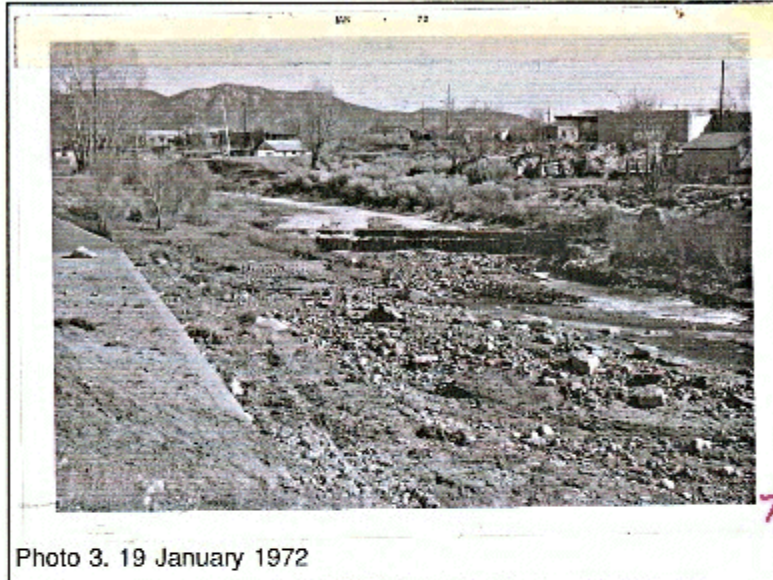
Photo 3. 19 January 1972

Inspection Report, 19 January 1972
Photo Note: River has scoured about 1 foot compared to 2 April 70.

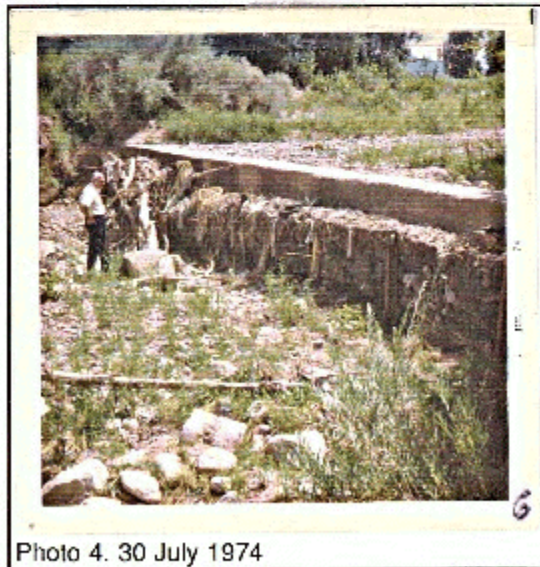
Photo 4. 30 July 1974

Inspection Report, 30 July 1974
Photo Note: Single row of rail-braced gabions protecting sewer line. Scour 2 or 3 feet below bottom of gabions, but they have been held in place by rails and are not damaged

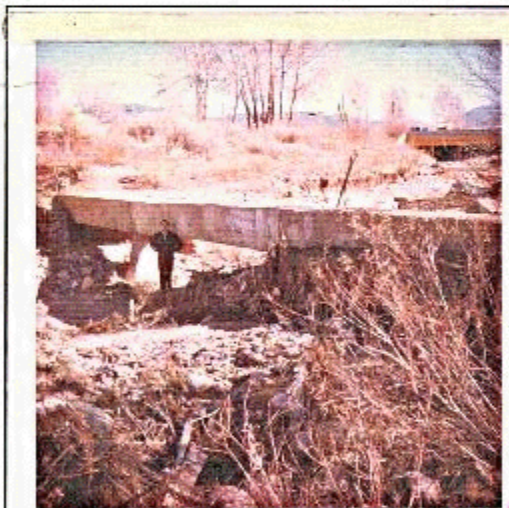
Photo 8. 23 November 1976

Scour action continued in 1976, causing total failure and removal of much of the rail-and gabion structure supporting the downstream side of a concrete-encased sewer line. Scour action is now able to progress upstream, which is the stated objective of the City Engineer. The sewer line is scheduled for replacement this winter by a steel free span pipe a few inches higher and a few feet downstream.

Photo Notes: River deepened about 6 feet in 5 years primarily due to the removal of check dams and other artificial grade controls by the City. The gabion structure collapsed due to undercutting. Bed scouring continuing. Structure reported as severely damaged in 1975.

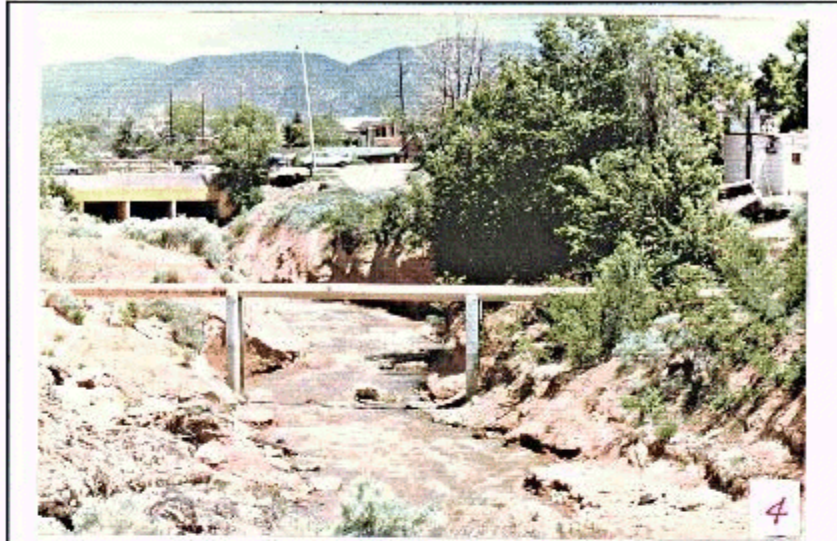
Photo 10. 19 May 1983

Inspection Report, 19 May 1983
Photo Note: There seems to be some cutting in channel.

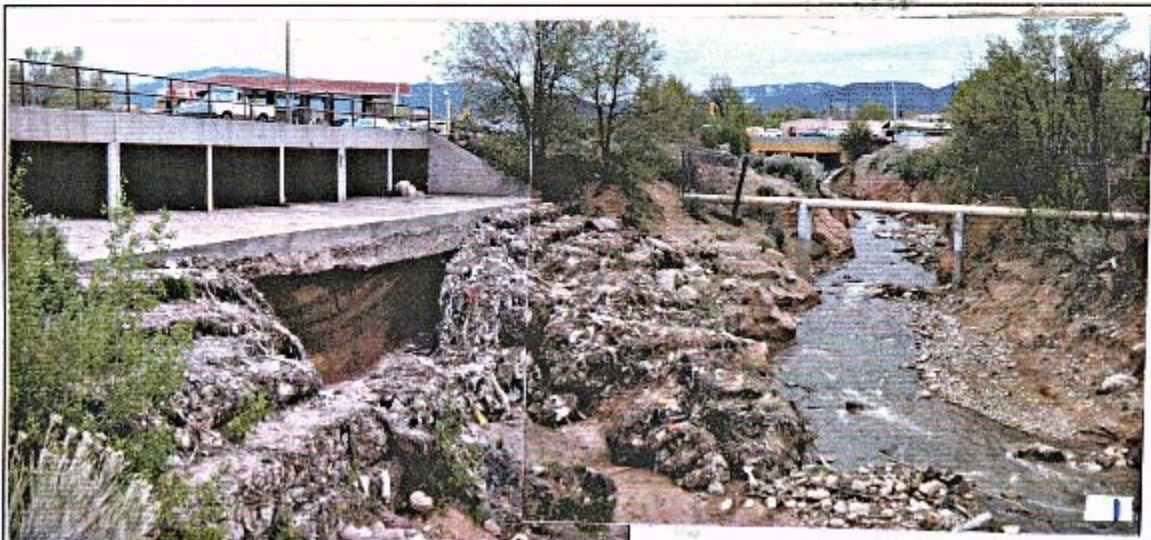
Photo 11. 25 April 1985

Inspection Report, 25 April 1985
Photo Note: River grade was 12 feet higher in 1970. Flowed over sewer pipe.
