NDE Applied to Pressure Vessel Evaluations

Ryan Malone, P.E.

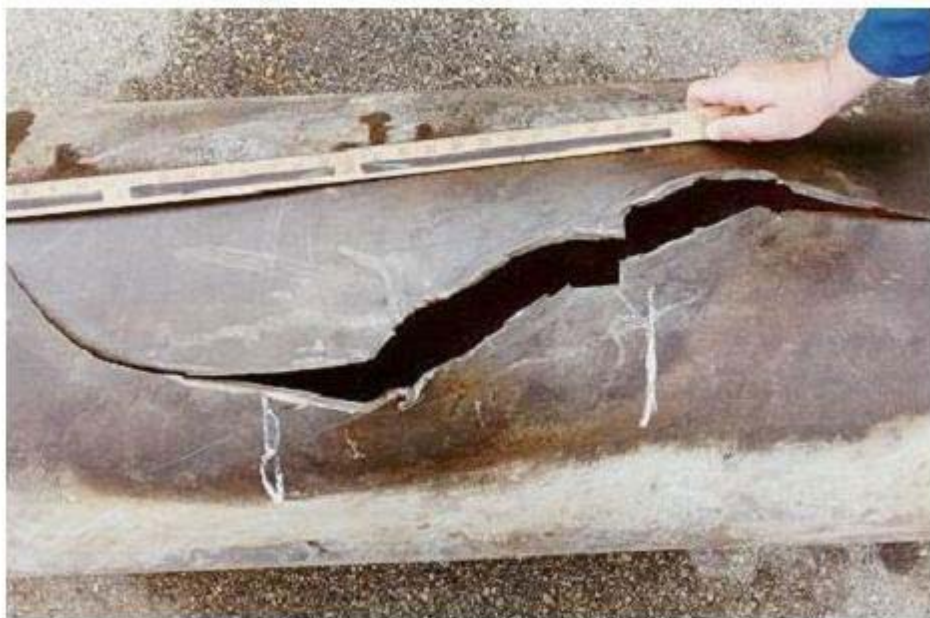
Brittle Fracture is a sudden stress fracture where the material exhibits no evidence of ductility or plastic deformation. This type of failure originates at a material flaw. Figures 1 and 2 below show brittle fracture during hydrotest on a 20-inch carbon steel pipeline and the gouges that caused the failure [8].

Figure 1 Brittle fracture failure during hydrotest of 20-inch OD carbon steel pipeline [8].

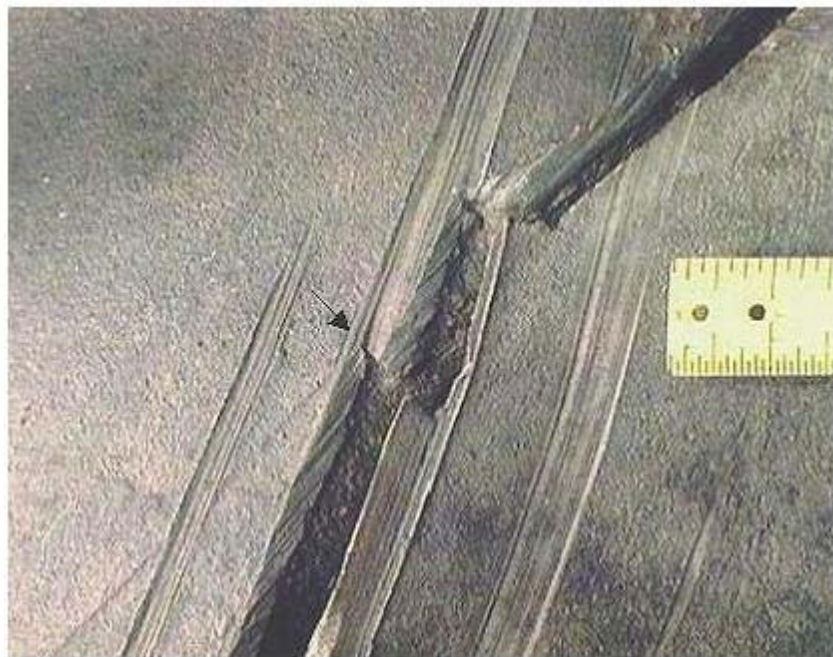
Figure 2 Fracture origin (arrow) and gouges that caused brittle fracture failure on 20-inch OD carbon steel pipeline [8].

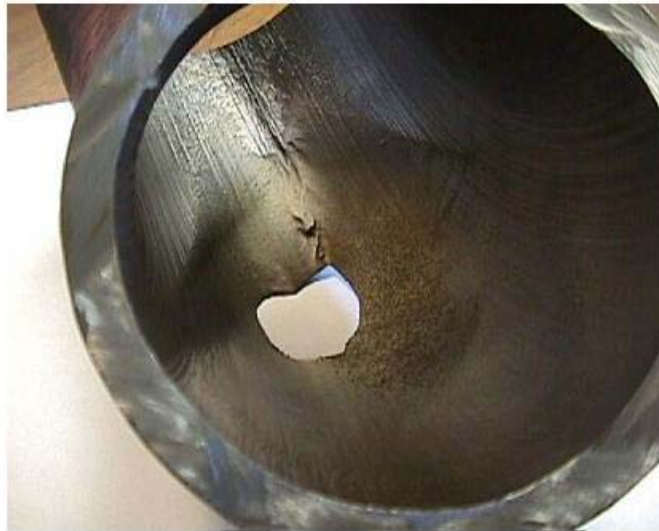
corrosion contribution to erosion by the removing protective surfaces layers allowing further erosion to act on the material [8]. Figure 4 below shows erosion on the inside surface of an elbow [8].

Figure 4 Erosion of return bend [8].

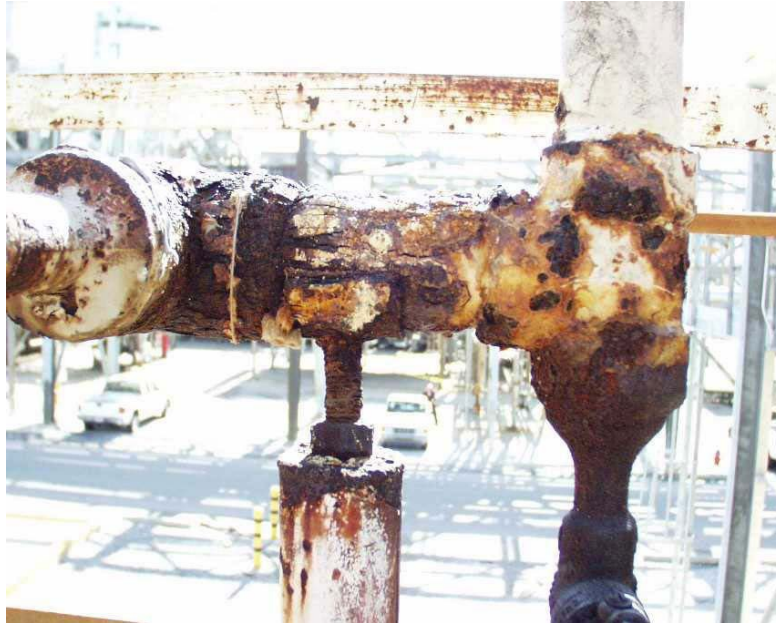
Pressure vessels are often insulated to prevent unwanted heat transfer from the pressure vessel. If the insulation is not properly sealed moisture can get between the vessel wall and the insulation causing aggressive corrosion. Between the temperatures of 212° F and 250° F the corrosion becomes more severe because the moisture is less likely to vaporize and the insulation remains wet for a longer period of time [8]. Figure 7 and 8 show an insulated liquid level bridal on a pressure vessel and a corresponding profile RT film [8].

Figure 7 Insulated liquid level bridal with CUI [8].

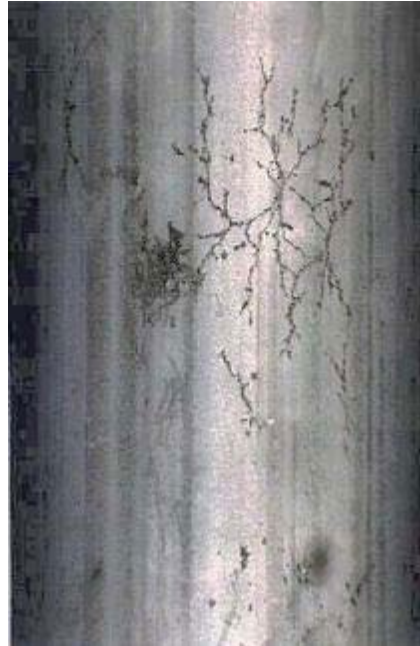
Stainless steel vessels are subject to chloride stress corrosion cracking (Cl SCC) when subjected to the combination of tensile stress, temperature, and an aqueous chloride environment. The presence of oxygen in solution increasing the probability of cracking [8]. Figure 9 shows an example of SCC.

Figure 9 Close-up view of tight web appearing SSC cracks on Type 316L SS tubes in steam service [8].

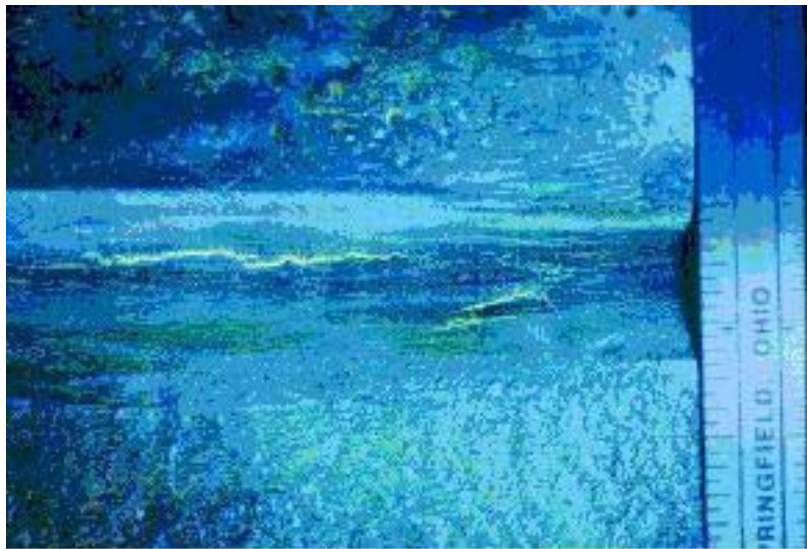
Figure 14 SOHIC damage shown using WFMT [8].

SOHIC is similar to HIC, but appears as layers of cracks, resulting in a through-thickness crack. The crack is perpendicular to the surface stress driver. These cracks usually appear in the base metal near the weld metal heat affected zone (HAZ) [8]. Examples are shown in Figure 13 and 14 [8].

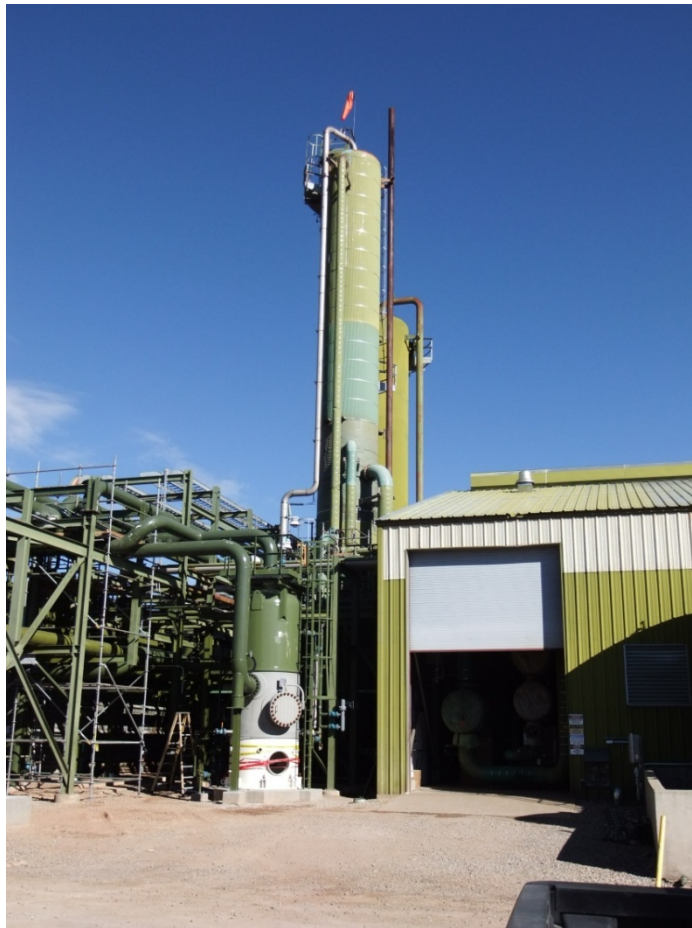
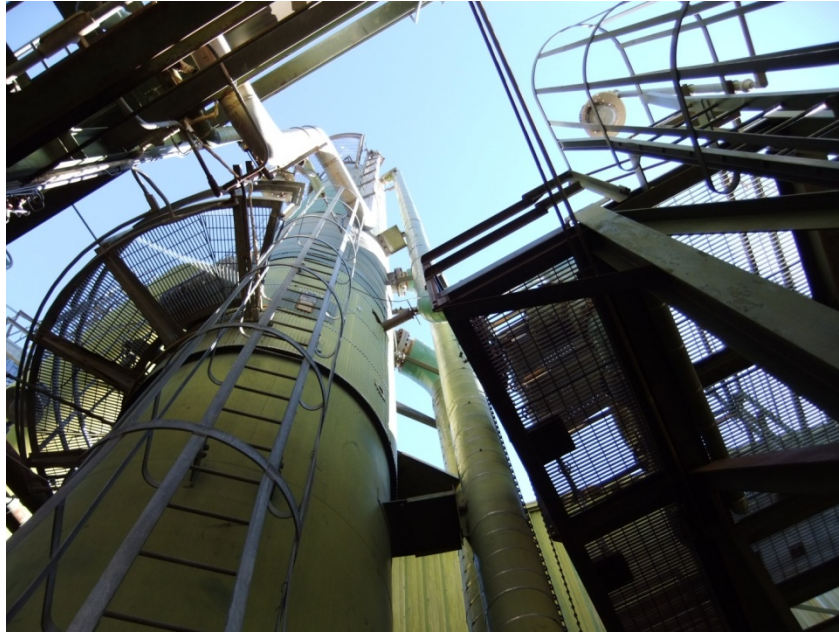
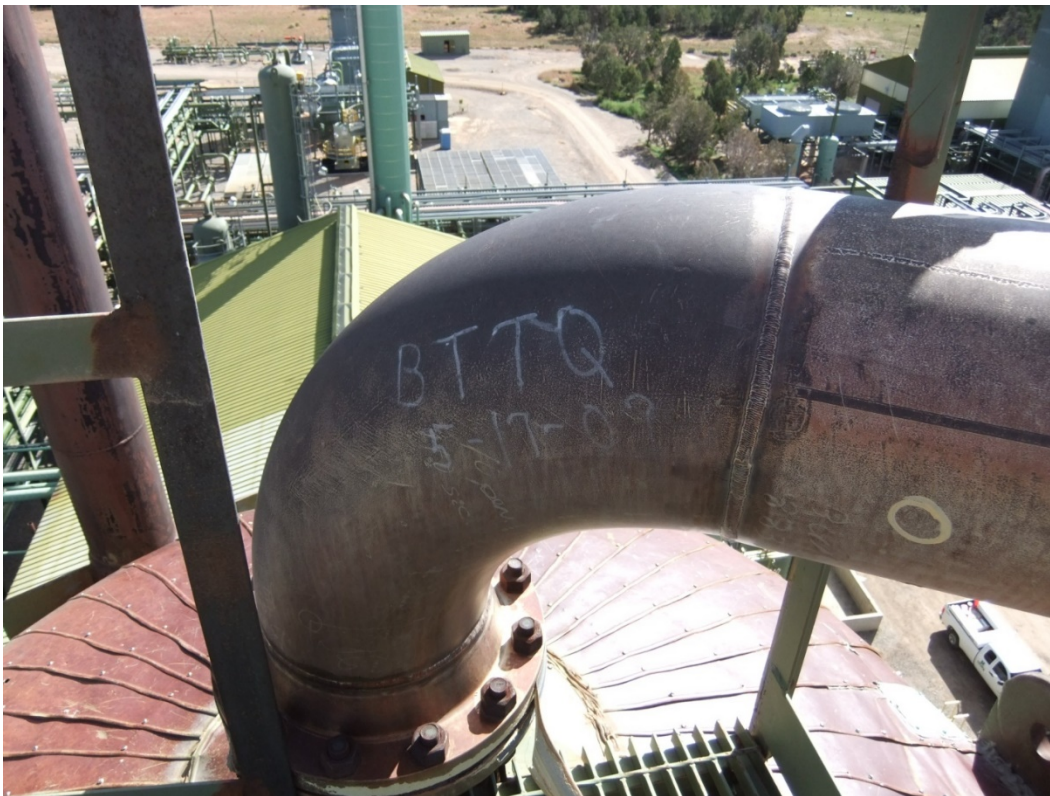
An external visual inspection can be completed using the guidelines provided in API 510 Vessel Inspection Code: Maintenance Inspection, Rating, Repair, and Alteration. The inspector should be close to the vessel and use light, magnifying glass, and scraping tools to look for possible issues. Often an external visual inspection can be an intimidating task requiring the technician to wear a safety harness and climb while carrying his inspection equipment. An example is shown in Figures 16, 17, and 18 below.

Figure 16 Amine contactor tower at major oil and gas company owned natural gas treating facility.

Figure 17 View looking up at amine contactor tower at a major oil and gas company natural gas treating facility.

Figure 18 View of outlet piping at top of amine contactor tower at a major oil and gas company natural gas treating facility.

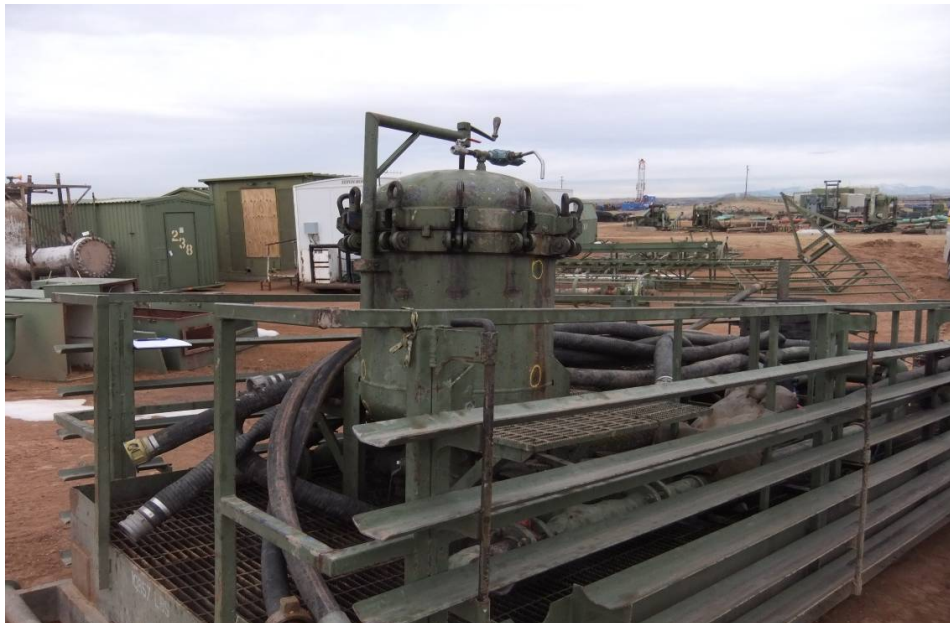
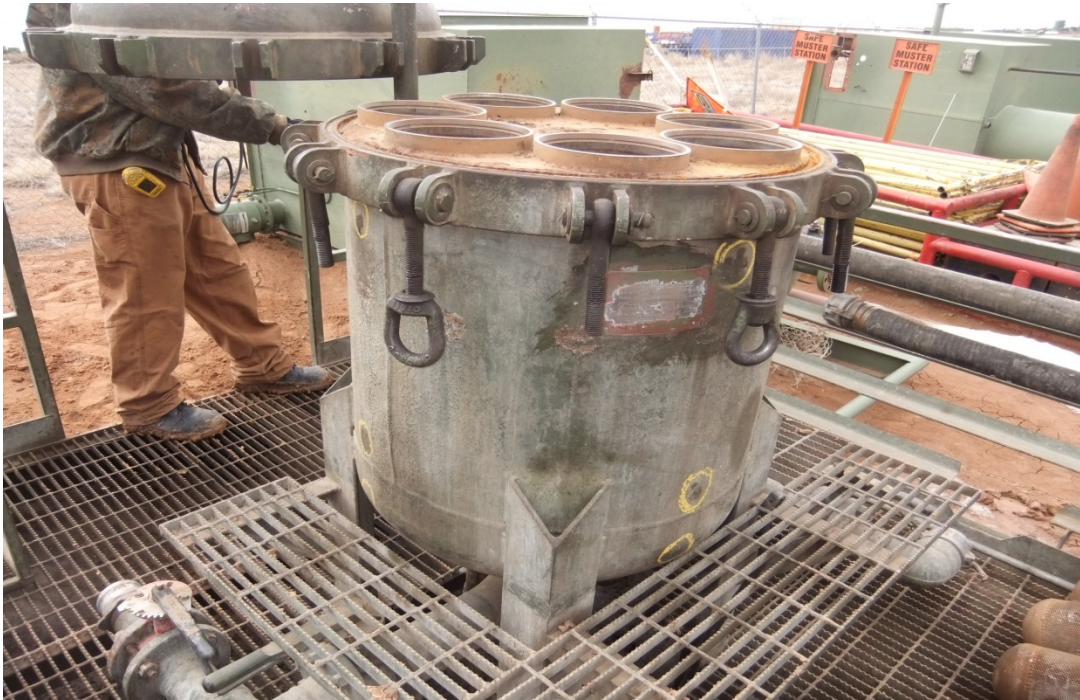
Figure 19 Filter Specialists, Inc. sock filter vessel on portable skid used for filtering water in natural gas drilling operations for a major oil and gas company.

Figure 20 Filter Specialists, Inc. sock filter vessel on portable skid with quick opening closure opened.

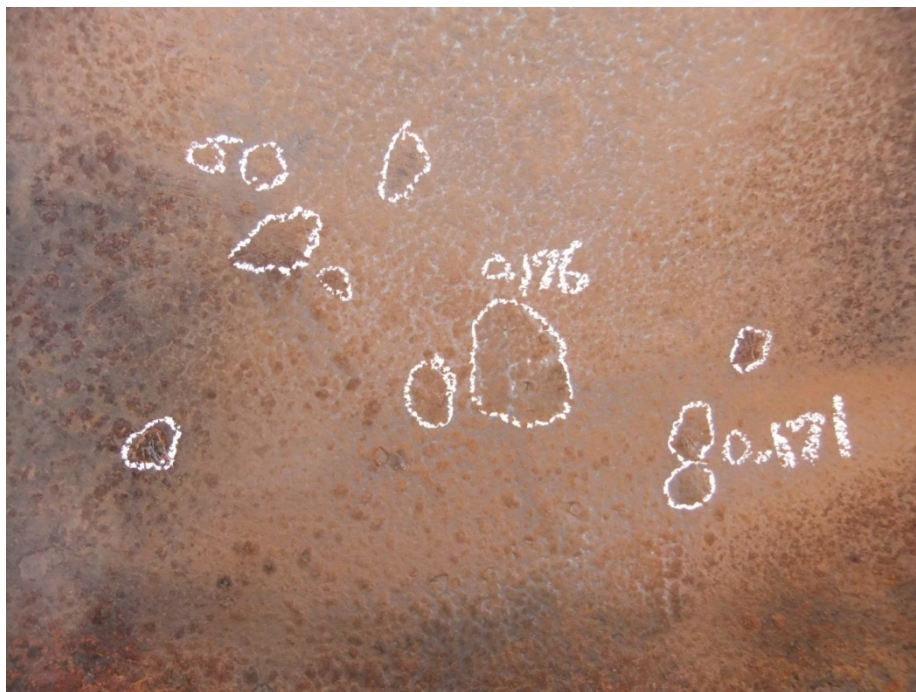
Figure 21 Pitting identified during internal inspection of pressure vessel.

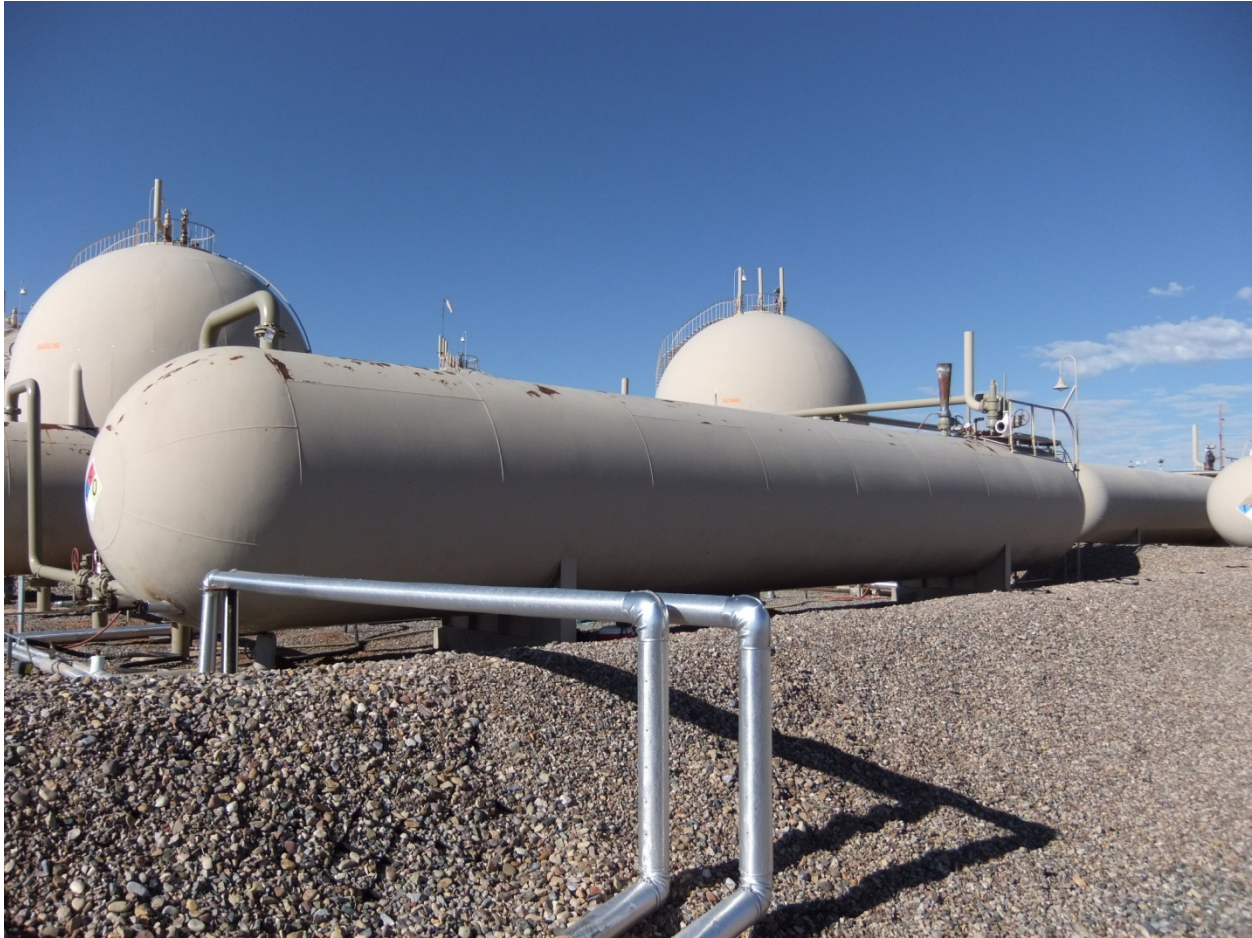
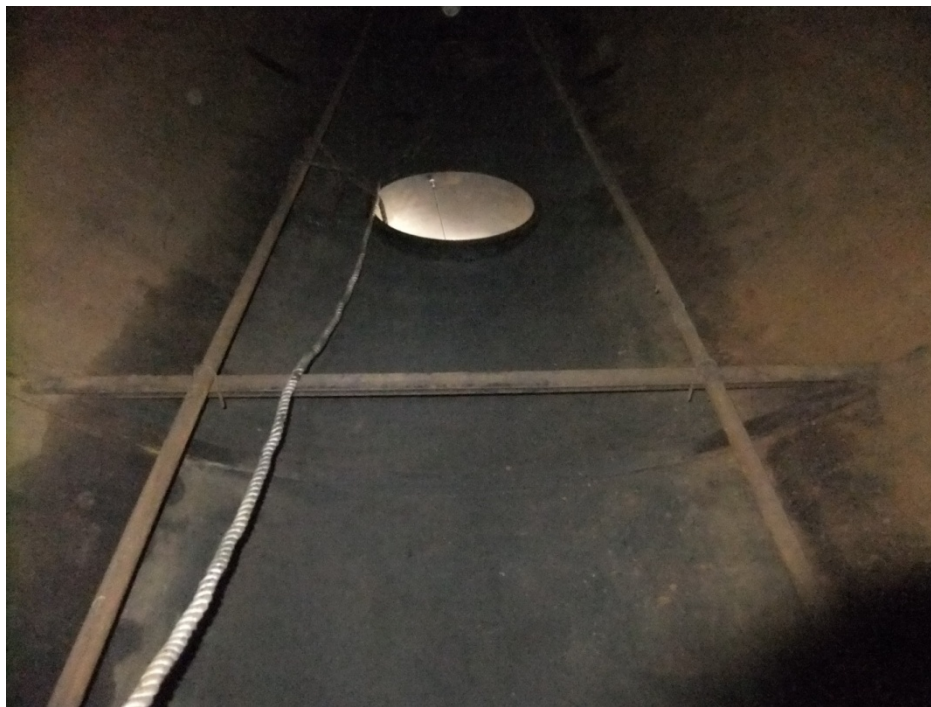
An internal visual inspection is the best method of assessing a pressure vessel. This is often a difficult task due to the complications involved with getting internal access and cleaning of a vessel. Typical tools used in an internal inspection include flash lights, magnifying glasses, pit depth gauges, and scrapers for removing surface residue. Some vessels easily accommodate an internal inspection. This filter vessel is often out of service and has a quick opening closure head, easily accommodating an internal inspection. Other internal inspections are more complicated requiring a vessel to be removed from service, internally cleaned, and air circulation provided. An example from Sandstone Engineering is shown in Figures 22, 23, and 24 below.

Figure 22 View of liquids storage bullet tank at a major oil and gas producer's natural gas processing facility. Vessel built in 1955 by Riley Beard and still in service in 2011.

Figure 23 Internal view after internal inspection on west head of bullet tank at a major oil and gas producer's natural gas processing facility.

Figure 24 Internal view after internal inspection on bottom of bullet tank at a major oil and gas producer's natural gas processing facility.

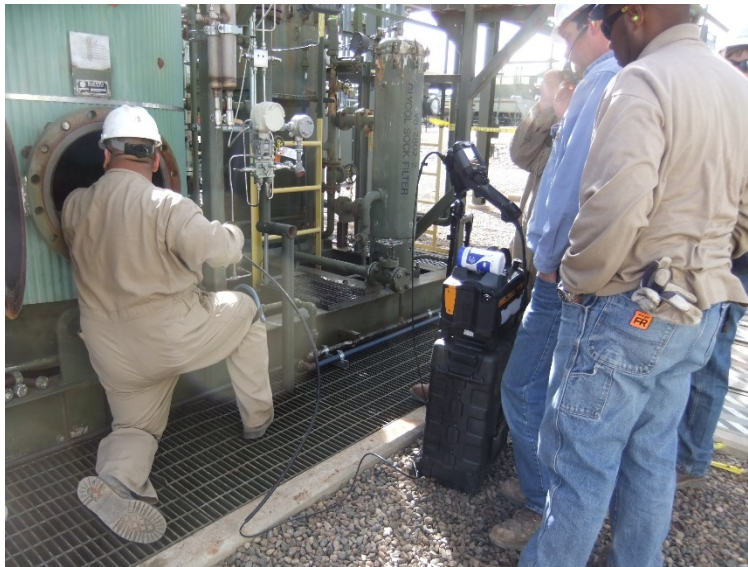
If a pressure vessel is too small for an internal inspection or does not have a large enough manway to accommodate an internal inspection, a remote video borescope can be used. The vessel must be removed from service to accommodate the borescope inspection.

Figure 25 Internal inspection of vessel using an articulating borescope

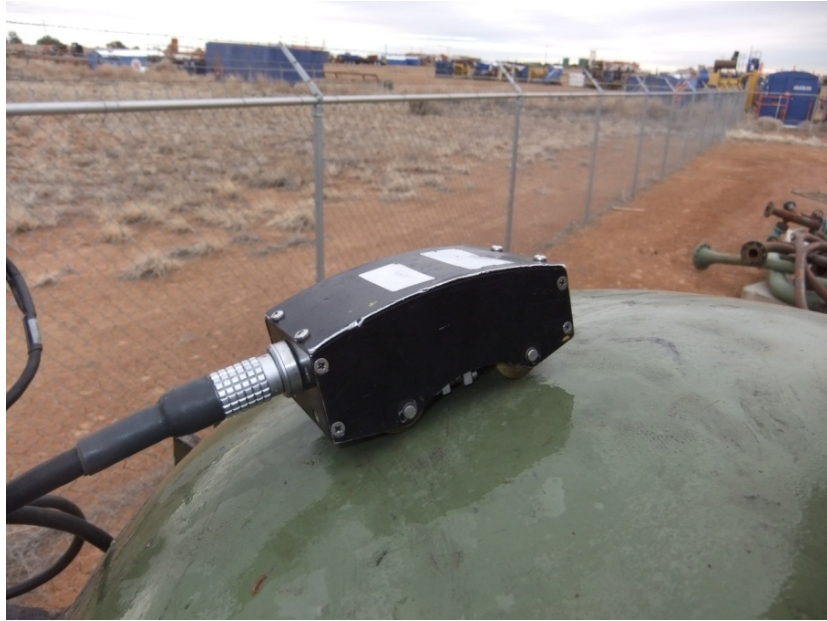
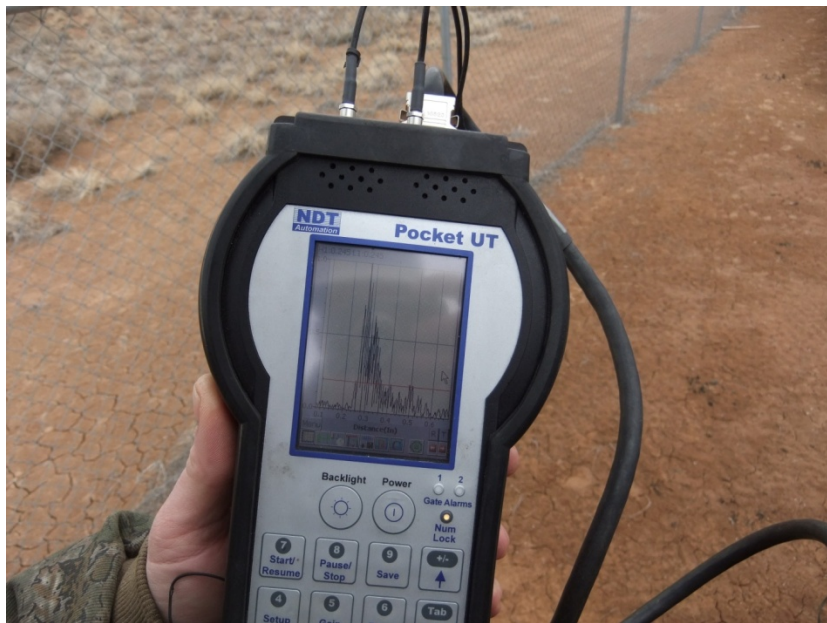
Ultrasonic thickness inspection is widely used in suitability for service evaluation of pressure vessels. There are several variations of this technique allowing the technician to efficiently assess the condition of the vessel. Often the ultrasonic inspection is limited to ultrasonic thickness measurements at predetermined locations. These locations are periodically checked and input into a database to monitor the corrosion. If an abnormality is detected, then a more detailed inspection ensues [11]. When an internal inspection cannot be completed, and it is desired to ultrasonically scan a large surface area of a pressure vessel a “Pocket-UT” instrument can be used. This instrument uses water as the couplant and has a magnetic surface with a track ball transducer inside the scanner assembly allowing the technician to scan a significant surface area in a short amount of time. The transducer assembly resembles a computer mouse. By watching the waveform, the operator can identify low areas, which are marked and then more closely inspected with an ultrasonic A-Scan or B-Scan. A similar transducer attached to a “crawler” can be used to scan significant areas of a large pressure vessel. The “crawler” can be remotely controlled or attached to an extension pole.

Figure 26 "Pocket-UT" transducer assembly shown on a vessel top head, courtesy of Sandstone Engineering.

Figure 27 "Pocket-UT" transducer assembly shown on a vessel top head, courtesy of Sandstone Engineering.

Figure 28 Bottom view of "Pocket-UT" transducer assembly with liquid filled track-ball and encoder

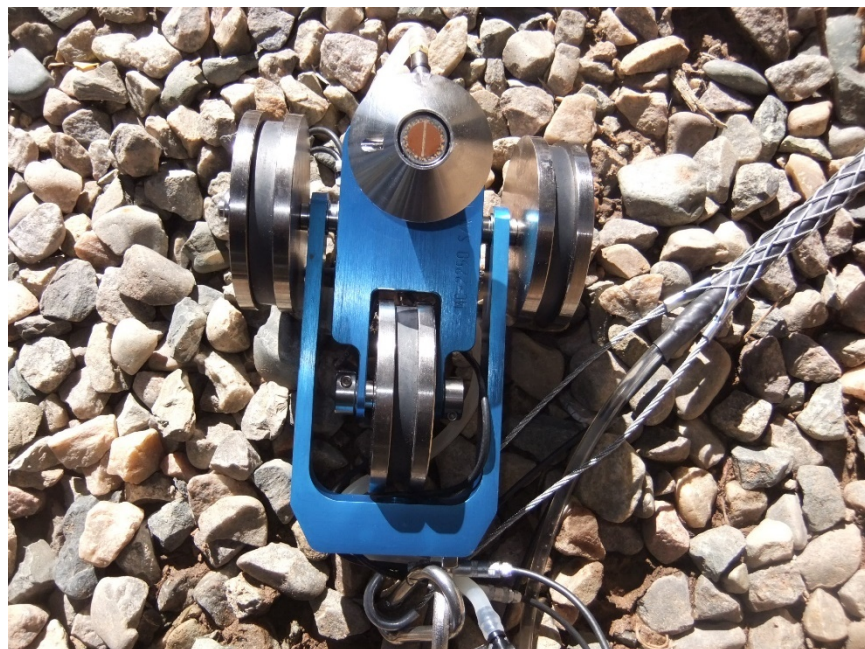
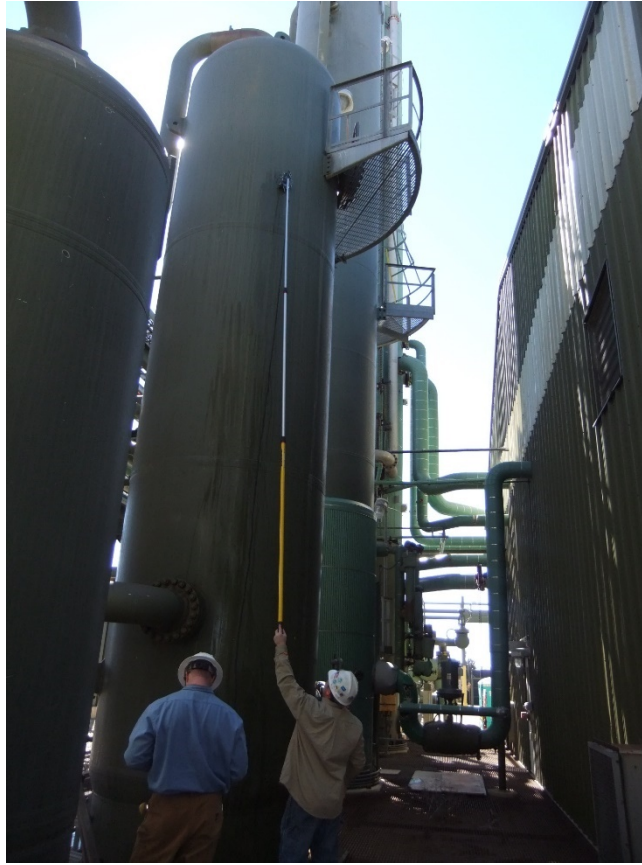
Figure 29 Bottom view of manual UT crawler and spring loaded transducer

Figure 30 Top view of manual UT crawler on pressure vessel tower

Figure 31 View of manual UT crawler on pressure vessel tower, courtesy of Sandstone Engineering

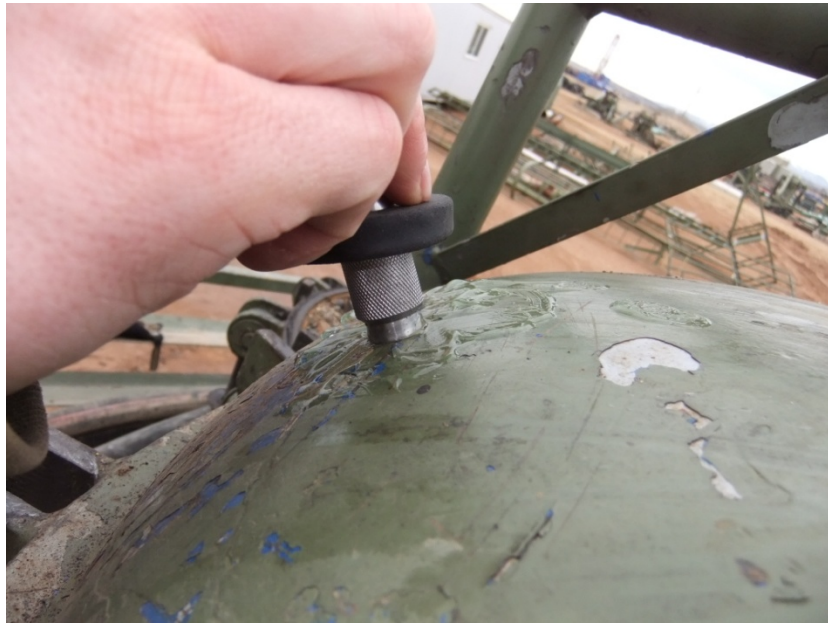
Once ultrasonic scanning instrumentation has been used to identify potential problems areas, a more detailed inspection is completed using a more accurate transducer and instrument. The most common is an ultrasonic thickness instrument capable of collecting A-Scan thickness measurements and B-Scan thickness profiles. An example of each is shown below, courtesy of Sandstone Engineering in Farmington, NM. Not shown below is an example of a C-Scan. Ultrasonic thickness transducers can be combined with position encoders. When automated encodes are combined with a B-scan, the result is known as a C-scan.

Figure 32 Topcoat ultrasonic transducer and couplant on pressure vessel head

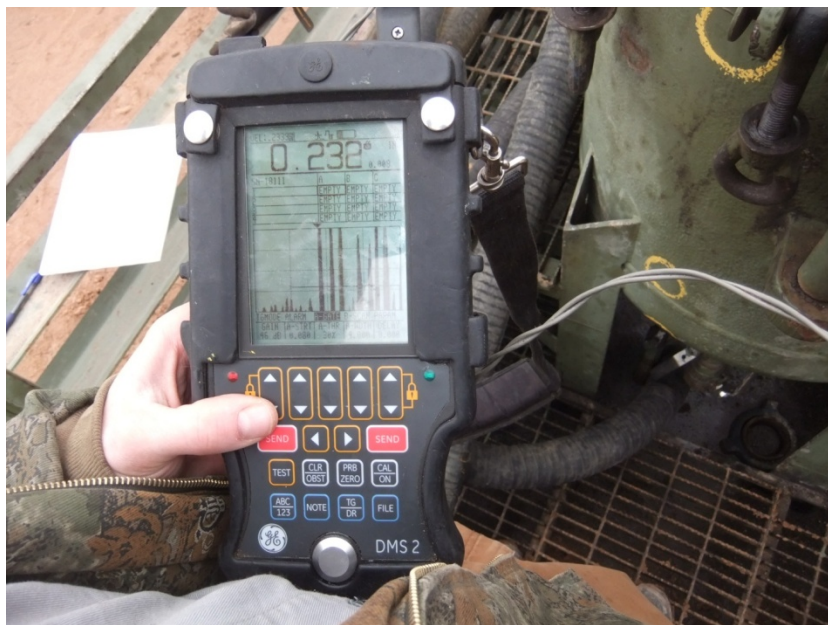
Figure 33 GE DMS 2 A-Scan waveform output from pressure vessel inspection

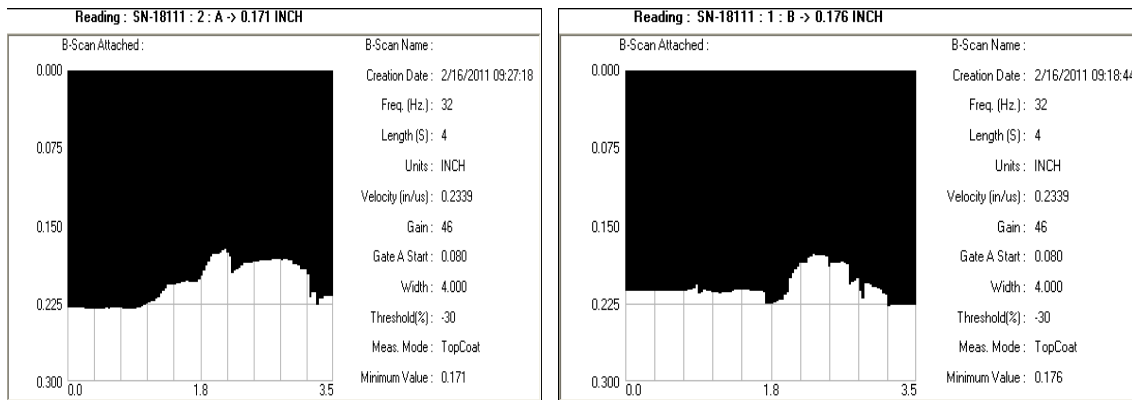
Figure 34 GE DMS 2 B-Scan output from inspection of pressure vessel top head, ¼" nominal wall thickness. The large yellow circle identifies potential problems areas identified by the "Pocket UT"

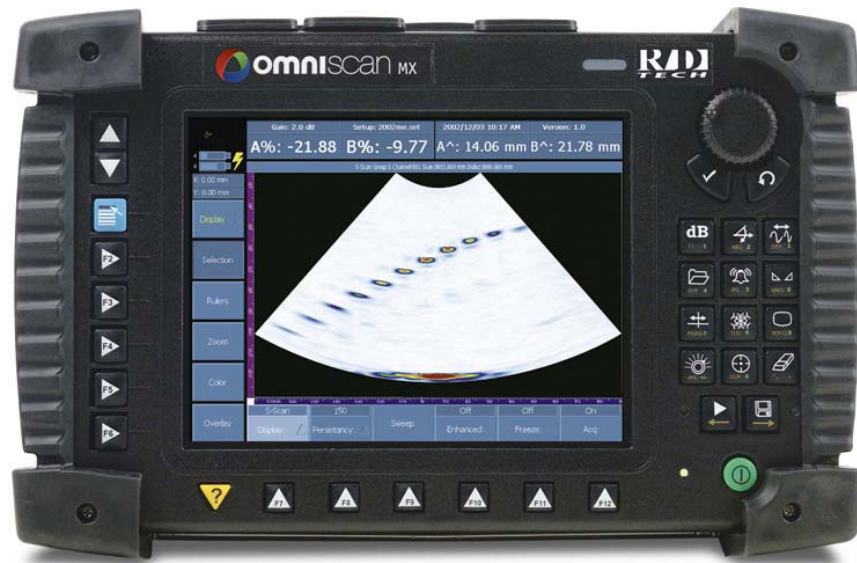
When a weld inspection is required, or a potential material lamination is suspected an ultrasonic shear wave inspection or ultrasonic phased array inspection is often completed. These inspections are often referred to as angle beam ultrasonic inspections. By sending the sound wave into the material at an angle the technician is able to inspect for crack, inclusions, or laminations. Phased array inspection systems for pressure vessels allow electronic control of the sound beam allowing the operator to scan, sweep, steer, and focus the ultrasound [12]. A phased array ultrasonic inspection can also be used to inspect for cracks resulting from damage to a pressure vessel. Some phased array photographs are shown below.

Figure 35 Array transducer on wedge block [12].

Figure 36 OmniScan portable phased array equipment [12].

Figure 37 OmniScan portable phased array equipment [12].

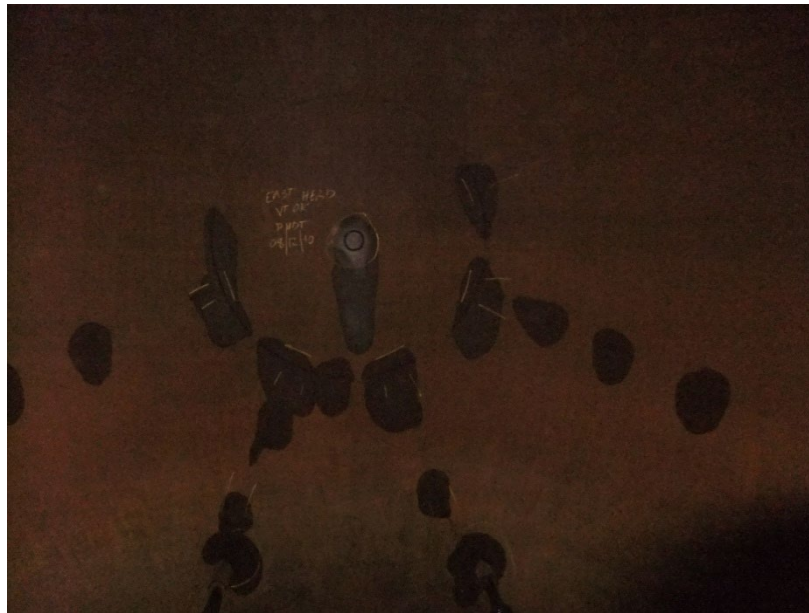
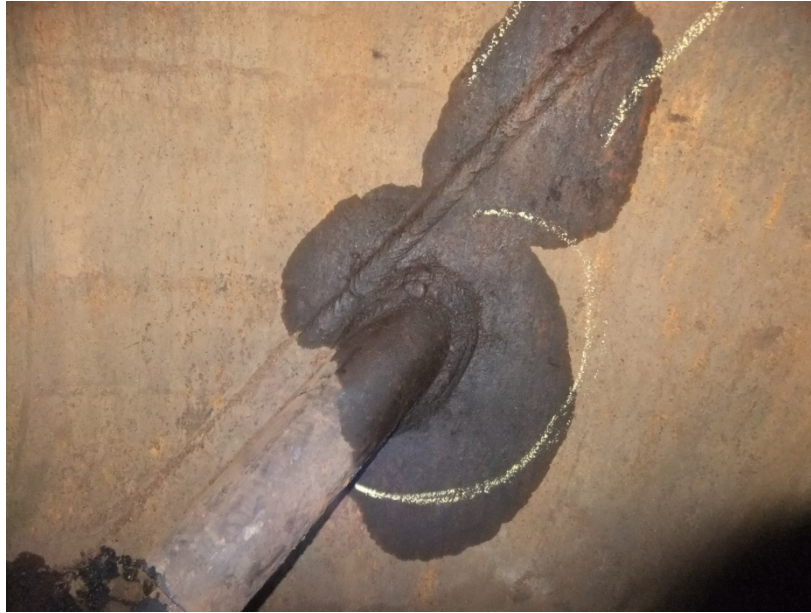
Magnetic particle inspections are often completed on the welds if the vessel is in service potentially leading to cracking such as sulfide service. Other pressure vessel magnetic particle weld inspections are completed at scheduled intervals as part of the inspection program [15]. Detailed WFMT inspections are often completed at nozzle penetrations due to potential of crack formation at these locations [15]. Cracks can form due to excessive nozzle external piping loads, lack of adequate weld penetration, or chemical attack. By performing a magnetic particle inspection over the vessel welds any surface cracks can be identified. An example of wet fluorescent magnetic particle (WFMT) inspection is shown below.

Figure 38 Internal visual inspection showing post WFMT inspection of ~30% of hemispherical head welds.

Figure 39 Internal visual inspection showing post WFMT inspection of nozzle internal weld. Courtesy of Sandstone Engineering in Farmington, N.M.

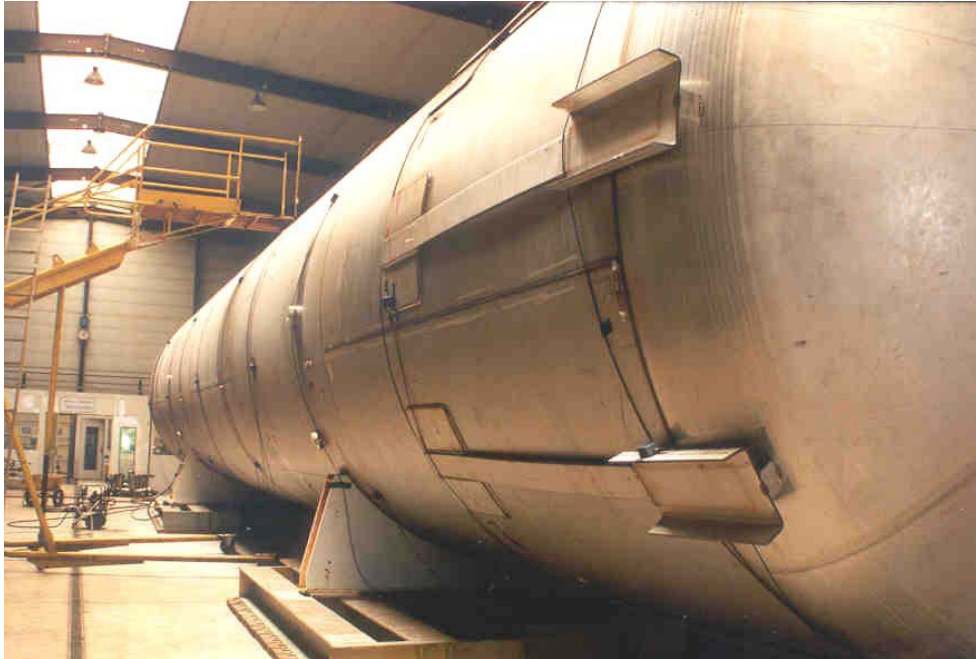
Acoustic emission is a very thorough inspection method capable of assessing the volumetric integrity of a pressure vessel during a pressure test period [16]. This method, like ultrasonic shear wave, has a code case (essentially an exemption) by ASME allowing its use in place of RT on some new pressure vessel inspections [16]. Acoustic emission sensors properly placed on a pressure vessel can detect the high-pitched sound caused by local metal deformation on a vessel [16]. By placing sensors and inducing stress (such as in a hydrostatic test) problem areas can be located on a vessel. European Pressure Equipment Directive member states have adopted regulations enabling acoustic emission monitoring of pneumatic pressure tests of pressure vessels in place of hydraulic proof tests [17]. The Centre for Technology and Innovation Management in the Netherlands has completed research showing the ability of using acoustic emission as a real time monitoring method to identify and locate possible weaknesses in pressure vessels [17]. An example is shown below.

Figure 40 Acoustic emission monitoring of pressure vessel final testing [17].

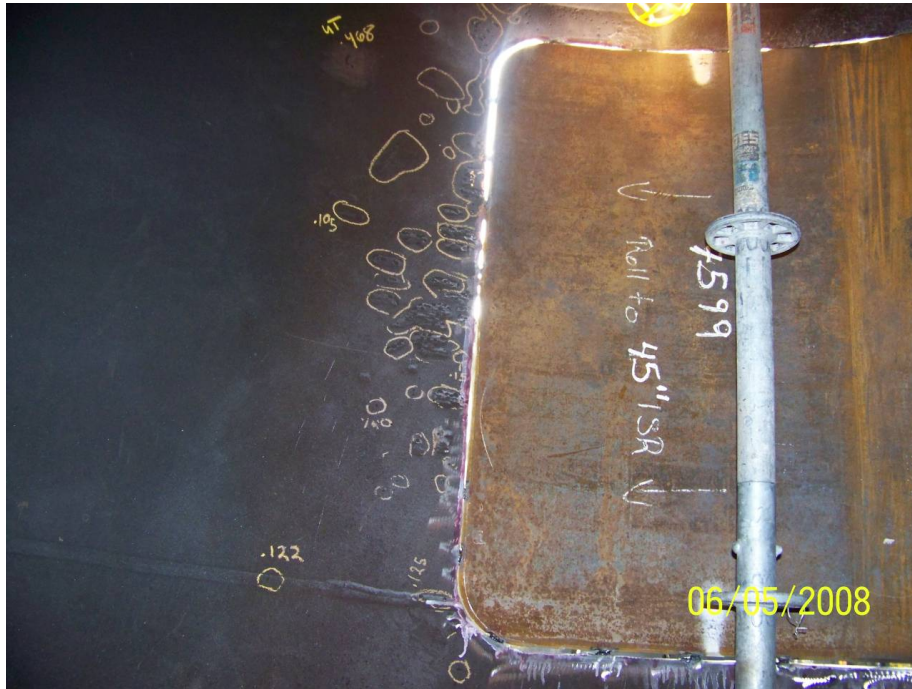
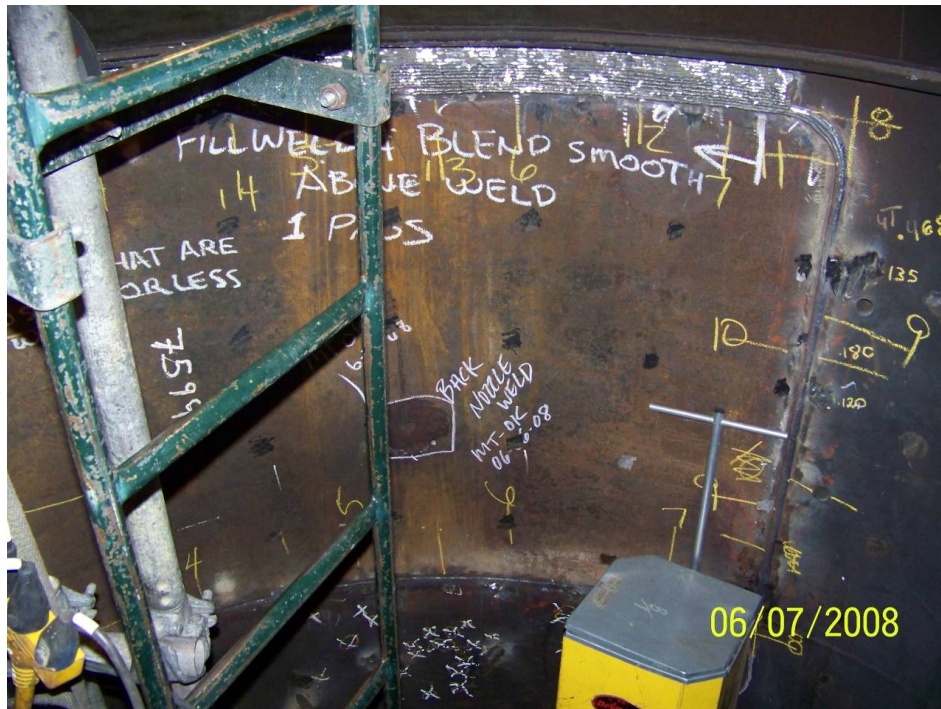
Repairing a pressure vessel requires a National Board “R” certificate holder to complete the work. API 510 [4] and NB 23 Part 3 [6] provide very detailed direction on the repair and re-rating of pressure vessels. The repairs must be performed under direct supervision and control of a qualified inspector [18]. Typical repairs include the gouging out of cracks, weld build-up over deep pitting or localized corrosion, and occasionally the replacement of a large corroded area with a patch. An example of a patch replacement and adjacent weld build up is shown in the following pictures. This repair was conducted on an amine contactor tower at a natural gas processing facility belonging to a major oil and gas producer. The vessel was subjected to pre-heat prior to welding and localized post weld heat treatment PWHT after the repair. Detailed NDE is completed after a repair using all of the techniques discussed above.

Figure 41 Photograph of fit-up of flush patch from inside of amine contactor tower and adjacent pitting. Photograph courtesy of Sandstone Engineering in Farmington, N.M.

Figure 42 Photograph of flush patch and weld build-up from inside of amine contactor tower. Photograph courtesy of Sandstone Engineering in Farmington, N.M.

Post repair inspection usually includes a very thorough visual inspection both during and after the repair. The welding is typically inspected by shear wave UT or RT both before and after PWHT.
