**Floodwater Lessons Learned:**

**Creede, CO**

**Creede, CO,  
Lessons Learned**

June 12, 1998

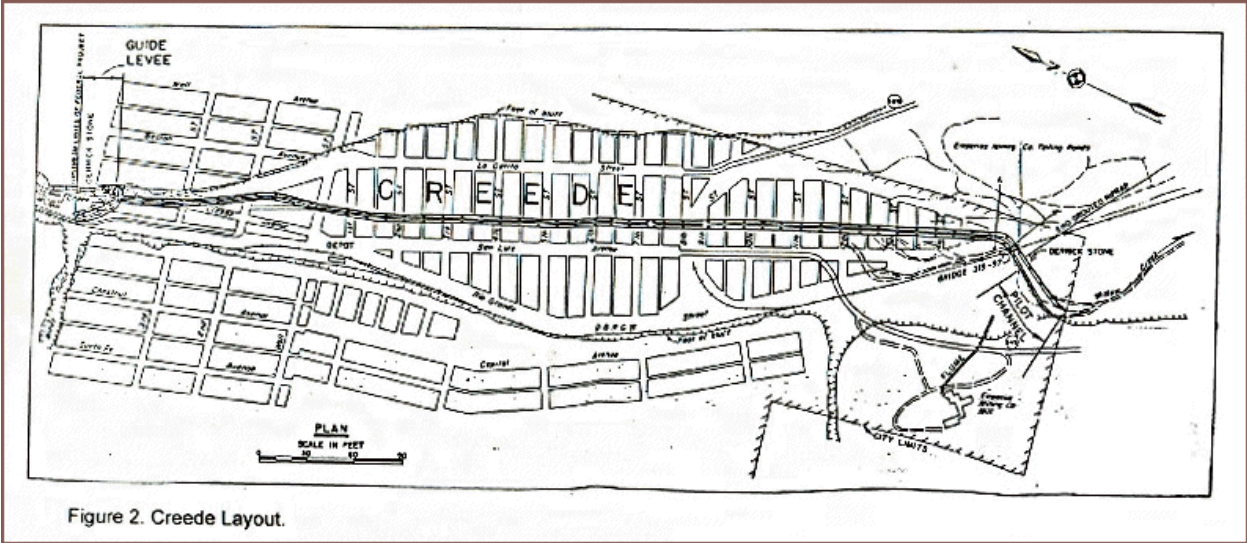
Figure 2. Creede Layout.

In 1944 Congress authorized construction of a timber crib wooden flume to replace the original wooden flume in Creede, CO constructed between 1890 and 1910. Fig. 1 shows the location. The War delayed the replacement and the Corps changed the design to grouted stone. Photos C-1-4 illustrate the history. Fig. 2 shows the layout. Channel length is 5527 feet. Bottom width is 8 feet. Depth is 7.5 feet. Sideslopes are 1.5:1. Slope is 0.015. Fig. 3 shows typical sections. Small, low clearance vehicular and pedestrian bridges cross the channel. Design discharge is 1800 cfs. Freeboard, based on the 0.012 design Manning's  $n$ , is as low as 1 foot in some reaches.
