US Army Corps of Engineers
(Albuquerque District)
Floodwater Lessons Learned
Socorro Diversion Channel

Floodwater Lessons Learned Socorro Diversion Channel

Socorro Diversion Channel

Title: Socorro Diversion Channel Project, Socorro, New Mexico
Sponsor: City of Socorro
Contract: DA-29-005-CIVENG-63-2
Final Inspection: 1964

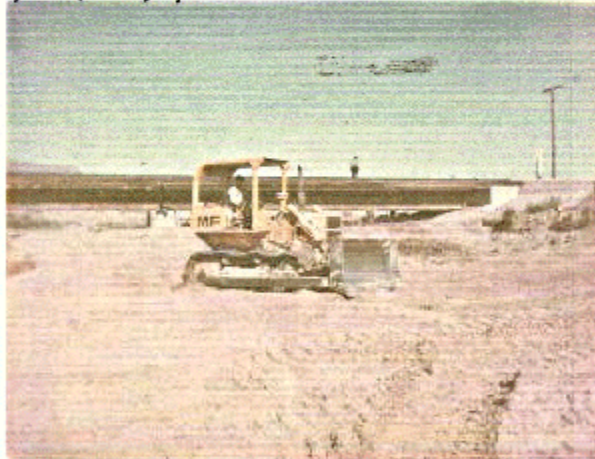
Photo 18. The City at work

Sediment transport at the outfall should be assessed, a task for which the Corps is now better equipped than at the time of initial design. Several alternatives merit thought:

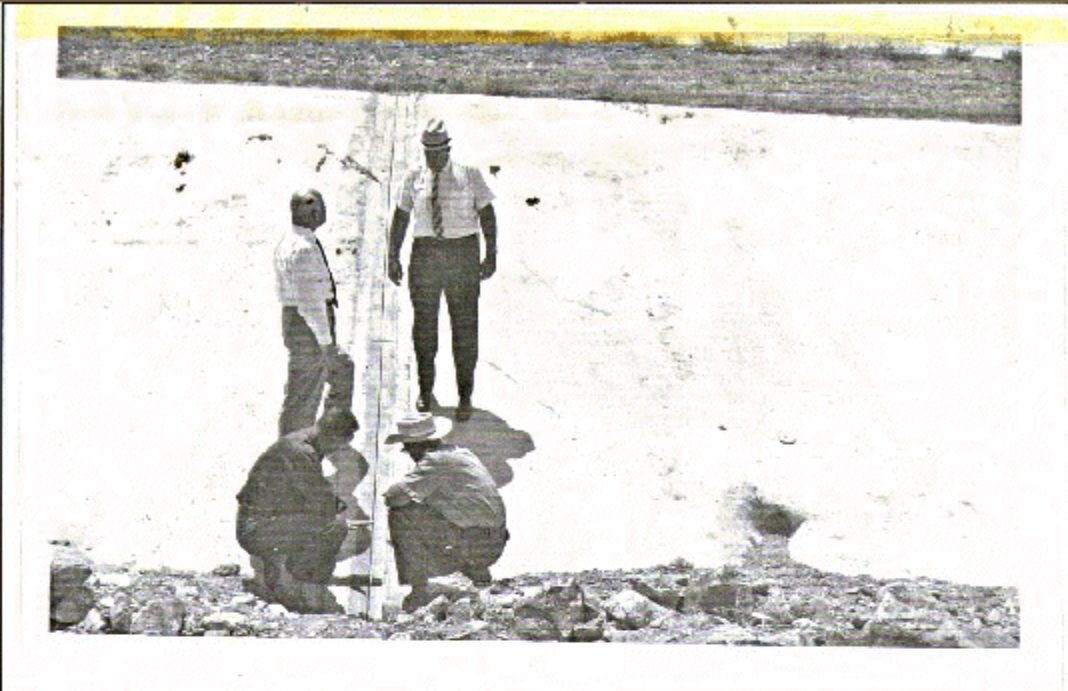
Photo 26. Mayor and Engineering Division Chief inspect the new gage.

In an inclined peak stage gage, the plate is removed after runoff to inspect the high silt mark. Photos 26-27 speak for themselves.

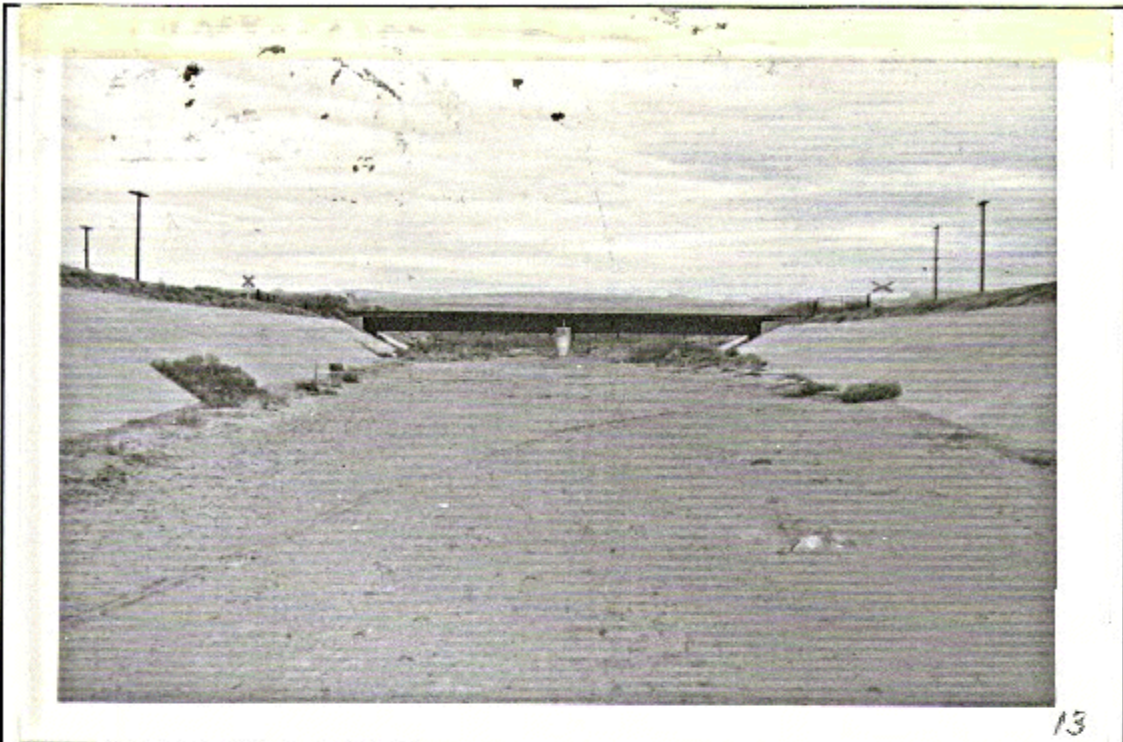
RR Photo 3. 3 December 1969

The railroad crossing of the outfall channel serves as a benchmark for deposition. Original clearance was 10.5 feet. The RR series of photos document the years since project construction.
