US Army Corps of Engineers

**Floodwater Lesson Learned
Channel Stabilization in Santa Fe, NM**

**CHANNEL STABILIZATION
IN SANTA FE, NEW MEXICO**

July 1997

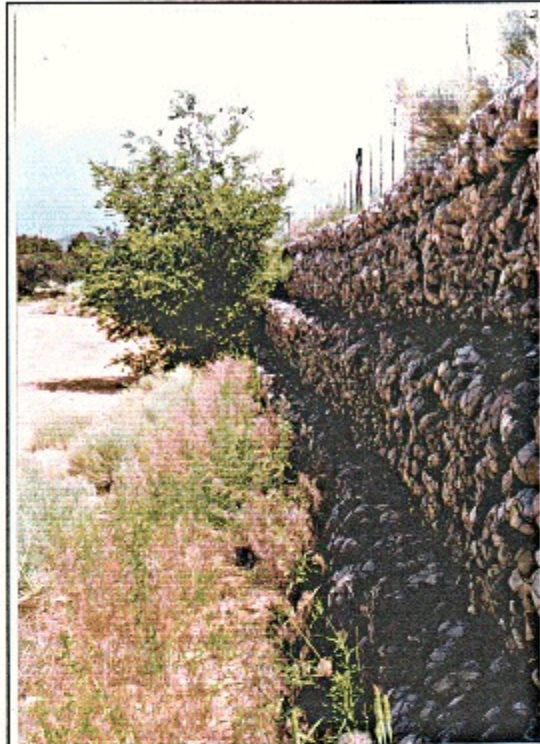
Figure 1. Stable sideslope protection.

Fig. 1 shows floodwall gabions tied at a 12-inch layback, not 18 inches as specified. Because the toe is stable, as indicated by the overgrowth, the construction error can be tolerated. If the toe begins to rotate, however, toppling may follow.

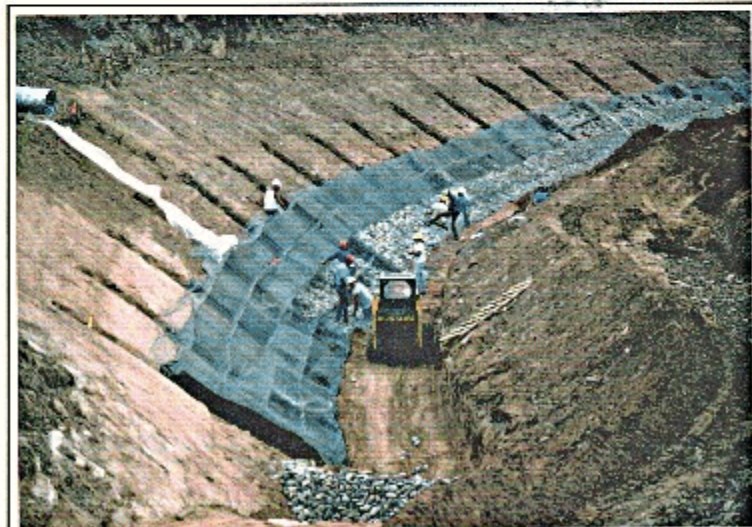
Figure 2. Trenched sideslope toe

Sidewalls fail when the toe is undercut. The footing must extend below any conceivable scour. Fig. 2 illustrates trenching to this effect. While a practice of, say, 5-foot cover may reflect general experience, the depth is only meaningful when long-term trends are understood.

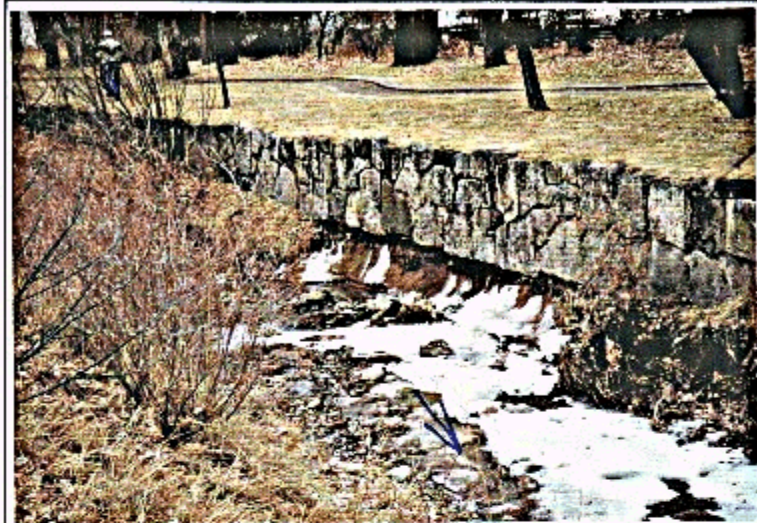
Figure 5. Suspended rock wall

The aesthetic rockwork in Fig. 5 appears to defy gravity. Undercut sidewalls must be retrofitted with gabion toes.

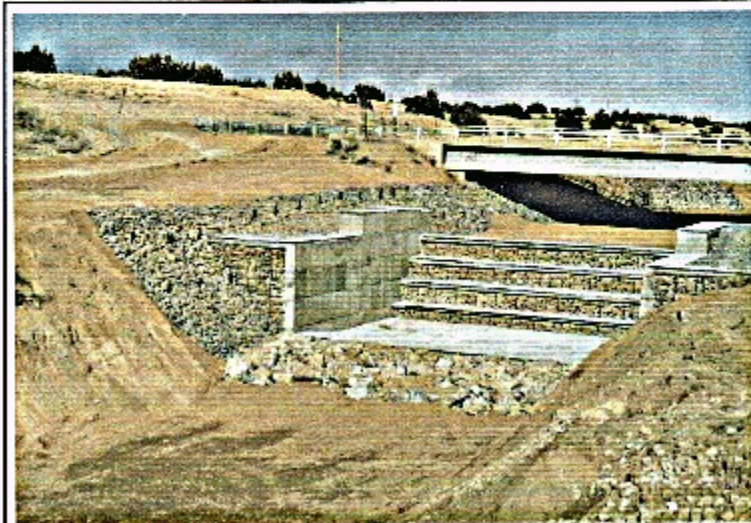
Figure 11. Design for permanence

Figs. 11 and 12 show a recent grade control improvement, bearing little resemblance to Phase I and II improvements. This structure resembles a suggested Maccaterri configuration.

While the grade control structure of Figs. 11 and 12 functions well hydraulically, its rock mattress wall is vulnerable to undercutting, as seen in Fig. 13. Specified toe burial was not done.

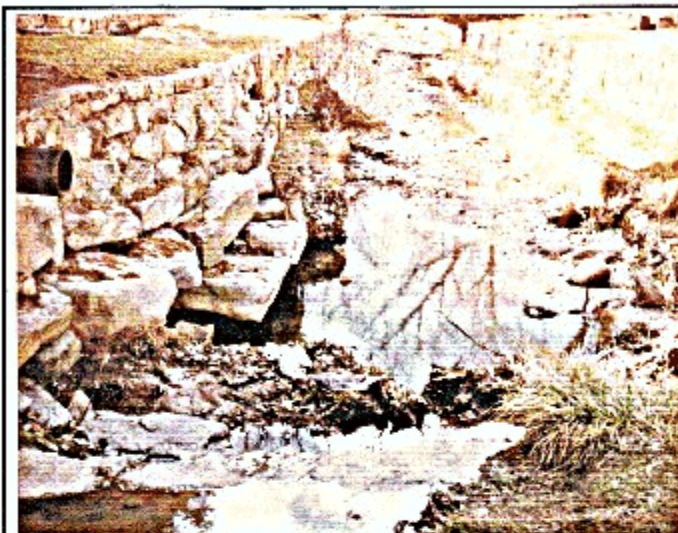
Figure 15. Undercutting below grade control

Older grade control structures not purposefully breached, such as the rock wall weir in the bottom of Fig. 15, need care. The slab rocks below this structure are undercut.

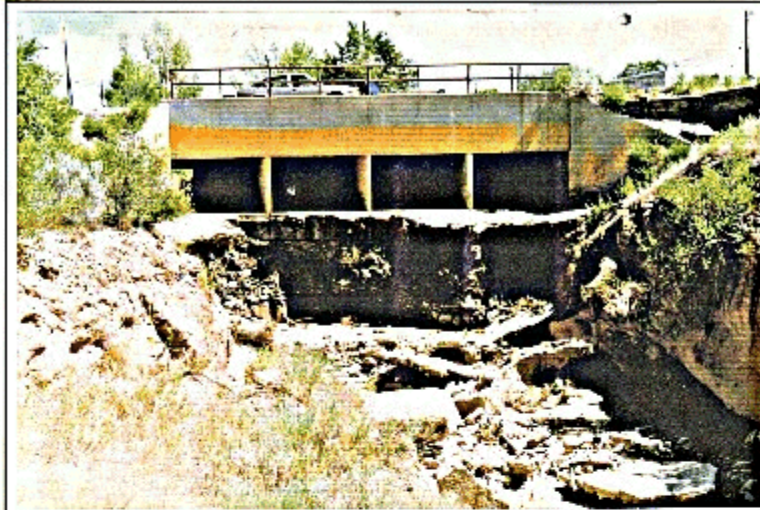
Figure 17. One way to halt a headcut

Visually, Fig. 17 seems an unlikely candidate for the "What Worked" category. The box culvert can arrest a headcut. Until they collapse into the void below, box culverts provide a line of defense.

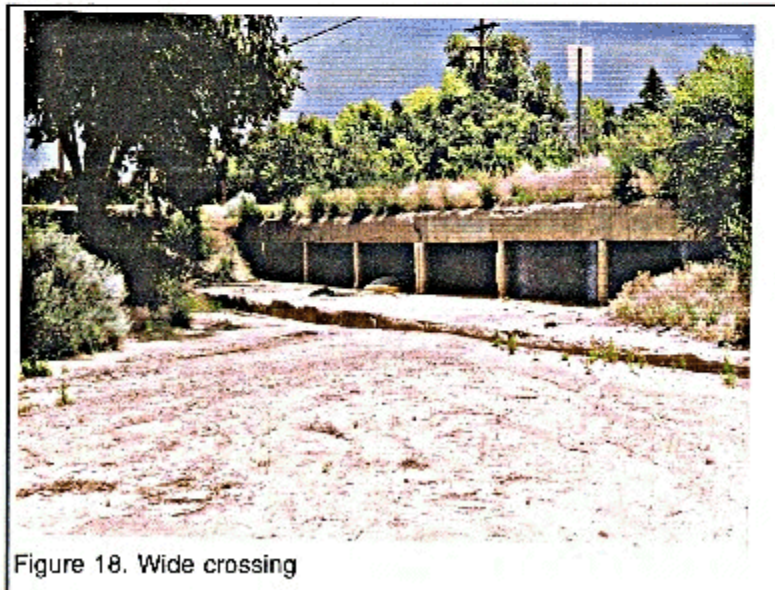
Figure 18. Wide crossing

Crossings that do not constrict the bed are less likely to induce scour, as shown by the 70-year stability in Fig. 18.

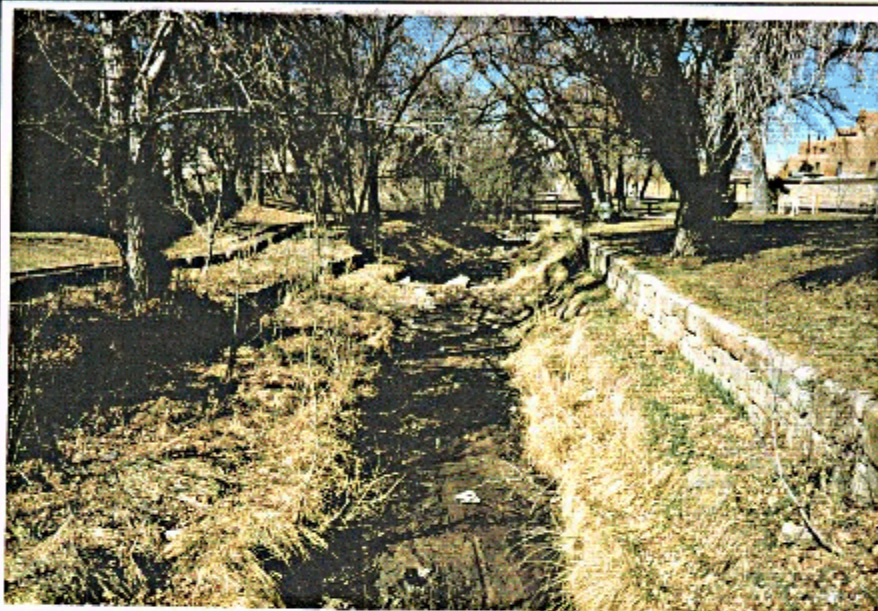
Figure 24. Toe vegetation

Where general scour is absent, vegetation can protect sidewall footings. In Fig. 24, gabions protecting the older rock wall are successfully overgrown with grass.

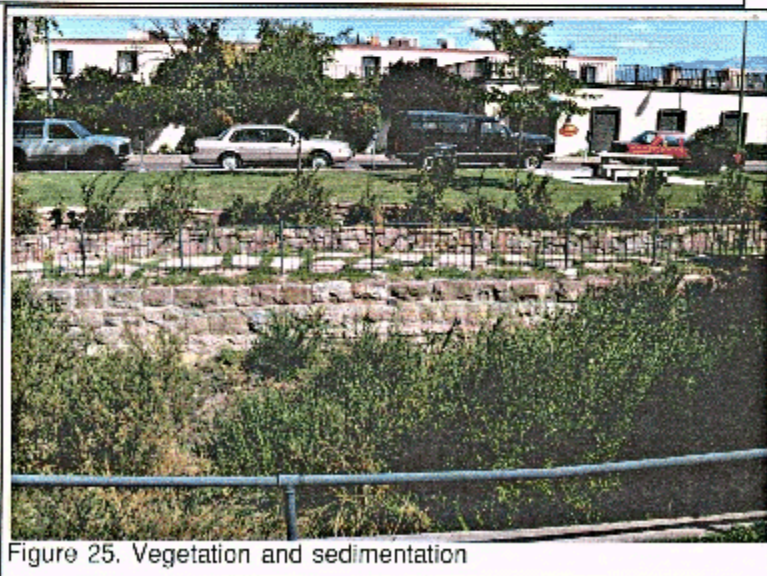
Figure 25. Vegetation and sedimentation

Fig. 22 shows complementary vegetation and siltation covering a gabion toe after 25 years. The buried mesh has probably corroded, which is acceptable if general scour does not occur.

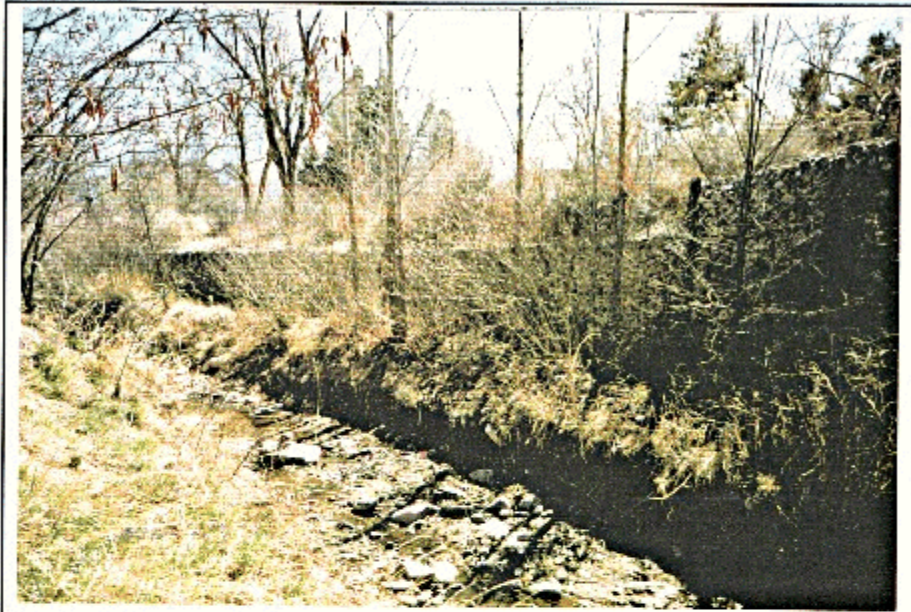
Figure 26. Tree protection

Trees provide additional wall protection, as illustrated In Fig. 26.

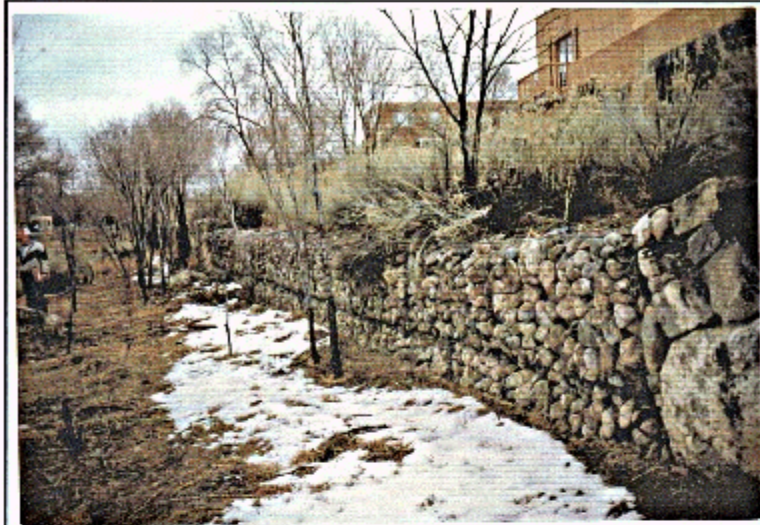
Figure 36. 25-year gabions in "as built" condition

The gabion rockfill has proven to be satisfactory. Riprap wire in reaches with infrequent ephemeral flows looks almost new after 25 years, as seen in Fig. 36

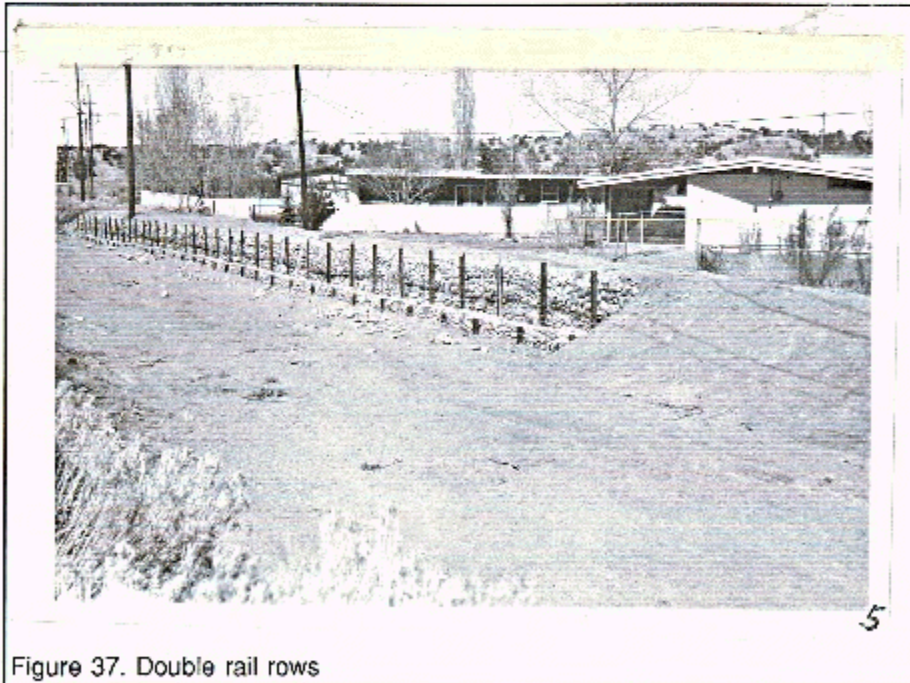
Figure 37. Double rail rows

Rails appear to be standard practice. Fig. 37 shows use of a double row.

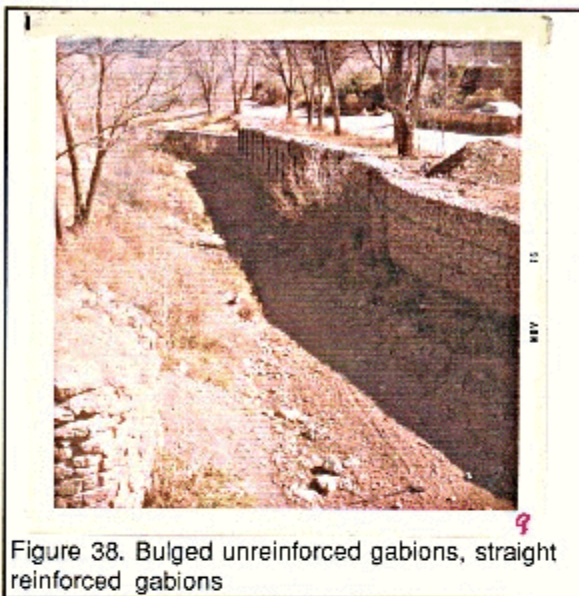
Figure 38. Bulged unreinforced gabions, straight reinforced gabions

The gabion wall in Fig. 38 is reinforced by rails in the far section and unreinforced in the near section. Note the bulging in the unreinforced section.

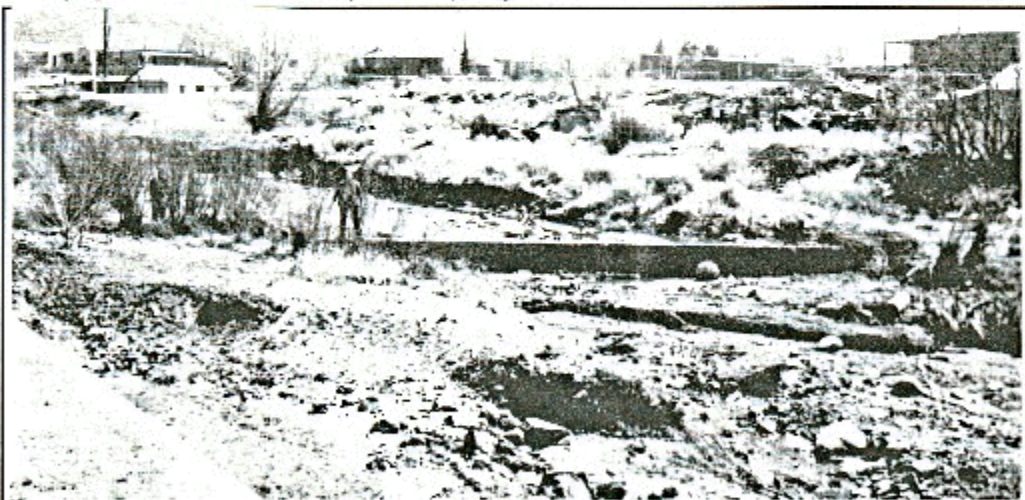
Photo 1. 20 August 1969

The sewer line was at channel grade, encased in a 3x3-foot concrete jacket. The channel reach was historically held in equilibrium by downstream grade control structures. The grade control structures had deteriorated and/or been removed by the City to increase flood conveyance capacity.

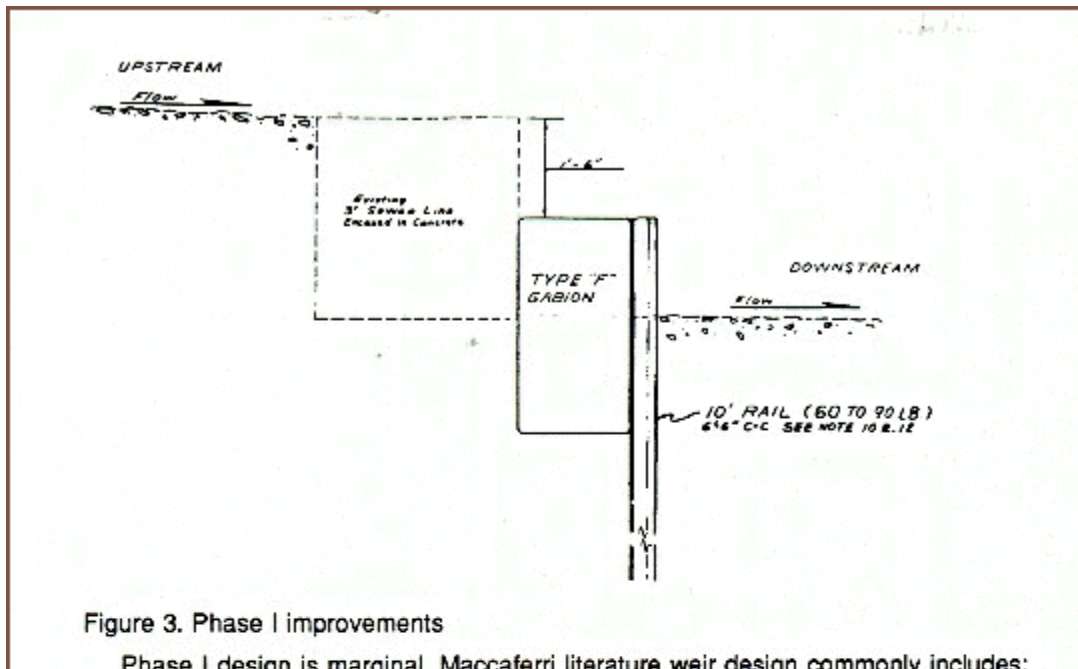
Figure 3. Phase I improvements

Design calculations and criteria are not archived in the inspection reports. Fig. 3 is the design drawing.

Phase I design is marginal. Maccaferri literature weir design commonly includes:

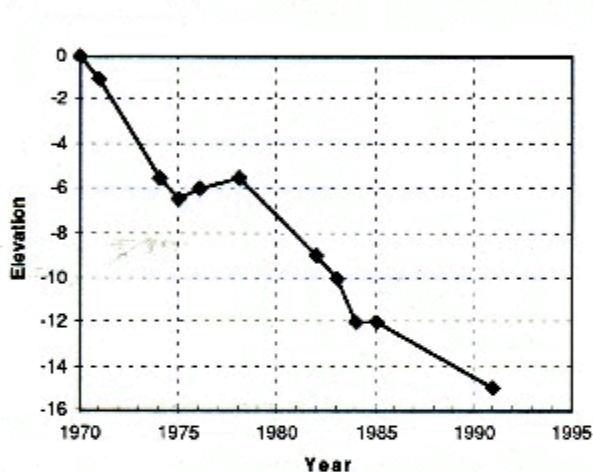
Figure 6. Channel elevation at sewer line crossing, 1970 = 0 feet

Despite Phase I, the channel continued to erode. Fig. 6 traces the subsequent degradation history.

Persistent erosion may have been due to both plunge from the drop and headcut progression from general scour. As the Phase I toe was undermined, the gabion baskets sagged, rotated and ruptured.

Fig. 6's apparent recovery in the mid-1970's probably reflects an error in a relative observation. No inspection notes suggest that the scour reversed.

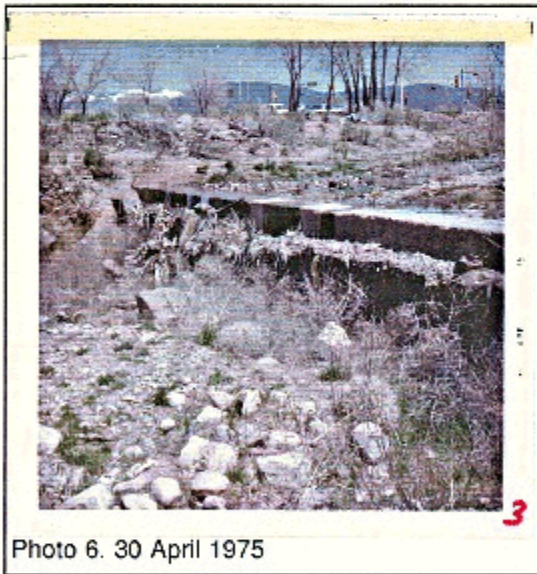
Photo 6. 30 April 1975

Inspection Report, 30 April 1975
At the sewer line crossing Santa Fe River, the gabions placed to prevent undercutting of the sewer line are themselves undercut, up to 3 or 4 feet. They are now held only by the driven steel rails, and are beginning to slump and break up.
Photo Note: Vertical rails have caught a lot of trash and partly obscure the row of gabions.

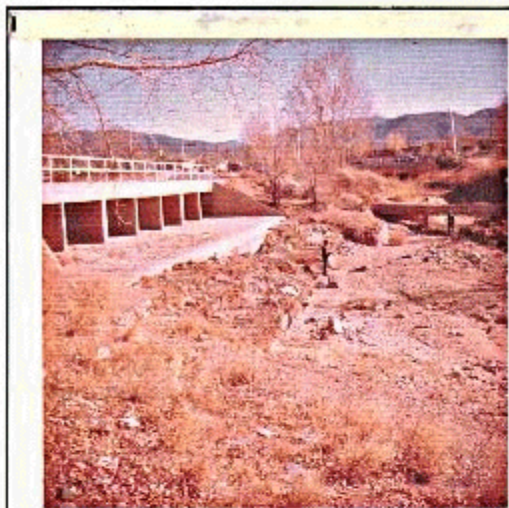
Photo 7. 23 November 1976

Inspection Report, 23 November 1976

Scour action continued in 1976, causing total failure and removal of much of the rail-and gabion structure supporting the downstream side of a concrete-encased sewer line. Scour action is now able to progress upstream, which is the stated objective of the City Engineer. The sewer line is scheduled for replacement this winter by a steel free span pipe a few inches higher and a few feet downstream.

Photo Notes: River deepened about 6 feet in 5 years primarily due to the removal of check dams and other artificial grade controls by the City. The gabion structure collapsed due to undercutting. Bed scouring continuing. Structure reported as severely damaged in 1975.

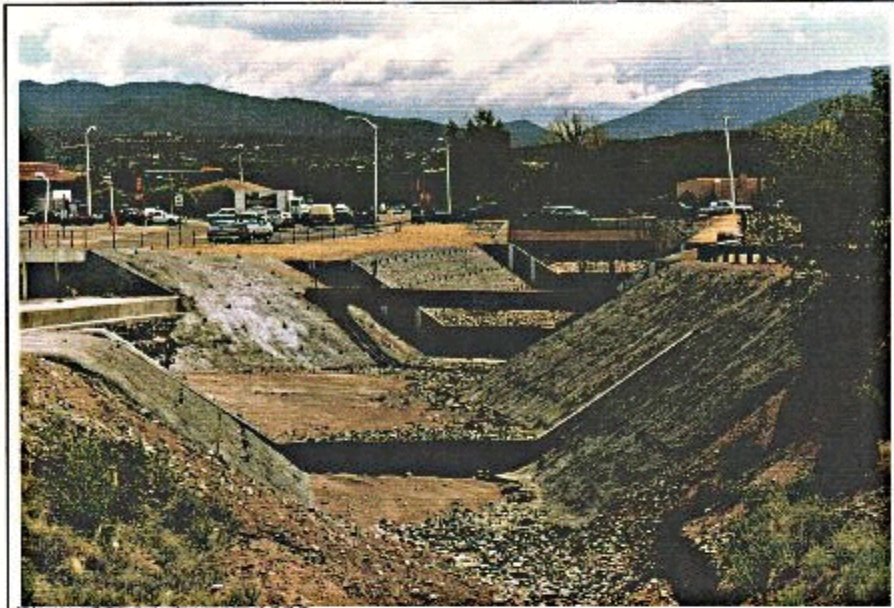
Photo 22. 14 August 1992

The reach from St. Francis Drive to the Arroyo Mascaras confluence was lined in 1992 in conjunction with New Mexico State Highway and Transportation Department work. Channel improvements included gabions and rock mattresses, concrete drop structures, and extensive grouting. The sewer line piers were removed, allowing the pipe to freely span the channel.

The drawings specify grouting the channel bottom only. As-built, the sidewalls are grouted as well, reducing any hope the structure ever had for attractiveness.

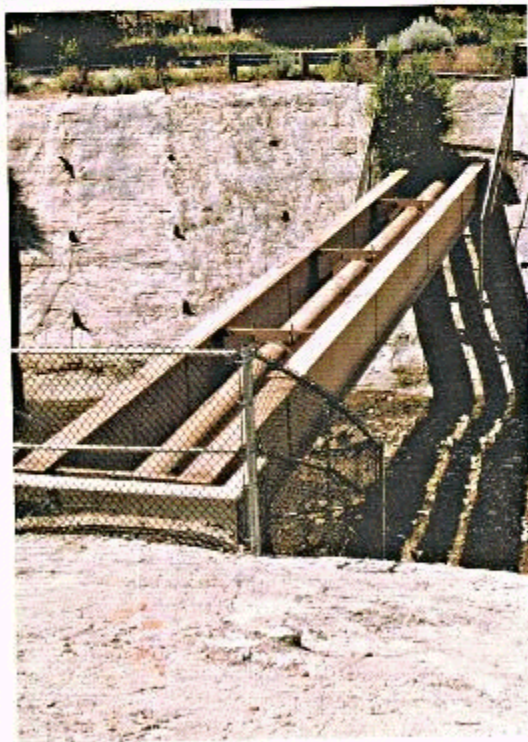
Photo 27. 26 June 1997

FEMA mapping indicates that the pipe is below the 100-year water surface. Flood flow overtops St. Francis Drive and reenters the channel in this reach. The sewer line is but a minuscule aspect of Santa Fe's vulnerability to probable flood events. I-beams bracketing the sewer line may shield the line from debris impact.
